# EC-8639 massage chair service

## 一、Product introduction

### 3、 External Side Structure:

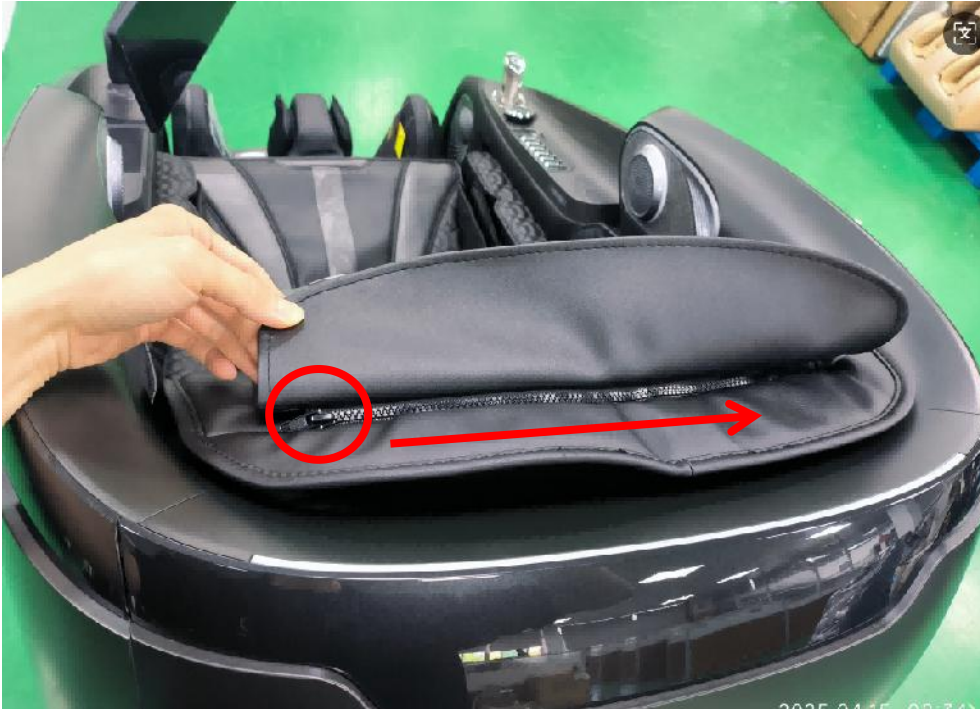
unzip the zipper

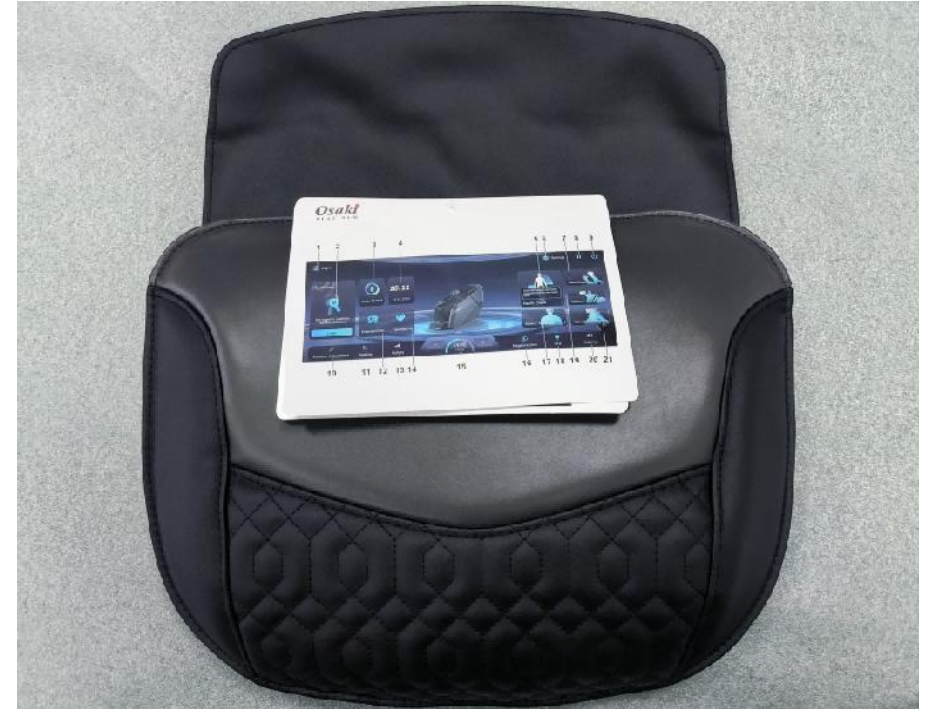
remove the pillow

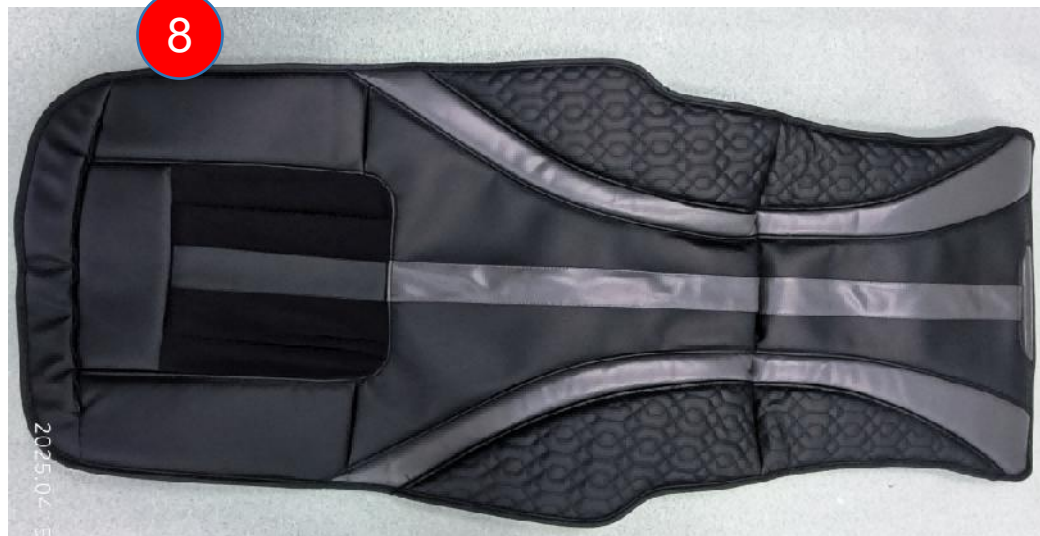
remove backrest pad

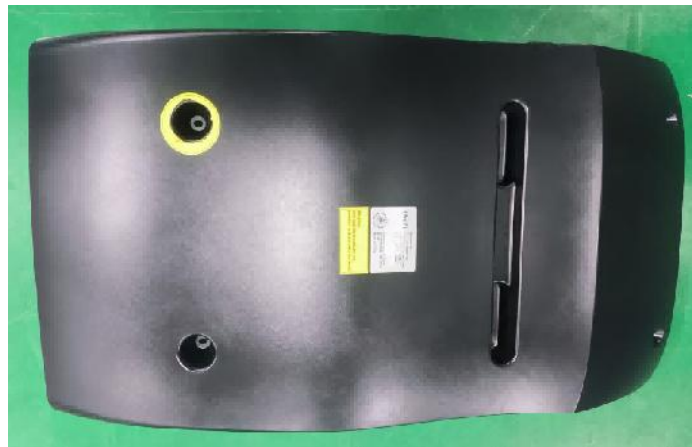
4

remove the rear cover

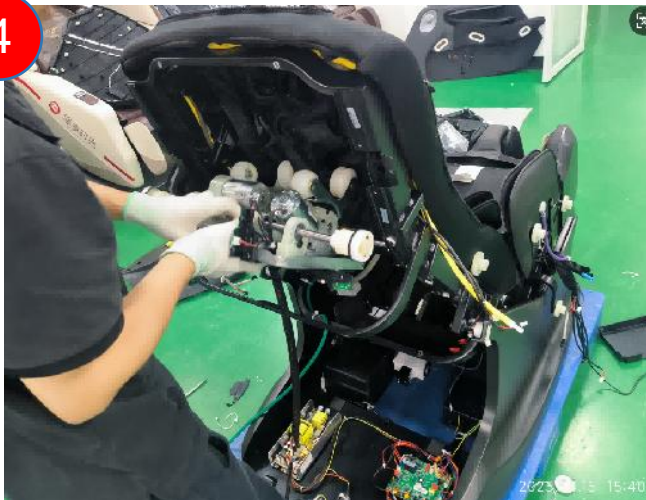
remove lower gear box

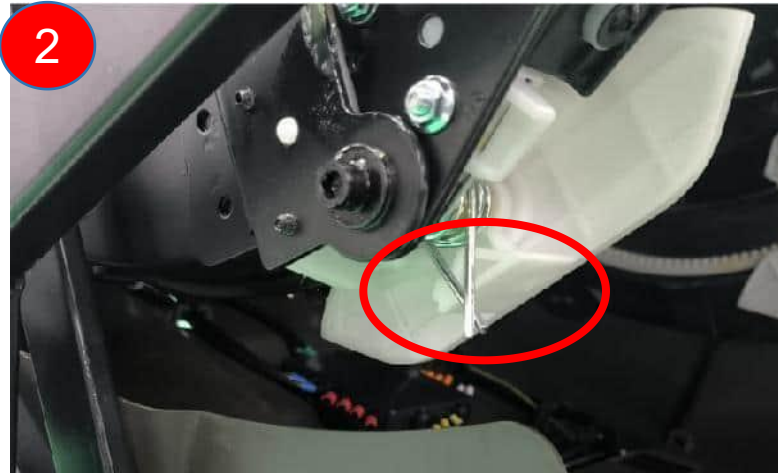
clamp the spring open with  
apointed nose pliers

Spring released

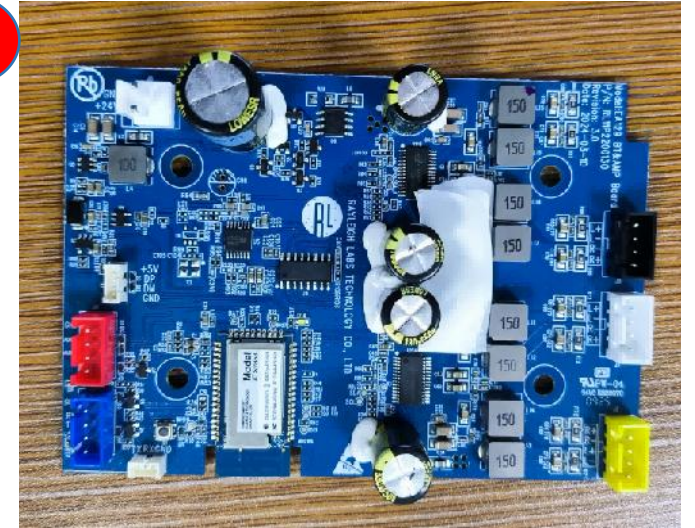
10

remove Bluetooth PCB

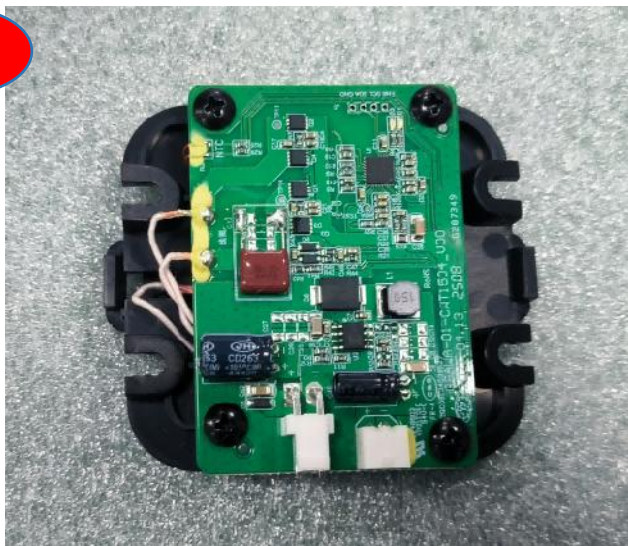
remove wireless charging unit

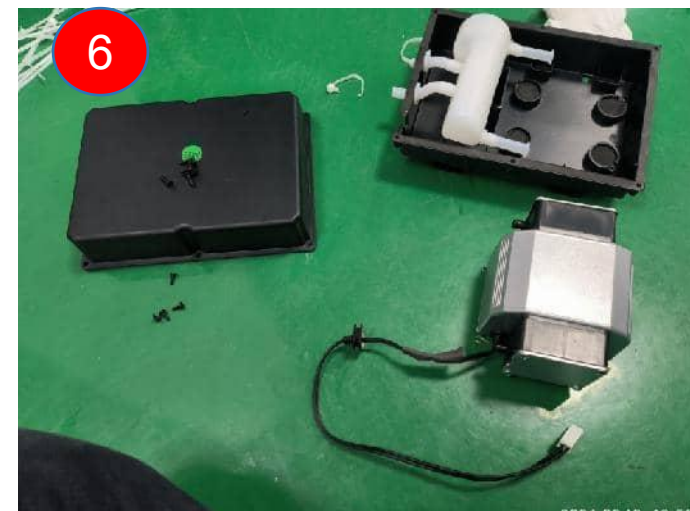
separate the air pump

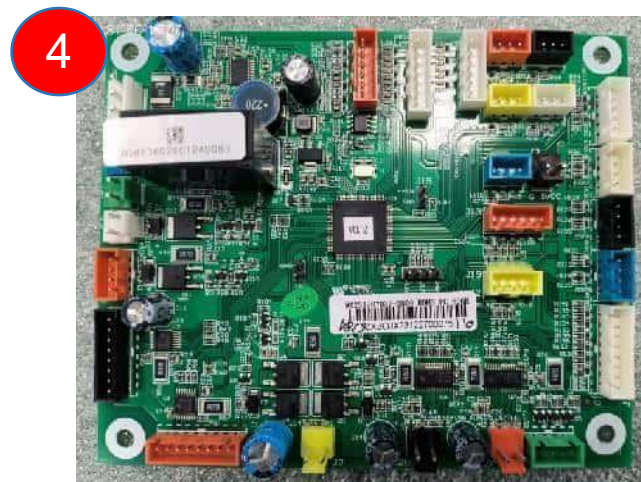
main PCB

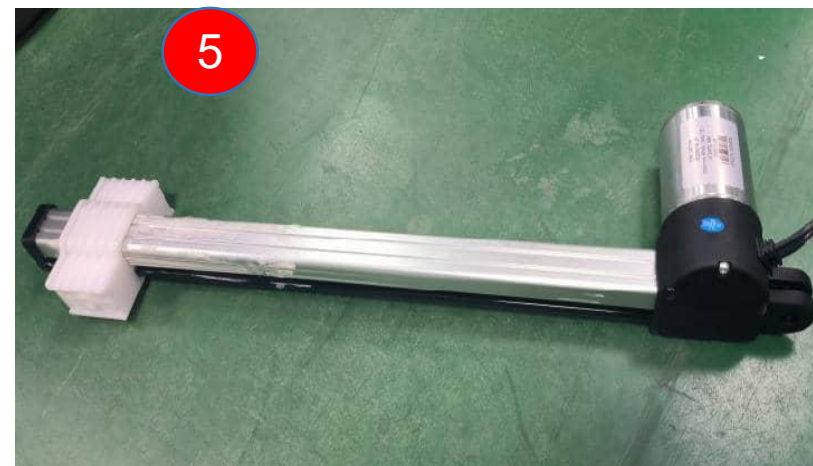
Remove the front pin and rear screw

remove backrest actuator

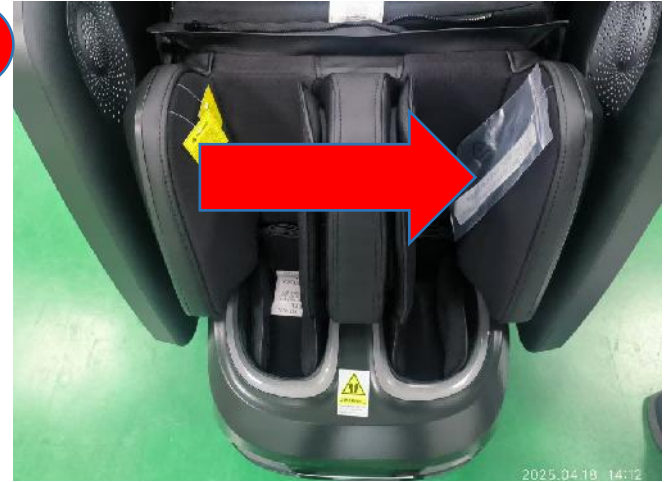
3

Move the legrest to the right
