Aster Massage chair after-sales maintenance

Aster Massage chair after-sales maintenance-product internal Structure and disassembly

- 1. Parts name
- 2. Internal structure diagram
- 3. Driver board plug-in diagram
- 4. Product disassembly diagram

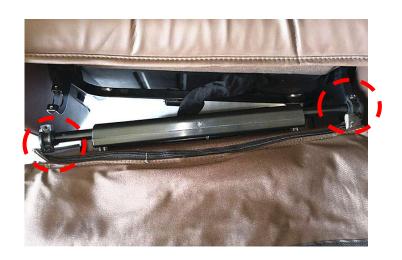
4. Footrest installation diagram

A. Connect the airhose and the cables

B. Remove the footrest sleeve at one end and fix the screws.

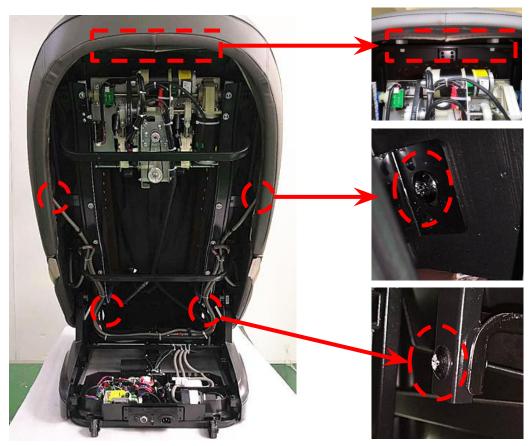
5. Disassembly diagram of armrest capsule

A. Remove the four screws which holding the armrest capsule

Take off the capsule air hose and wire harness plug and remote it

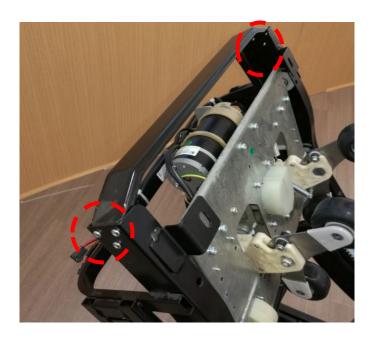
8. massage hand disassembly diagram

A. Remove the left and right 6 screws of the backrest steel frame and remove the upper limit switch. (note: remove the capsule first)

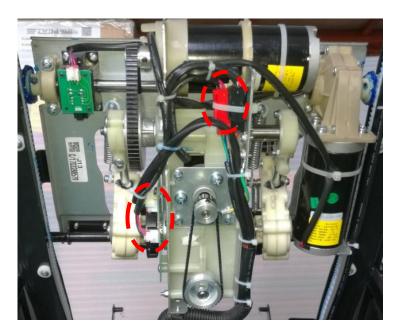
B. Cut the massage hand wire cables band.

Take note for the wires placing method for installation later

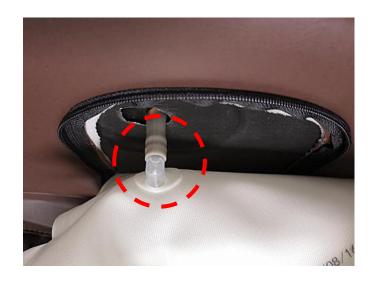
B. Separate the air bag from the airhose and remove the air bag

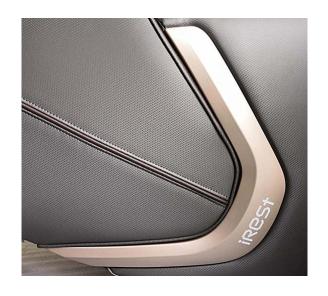
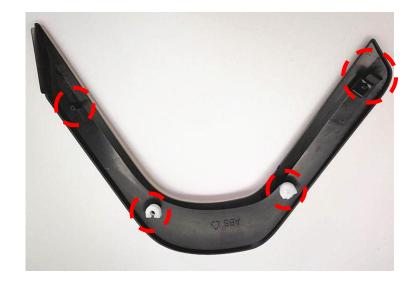
12. Armrest decoration strip disassembly diagram

A. Remove one screw from the inner decorative plate of the armrest and pull out the decorative cover with force from the lower end

B. The decorative strip is fixed by a screw, two car buttons and the upper end of the iron block

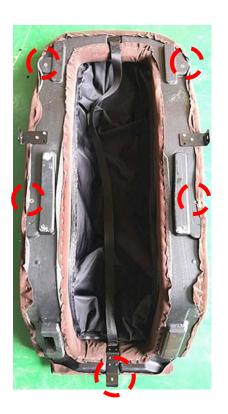
13. Backrest frame disassembly diagram

A. Remove the top 4 screws of the backrest frame

B, Remove the screw at one end of the bag strap and remove it from the massage hand, then you can take out the backrest frame
