EC-8507B massage chair service guide

- Product introduction
- 二、Massage chair tools and use
- 三、Circuit working principle
- 四、Massage chair removal instructions
- 五、Massage chair fault judgment

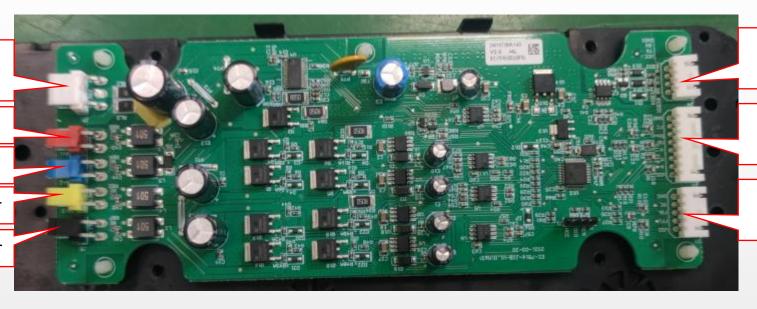
6. upper Gearbox PCB:

J7: 24V,connect underseat PCB J13

J6-1:telescopic motor

J6-2:tapping motor

J6-3:kneading motor

J5: telescopic motor

J4: signal ,connect underseat PCB J26

J2:Movement detection signal

J3:Movement detection signal

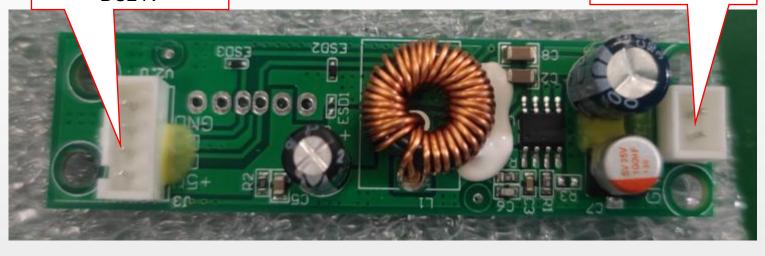
9. Charging PCB:

J3: connect underseat PCB J31 DC24V J2:Charging PCB communication ,c onnect USB PCB

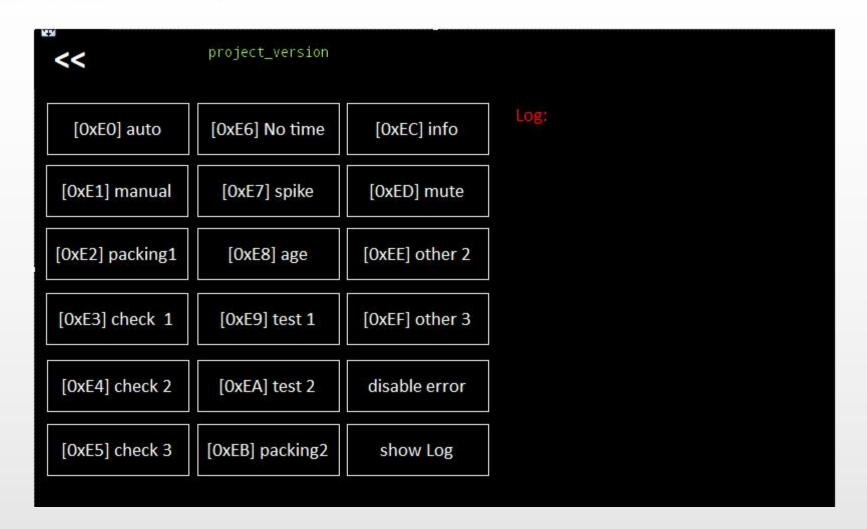
1, error code:

在设置页面屏幕最下方长按数秒,将弹出工程模式密码输入页面

密码: 0592

或 0000

长按此区域
