EC-8507B massage chair service guide

Table of Contents

- 一、 Product introduction
- 二、 Massage chair tools and use
- 三、 Circuit working principle
- 四、 Massage chair removal instructions
- 五、 Massage chair fault judgment

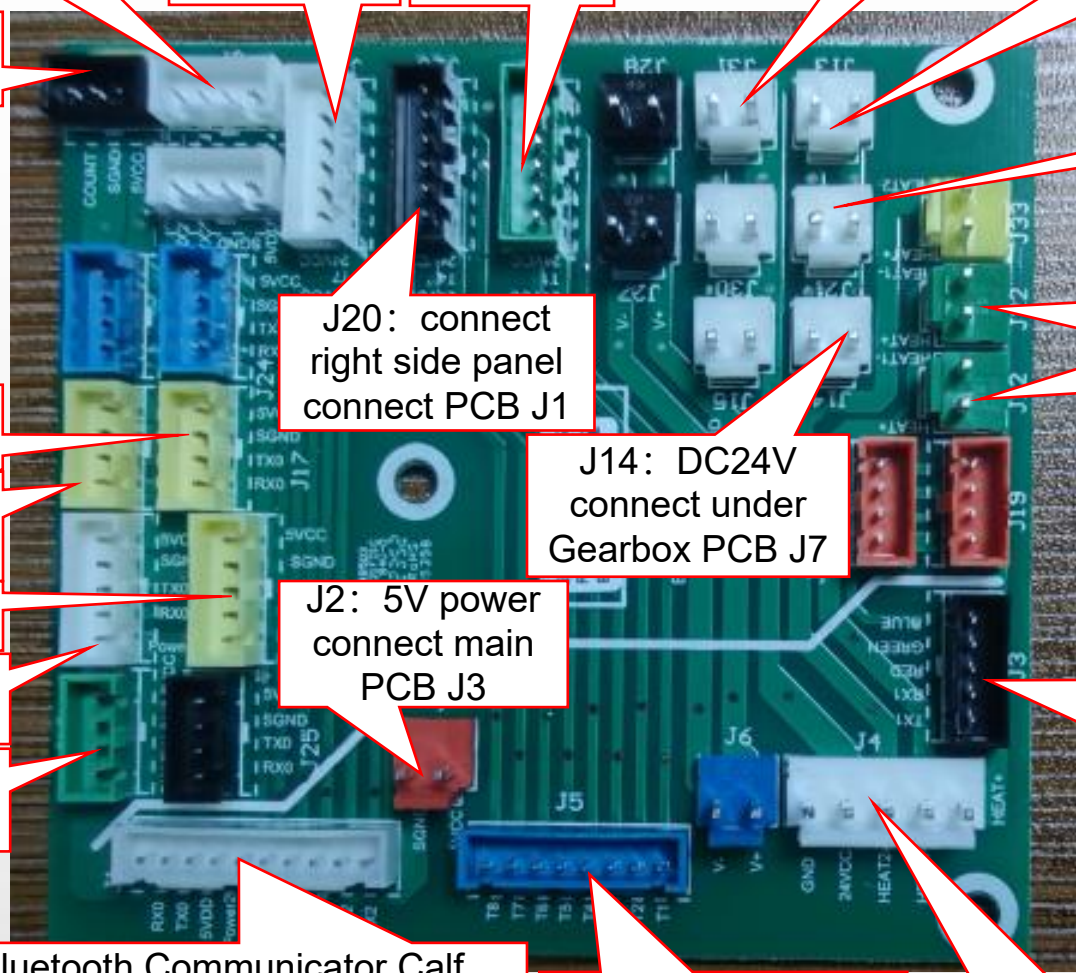
4、underseat PCB:

J7: Bluetooth communication

J32: Seat frame dual air valve

J16: 24v Left triple air valve

J31: 24v USB charge

J13: DC24V connect upper Gearbox PCB J7

J9: legrest actuator counting sensor

J21: DC24V output connect legrest PCB J8

J17: legrest communication connect legrest PCB J2

J22: heat

J26: upper Gearbox communication connect 3D PCB J4

J12: heat

J14: remote controller

J14: DC24V connect under Gearbox PCB J7

J8: Side panel controller connected to right side panel connect PCB J1

J2: 5V power connect main PCB J3

J3: under Gearbox communication, communication connect main PCB J16, J1

J10: under Gearbox communication connect PCB J2

J1: Bluetooth Communicator, Calf counting port, Sore Communication, pad control POWER1, side panel POWER2, leg/Gearbox/pad control communicate (communication connect main PCB J9, J11, J21, J14, J10, J14)

J5: side seat, arm, shoulder, inflated, Gearbox inflate (connect main PCB J6, J7)

J4: 24V input to heat additive, connect main PCB J4, J27

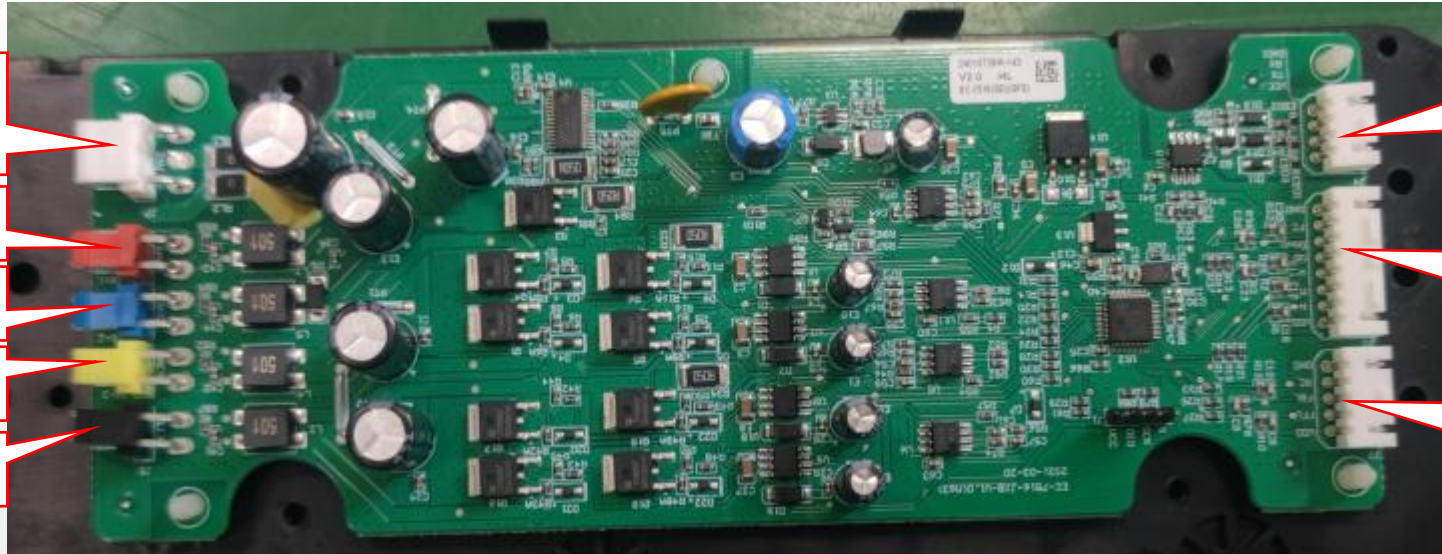
6、 upper Gearbox PCB:

J7: 24V,connect
underseat PCB J13

J6-1:telescopic motor

J6-2:tapping motor

J6-3:kneading motor

J5: telescopic motor

J4: signal ,connect
underseat PCB J26

J2:Movement
detection signal

J3:Movement
detection signal

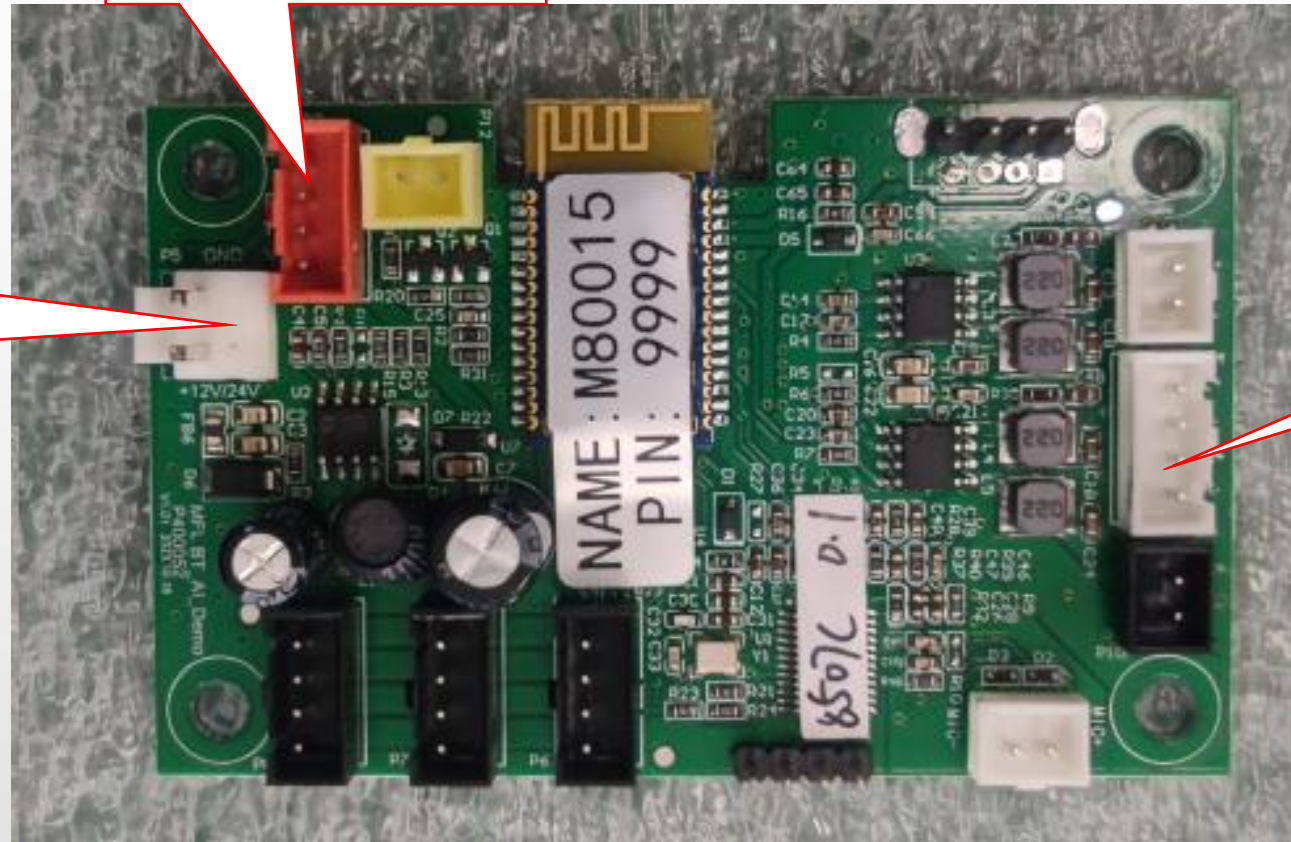
10、 Bluetooth PCB :

J6: Bluetooth communication,
connect right side panel
connect PCB J5

J1: connect
right side panel
connect PCB J2
24V

J16: hron communication
connect horn

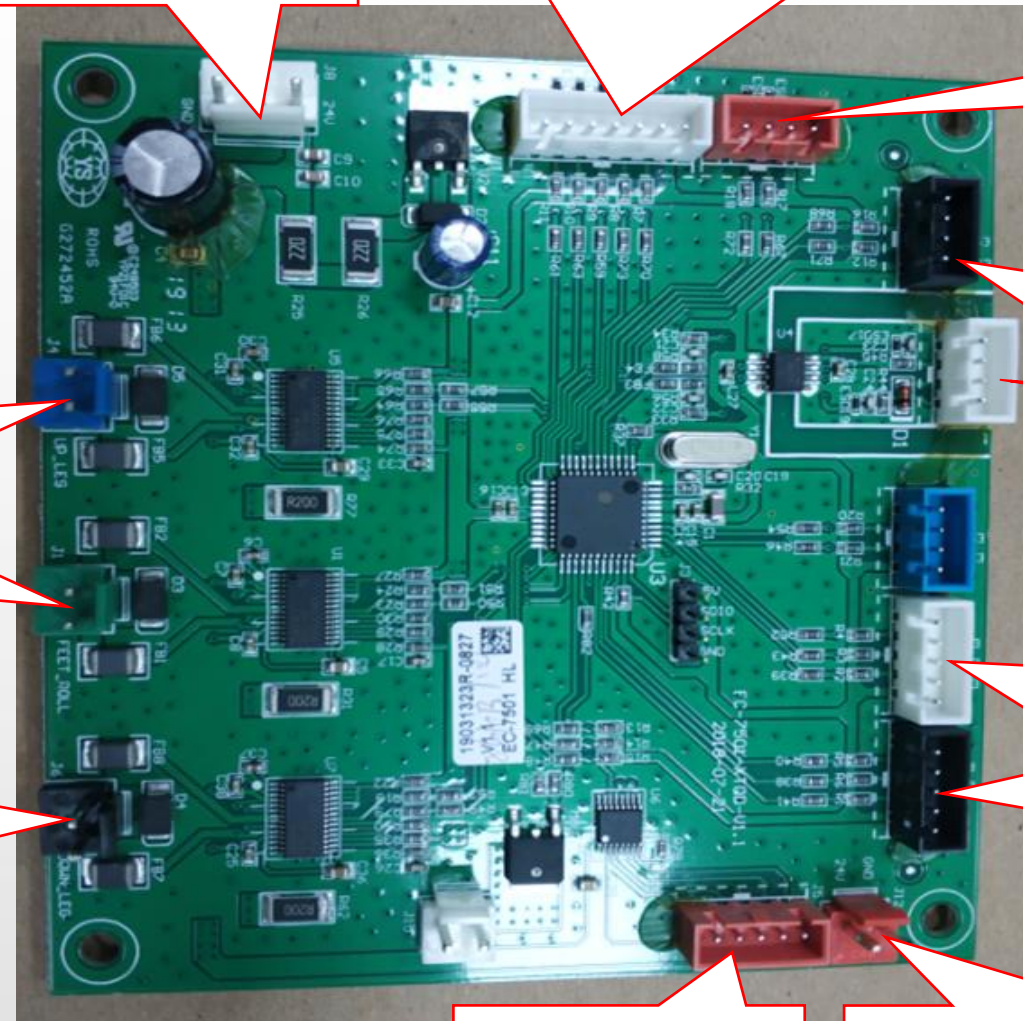
11、legrest PCB:

J8: 24V connect
underseat PCB J21

J10: Lower leg inflation port connected to air pressure
detection PCB J6

J7: Foot roll detection

J9: connect Leg
extension detection
PCB and touchdown
wheel

J4: upper legrest extension connect
upper legrest pinch motor

J2: communication,
connect underseat
PCB J17

J1: connect foot massage 24V

J13: Upper leg
extension detection
Connect anti pinch PCB
J1

J6: connect lower legrest extension
motor

J14: connect lower leg
extension detection

J5: Connect the
lower leg to inflate

J12: DC24 V power output connect
to air pressure detection PCB J4

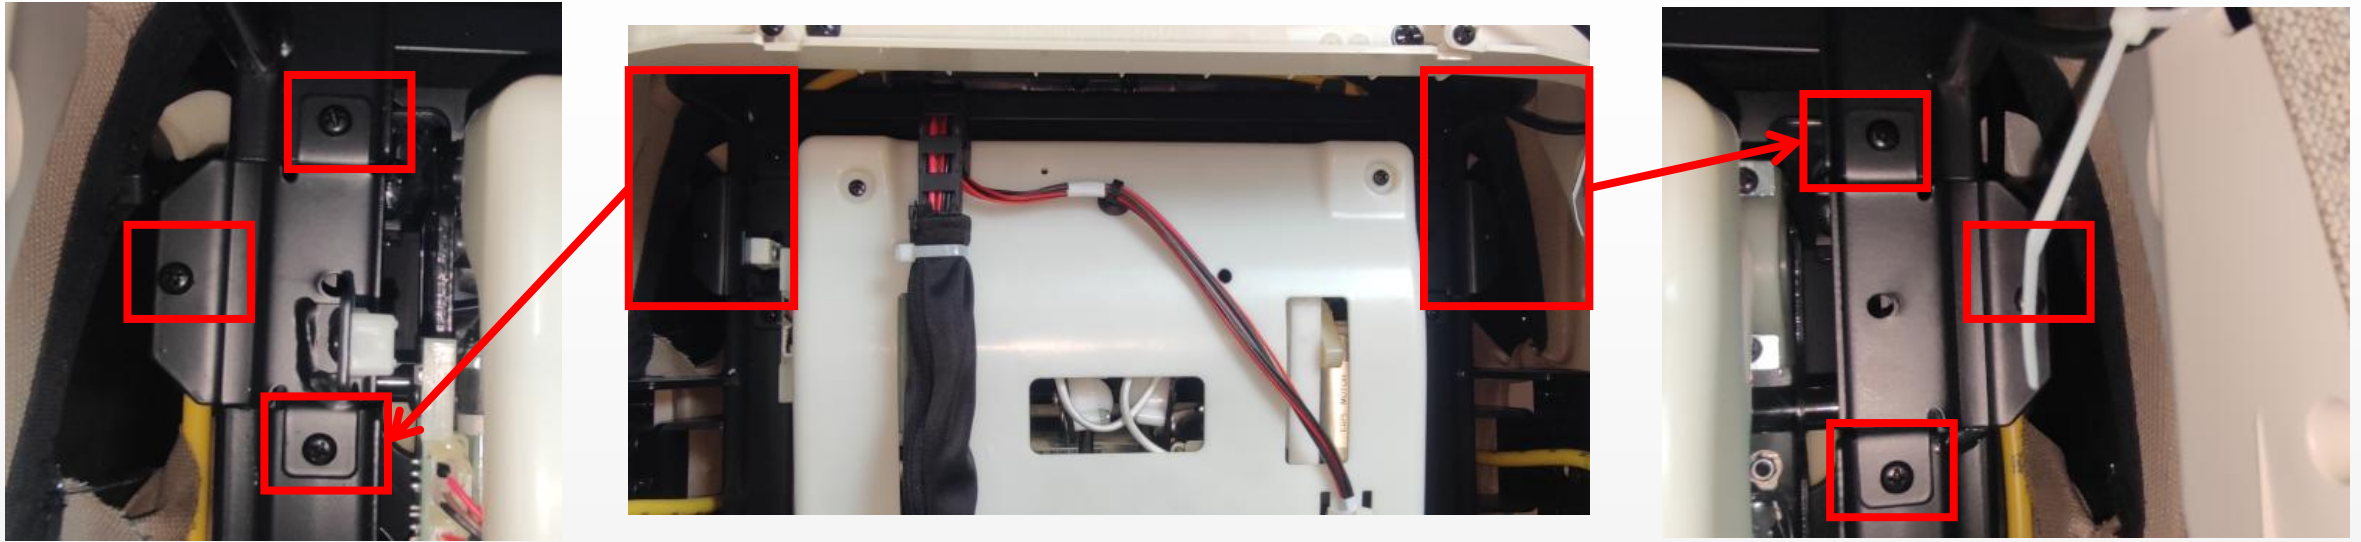
14、disassembly of the Gearbox:

D.Remove the baffle both side

E.connect red terminal with a 24V power, mechanism go up

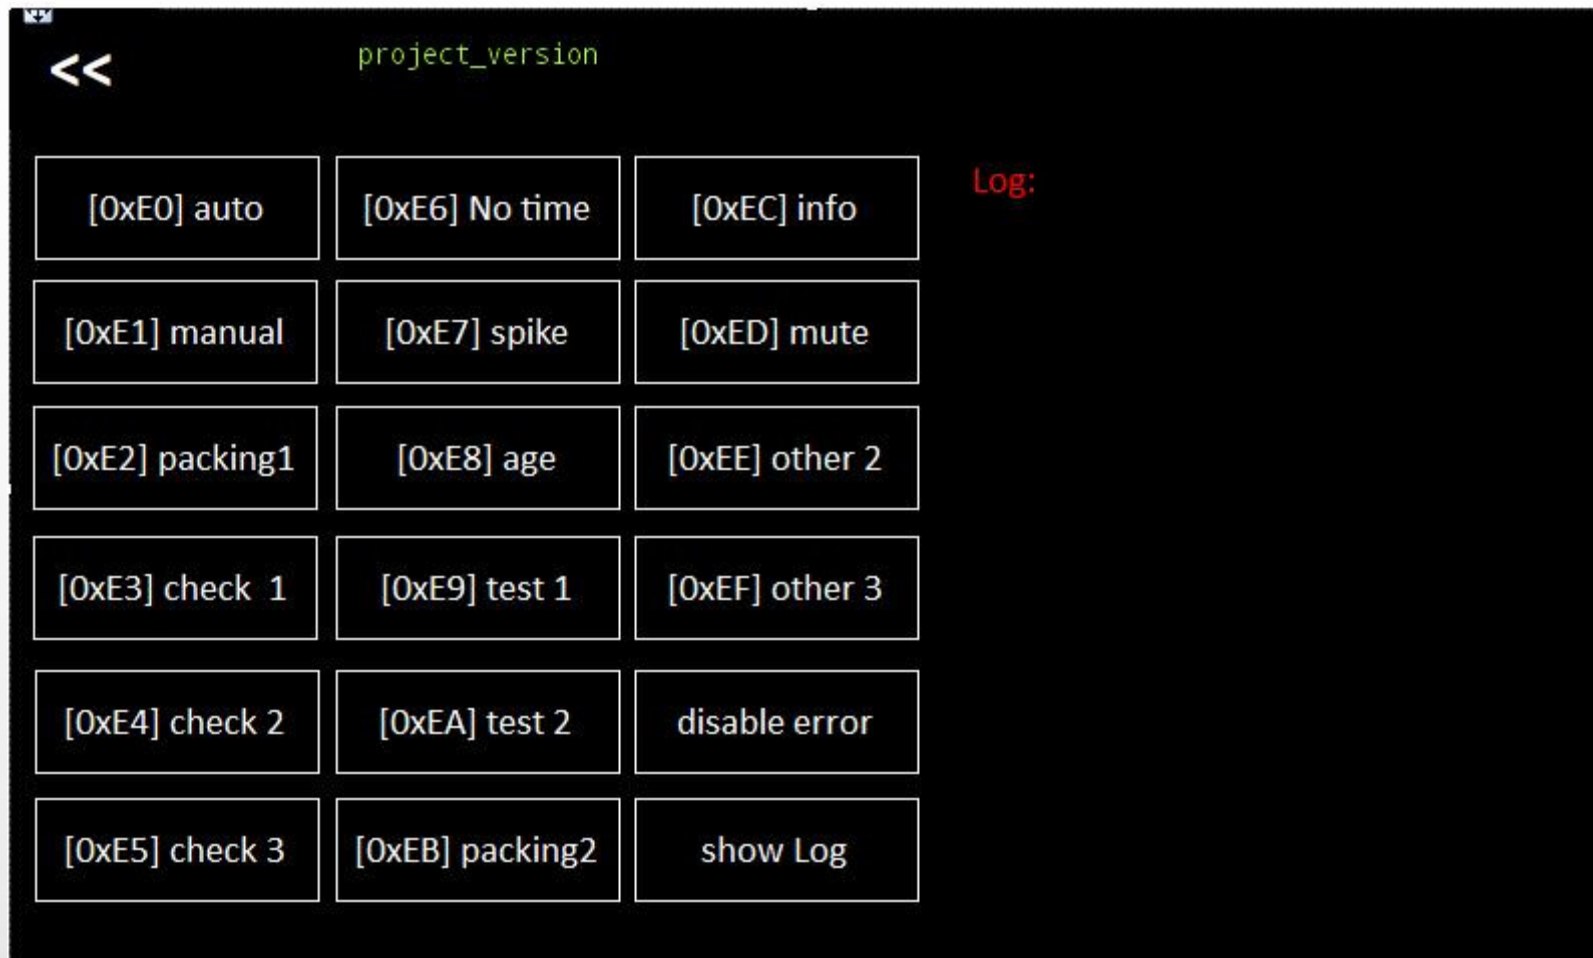
1、error code:

在设置页面屏幕最下方长按数秒,将弹出工程模式密码输入页面

密码: **0592**
或 **0000**

No.	phenomenon	problem description	steps of shooting the trouble	remark
1	remote control tested any key pressed more than 40 seconds	1.one of the KEY has been blocked.	1.Detect remote control buttons	enter auto-check model
2	The communication between remote controller and the main PCB has exceeded 4S and has not been successful	1.remote controller wire do not connect well	1.replace remote controller wire	enter auto-check model
3	upper backrest signal is abnormality	1.The connector of the backrest wire is not well connected 2.Backrest wire Broken	1.check the connector of backrest wire 2.change the backrest wire	enter auto-check model
4	upper mechanism rolling signal is abnormality	1.The connector of the backrest wire is not well connected 2.rolling sensor broken	1.check the connector of backrest wire 2.rolling sensor broken	enter auto-check model
5	remote control tested any key pressed more than 40 seconds	1.one of the KEY has been blocked.	1.check remote control or side panel controller	enter auto-check model
