产品维修手册

Maintenance Service Manual

产品型号/Model: EI-8602A-TIT

By the Easepal's Customer Service Dept.

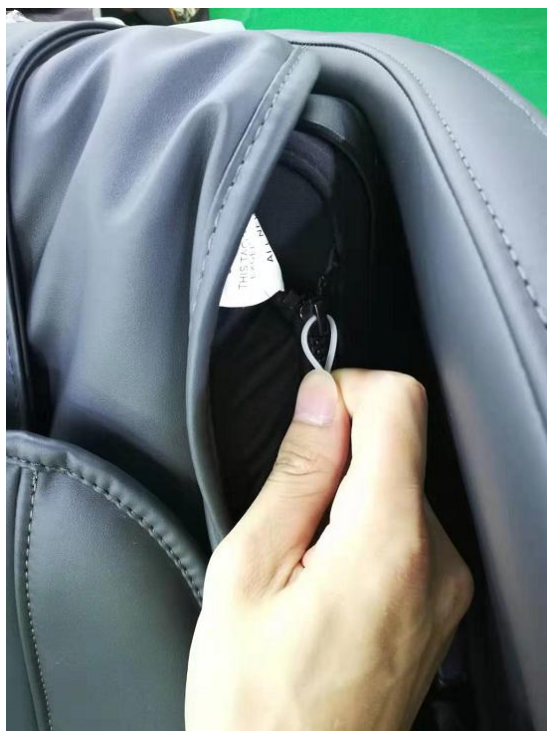
图 1

1. Pass through the zipper head with a small Cable Ties and pull it apart (figure 1), as shown in figure 2 after opening at 7th position

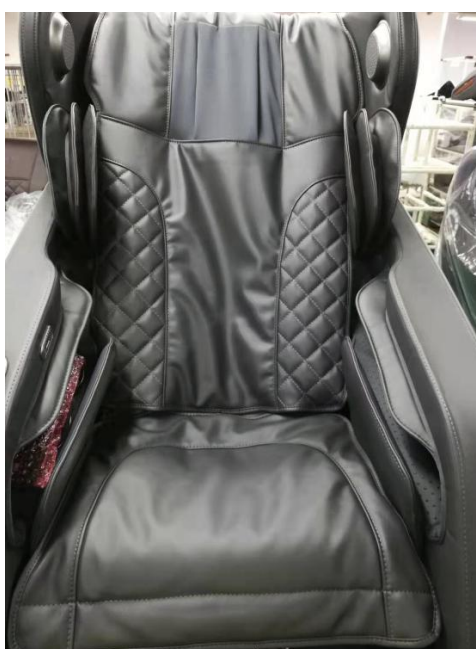
图 3

2. Put on the new cloak and zip up 7th position zippers as shown in figure 3 below

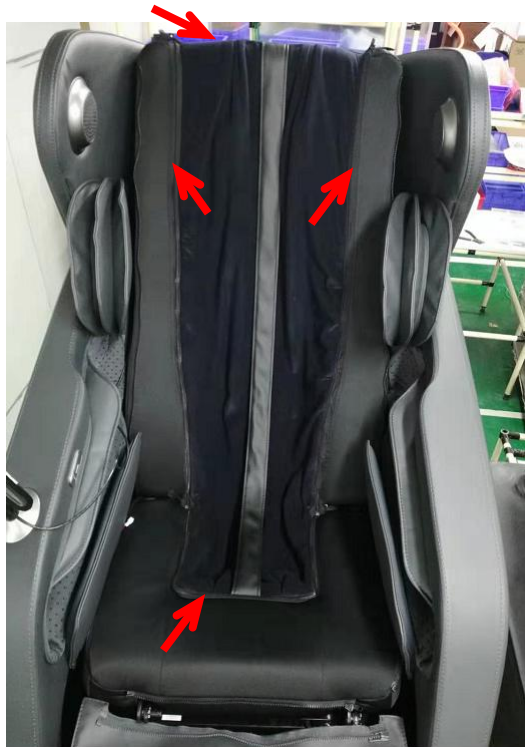
图 1

2. Open 4 zippers of flannelette according to figure 1

4. Replace the new flannelette with the steps in figure 2 and figure 1 to return to the operation.

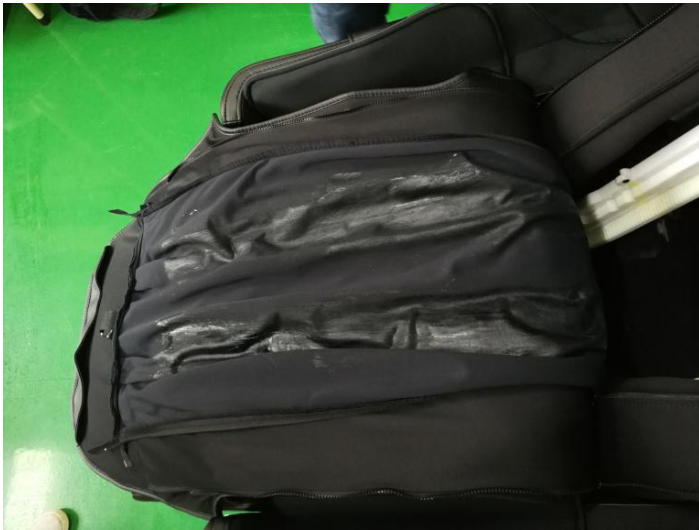
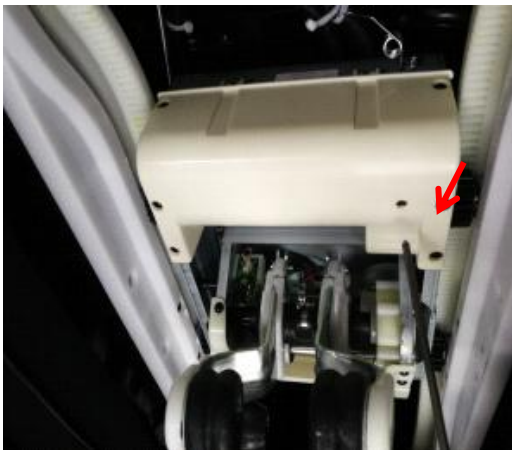
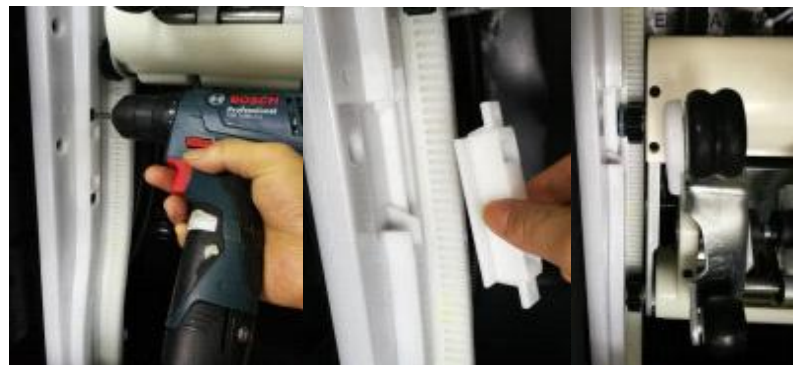
2. Use a screwdriver to revolve the worm through the repair hole to move the machine core away from the guideway to remove the baffle area, If the machine core does not block the baffle area of the guideway, jump directly to the next step.

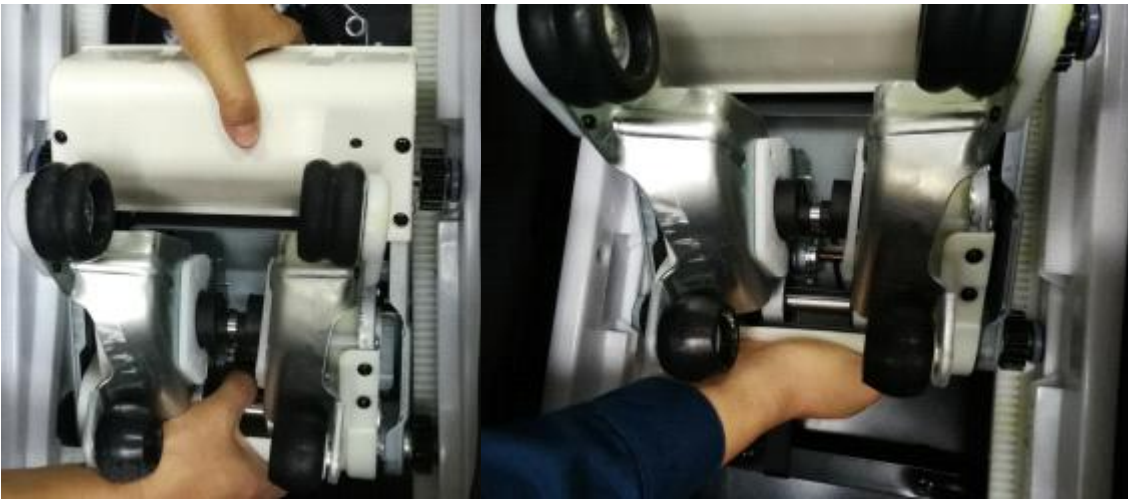
3. Remove the baffle from the left and right guideway with a screwdriver, Move the machine core to the position of the left and right guideway disassembly baffle

4. The walking gear comes out first and the front gear comes out again.

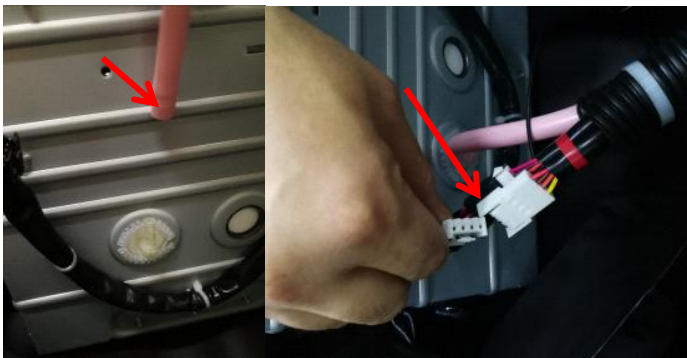
8. Connect the trachea to the terminal with a new machine core

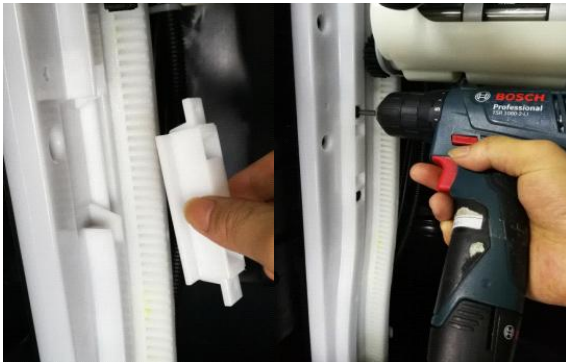
13. install the Remove baffle of the left and right guideway on the guideway

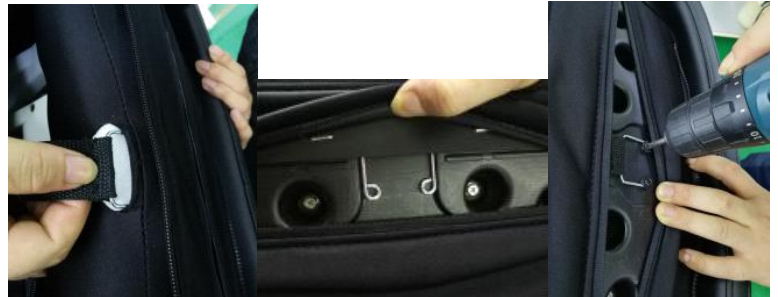
14. Pass the inverted hook through the elastic cloth and lock the 2 screws

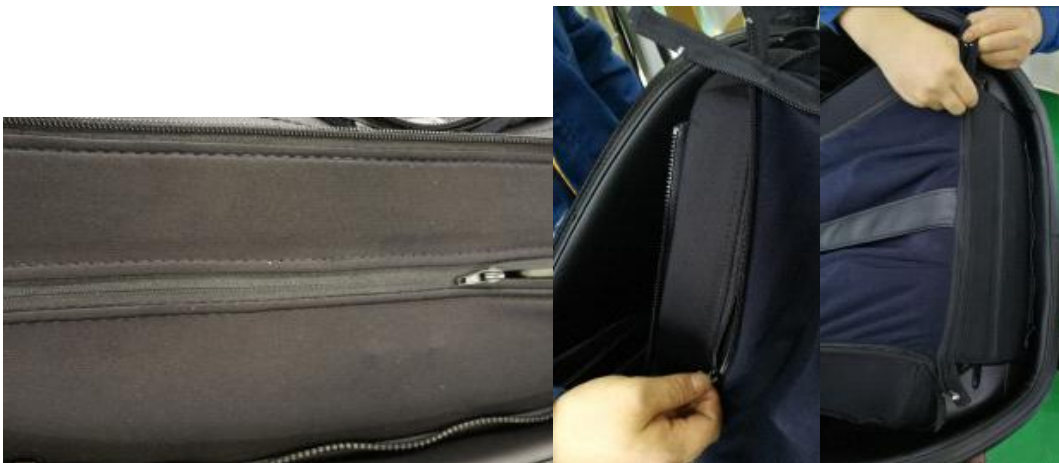
15. Pull 4 zippers.

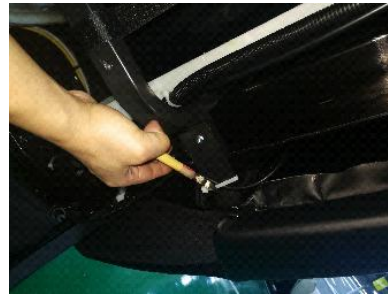
图 2

3. Cut off the tie belt that binds the hand controller to the side board, as shown in figure 2
4. Remove the two screws on the back rack, as shown in figure 3;

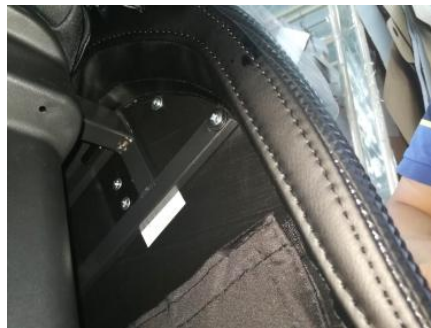
图 5

5. Unzip the shoulder air bag and remove the air bag screw with a screwdriver, as shown in figure 4;
6. Connect the power supply, run the massage chair to the back state, remove the screw at the front end of the side plate from below the calves as shown in figure 5, and then run the massage chair to the initial state and cut off the power supply

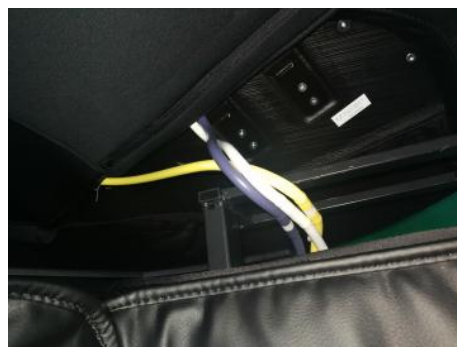
图 8

8. Lift the front end of the side plate up 20 × 30 mm so that the side plate hook is detached from the back frame as shown in figure 8.
9. Remove three connecting trachea from the side plate, as shown in figure 8.

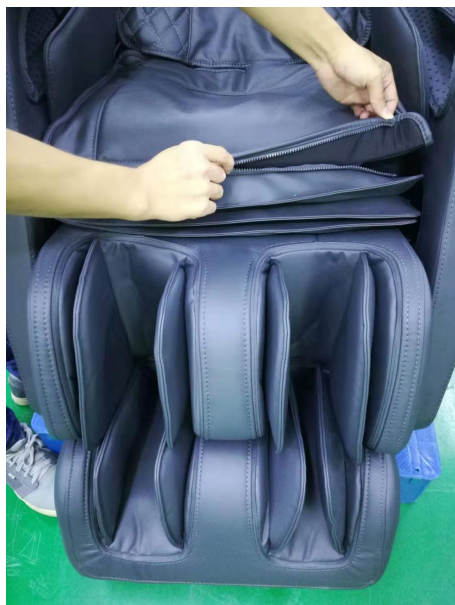
图 1

1. Unzipper as shown in figure 1;

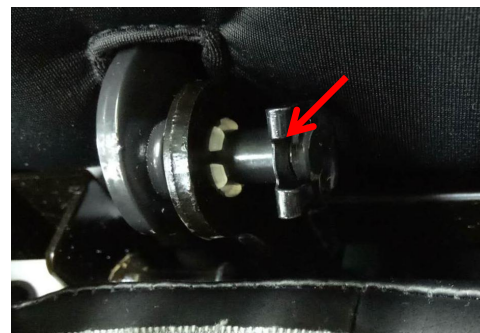
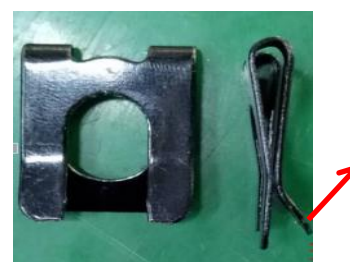
图 2

2. Break the DK Card bolt open with your fingers or pliers and take it up, as shown in figure 2;

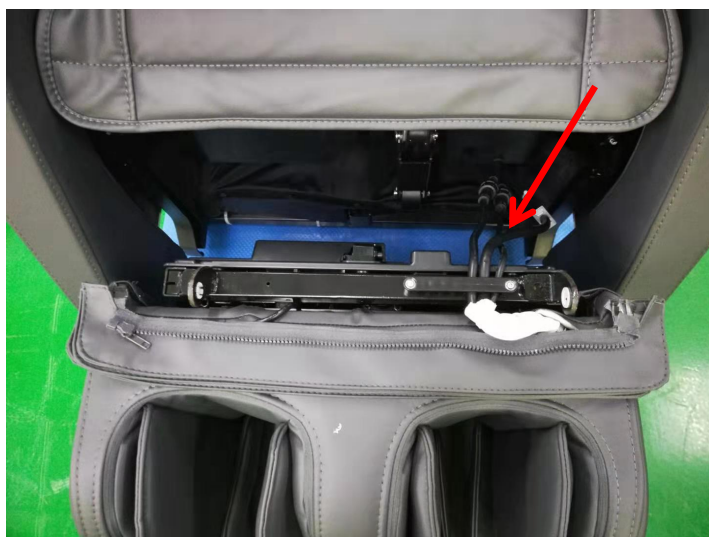
图 3

3. Remove the trachea and power cord connector, as shown in figure 3

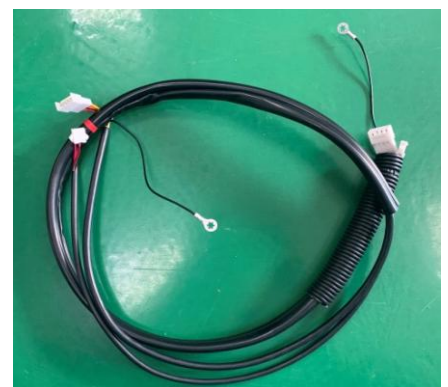
3. Pull out the docking terminal of the back frame of the lower cover of the seat and remove the backrest bus, as shown in the following figure.

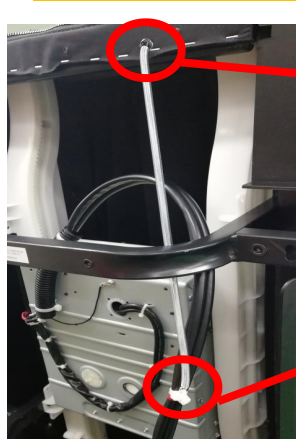
图 4

Pull spring of walking wire with lock

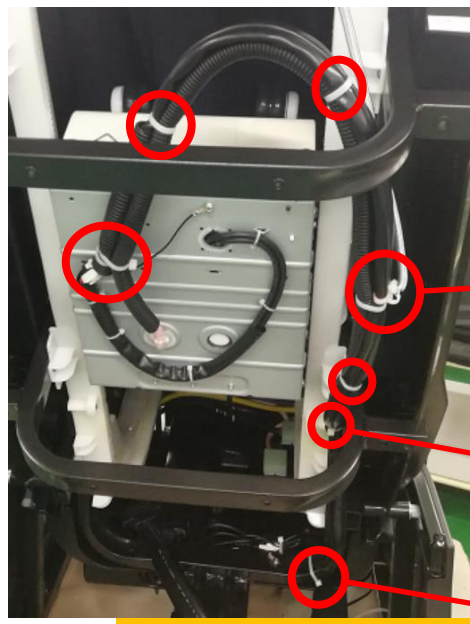
Band fixation (7 places)

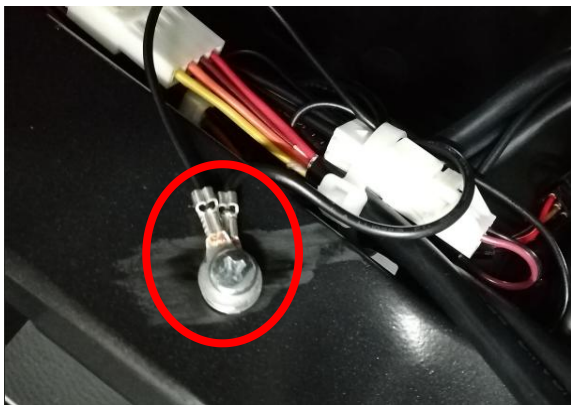
图 9

Nine-core connecting wire and 32 core wire earth wire with lock

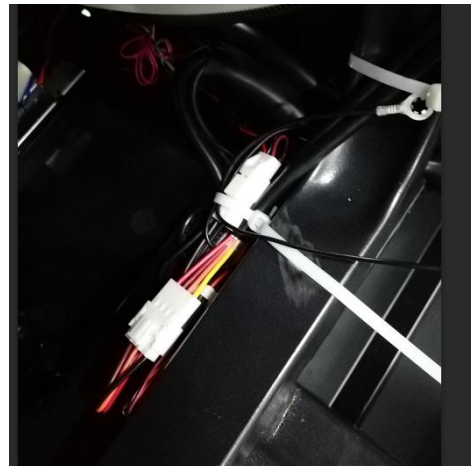
图 8

Straighten the line, tie the belt and fix it.

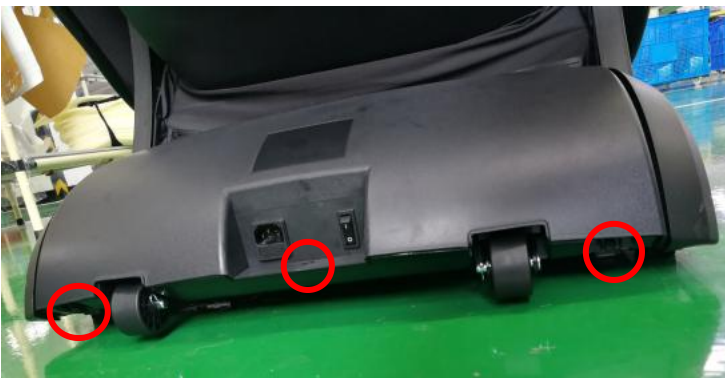
2.Remove 3 screws

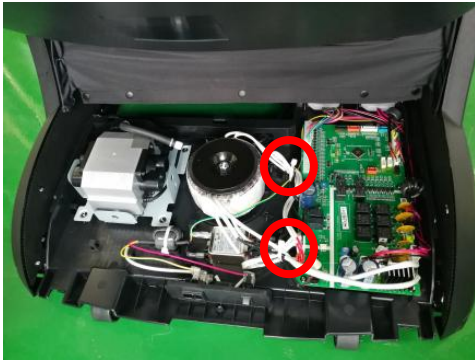
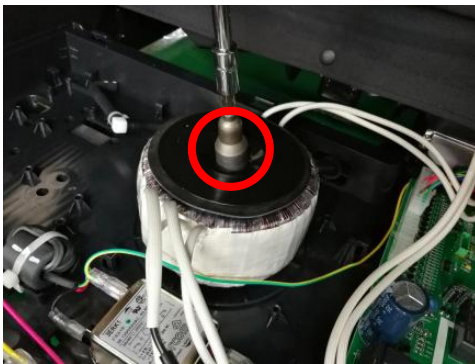
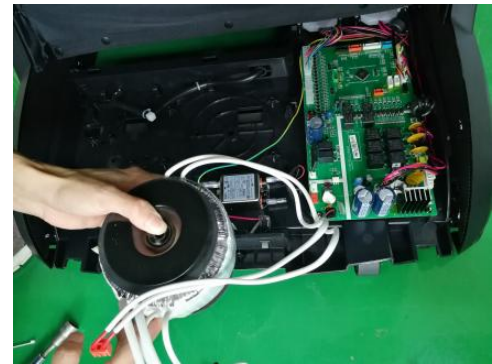
1. Transformer replacement: Cut the tie、 Unplug the terminal、 Remove the fixing screw from the transformer、 Remove transformer

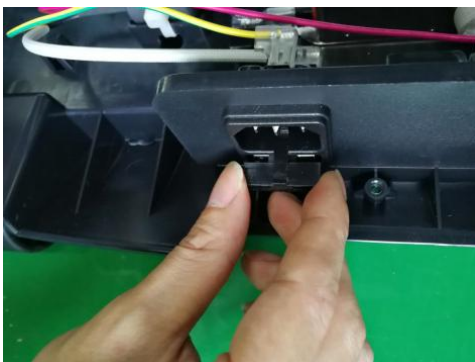
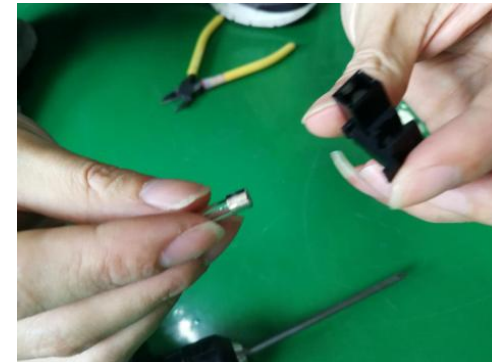
3.Fuse replacement: Remove insurance from socket, You can replace the fuse.
