产 品 维 修 手 册

Maintenance Service Manual

产品型号/Model: EI-8602A-TIT

适用电压规格/ Voltage Specification: 110-120V~

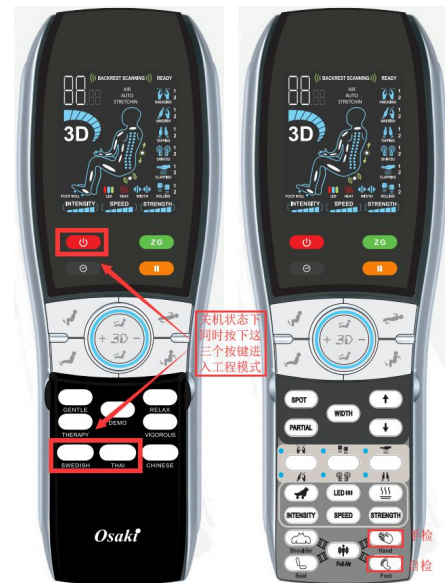
open: (1) Under the condition of shutdown, At the same time, hold down the three keys pointed to by the arrow, and you will hear a beep of the hand controller in a few seconds.

(2) Select one of the two project patterns shown in the following figure as needed

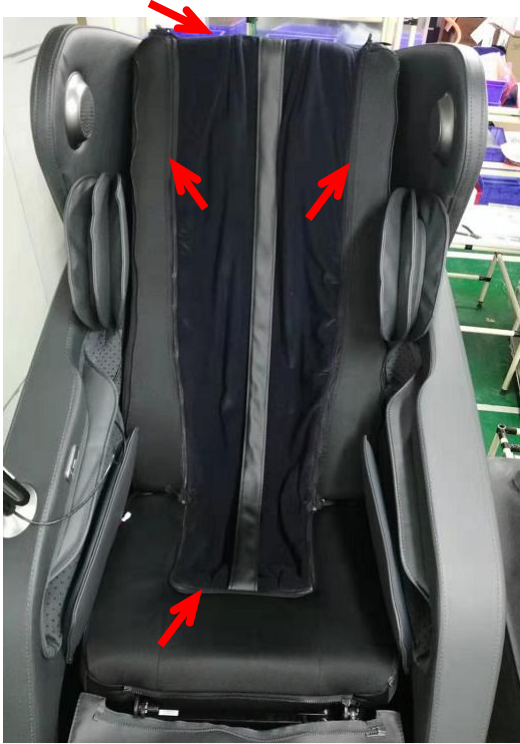
图 1

1. Press P6 to remove the cloak in the first step
2. Open 4 zippers of flannelette according to figure 1

3. Remove the two screws behind the back and the two screws under the pedestal As shown in figure 2
4. Replace the new flannelette with the steps in figure 2 and figure 1 to return to the operation.

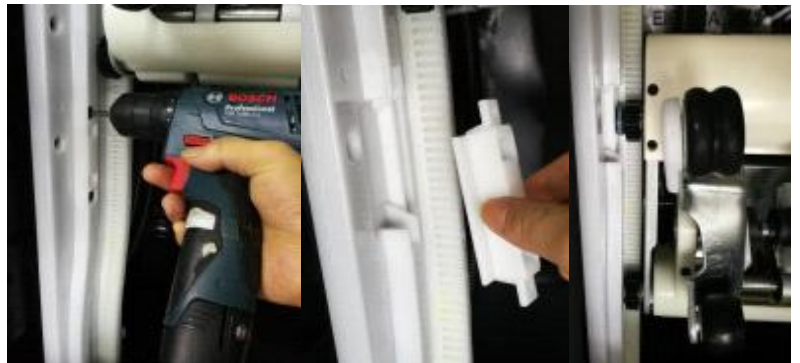
2. Use a screwdriver to revolve the worm through the repair hole to move the machine core away from the guideway to remove the baffle area, If the machine core does not block the baffle area of the guideway, jump directly to the next step.

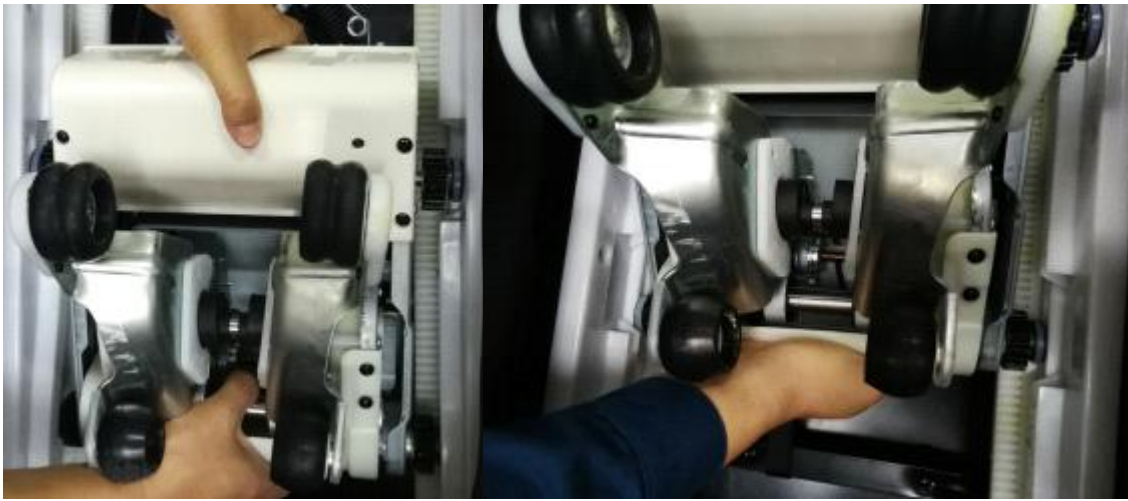
3. Remove the baffle from the left and right guideway with a screwdriver, Move the machine core to the position of the left and right guideway disassembly baffle

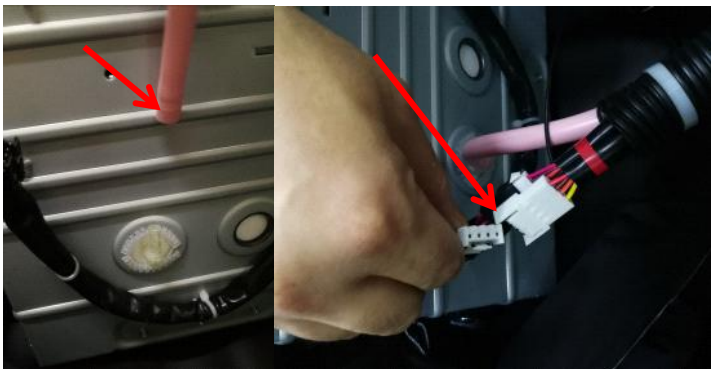
7. Pull out the trachea and terminal

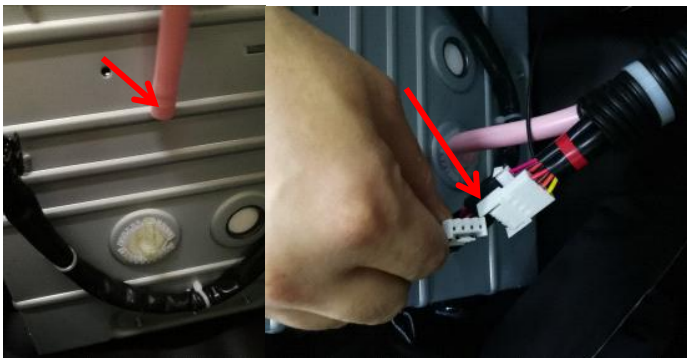
8. Connect the trachea to the terminal with a new machine core

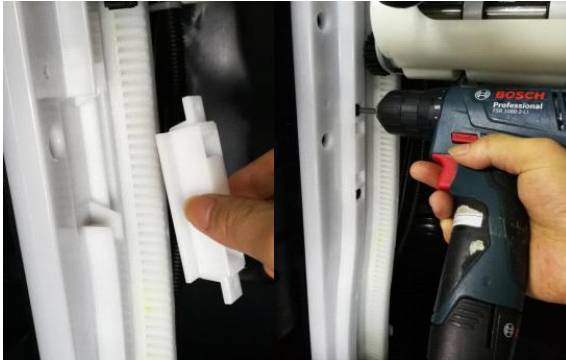
13. install the Remove baffle of the left and right guideway on the guideway

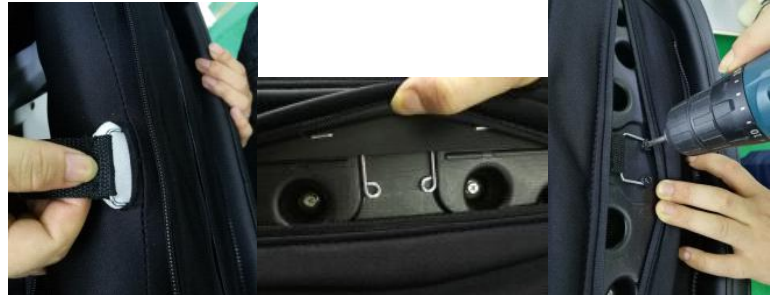
14. Pass the inverted hook through the elastic cloth and lock the 2 screws

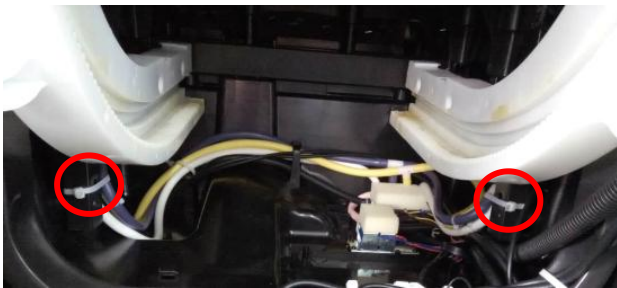
图 1

1. Run the massage chair to its original state, then cut off the power supply and unplug it;
2. Press P11 to remove the rear cover and cut the inner band of the lower cover with oblique pliers, as shown in figure 1;

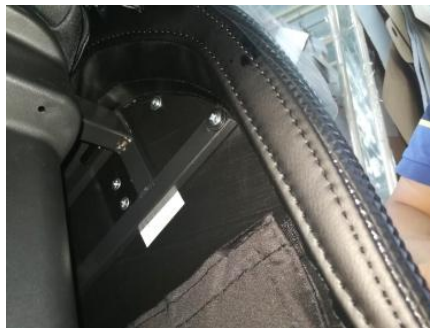
图 5

5. Unzip the shoulder air bag and remove the air bag screw with a screwdriver, as shown in figure 4;
6. Connect the power supply, run the massage chair to the back state, remove the screw at the front end of the side plate from below the calves as shown in figure 5, and then run the massage chair to the initial state and cut off the power supply

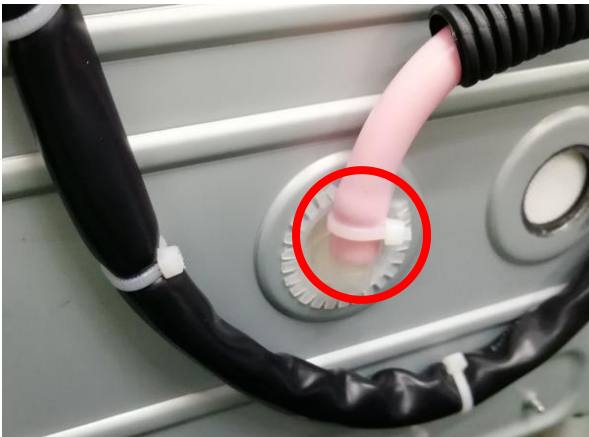
图 5

Connect the air duct assembly of the lower cover of the seat to the movemet, The trachea is inserted with alcohol, and the tie is fixed

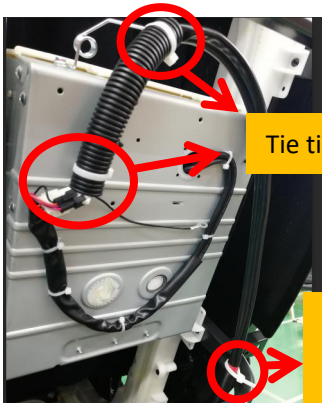
图 2

Tie tight in two places

The reserved position here is not tight.

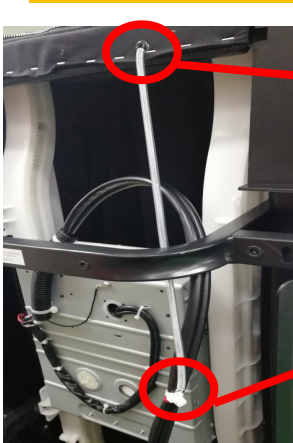
图 4

Pull spring of walking wire with lock

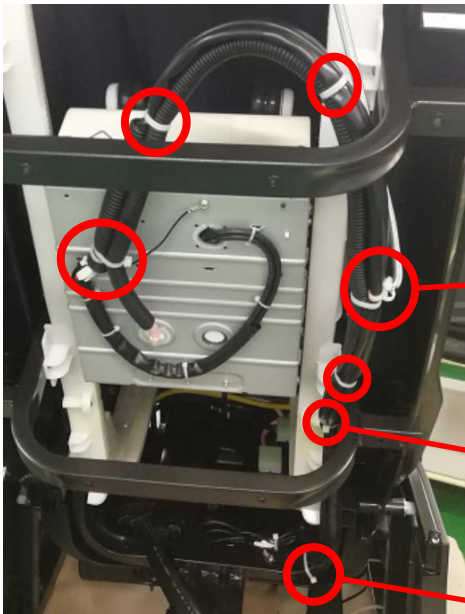
Band fixation (7 places)

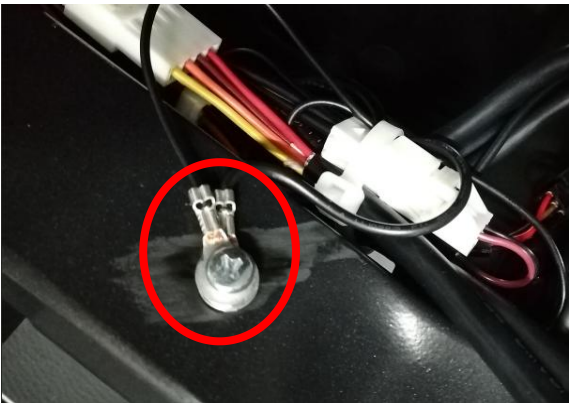
图 9

Nine-core connecting wire and 32 core wire earth wire with lock

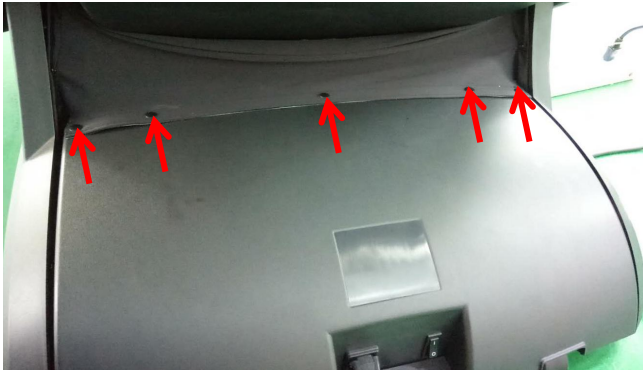
1.Remove 5 cloth sleeve pins on the top cover of the central box

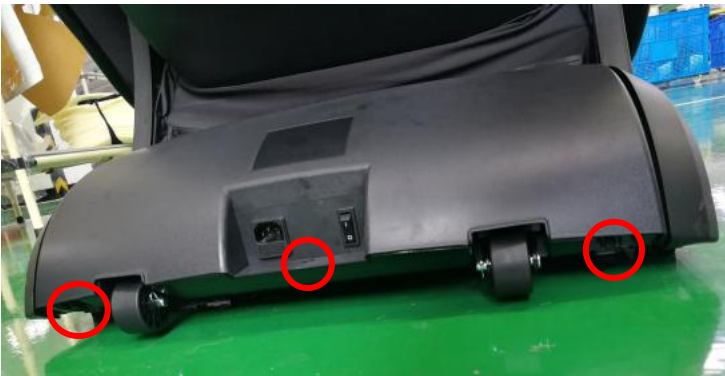
2.Remove 3 screws

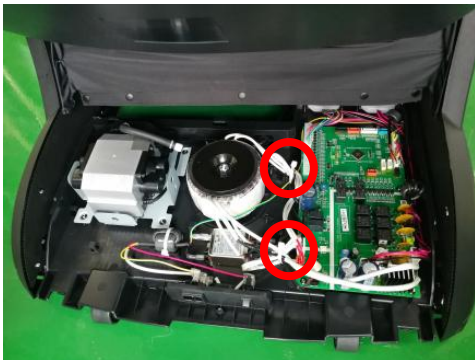
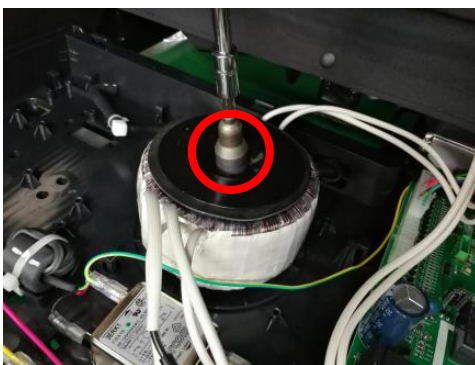
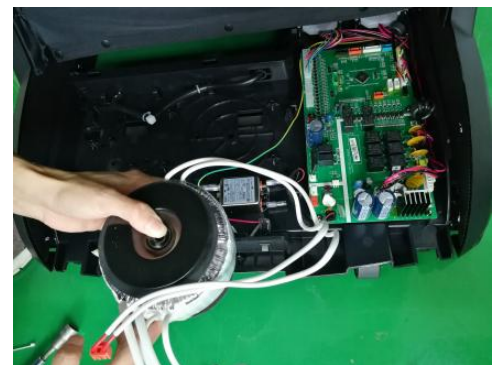
1. Transformer replacement: Cut the tie、 Unplug the terminal、 Remove the fixing screw from the transformer、 Remove transformer

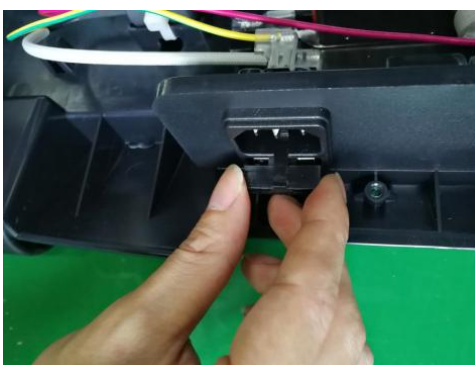
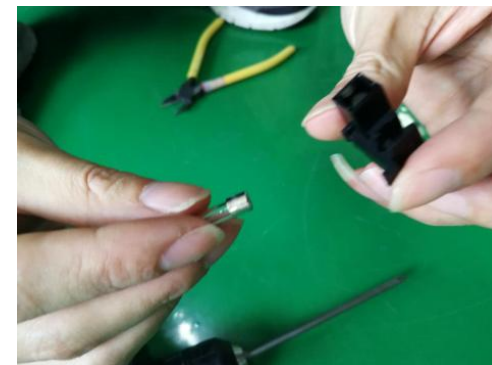
3.Fuse replacement: Remove insurance from socket, You can replace the fuse.
