iRest 🕏

2.1 Internal structure

- 1. The whole machine doesn't work
- 2. The massage hand does not work
- 3. The massage hand does not move up and down
- 4. Kneading function does not work
- 5. Tapping function does not work
- 6. Bluetooth does not work
- 7. One side speaker does not work
- 8. The backrest heating function does not work

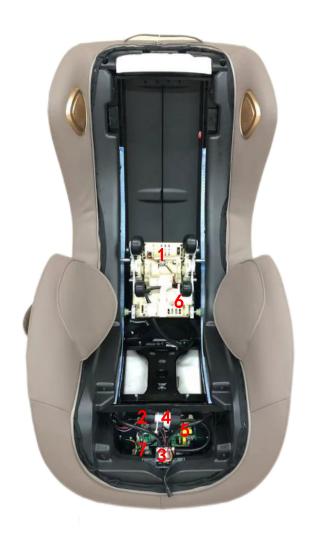
massage hand

ma²n PCB

solenoid valve

4 air pump

power board

massage hand PCB

bluetooth board

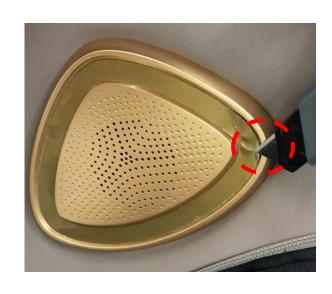
1

1. Gently lift the speaker cover sticker with a knife (Figure 1)

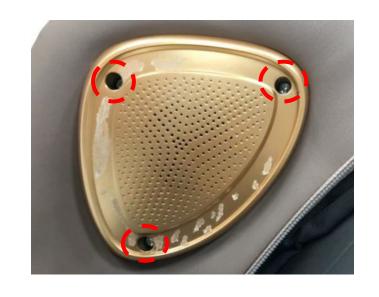
2

2. Remove 3 fixing screws (Figure 2)

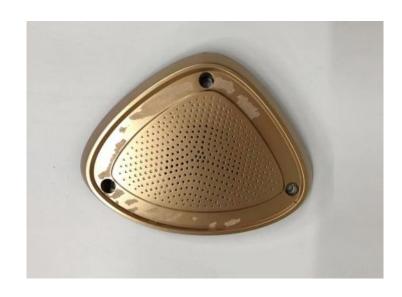
3

3. Take off the speaker cover (Figure 3)

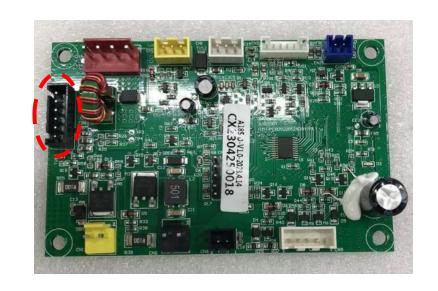
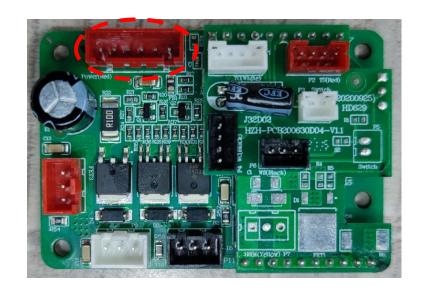
4. 2 massage hand doesn't work

- A. Check whether the wire harness on the massage hand has poor contact or plug-in fall off (Figure 1) (Figure 2);
- B. Check whether the plug on the massage hand PCB has voltage output, if not, replace a new PCB (Figure 1);
- C. If it has voltage output, check whether the wire harness from the main PCB to the massage hand PCB is damaged; (Figure 2) (Figure 3)
- D. If all A, B, C are ok, replace a new massage hand PCB (Figure 3)

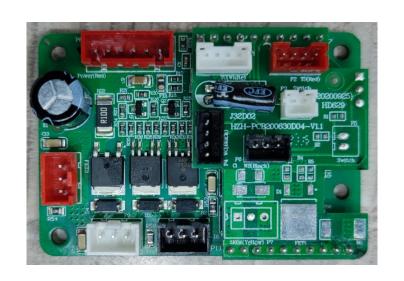
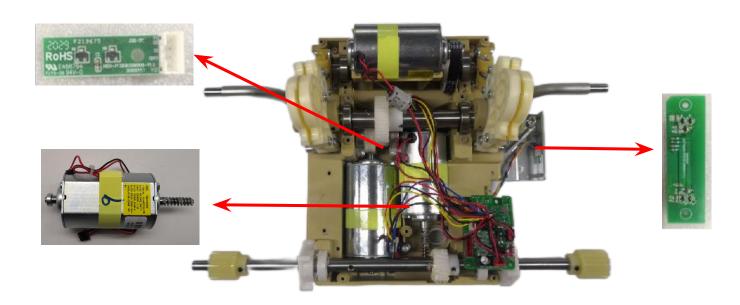
4.3 The massage hand does not move up and down

- A. Check whether the wire harness on the massage hand has poor contact or plug-in fall off (Figure 1) (Figure 2);
- B. Check the walking circle detection board (substitution method), walking distance detection board (substitution method), walking motor (multimeter to test, whether the resistance value $3-20\,\Omega$) (Figure 2);
- C. If above are ok, replace a new massage hand PCB.

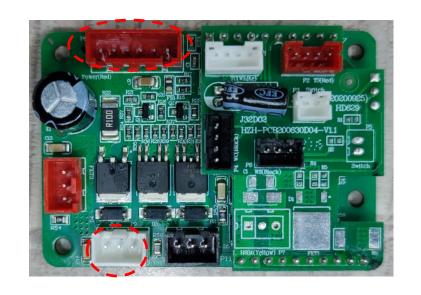
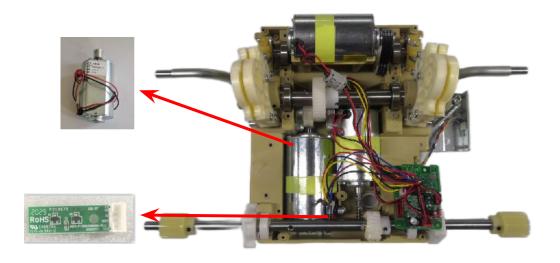
4.4 Kneading function does not work

- A. Check whether the plug on the massage hand has poor contact or plug-in fall off (Figure 1) (Figure 2);
- B. Check the **kneading circle detection board** (substitution method), **tapping motor** (multimeter to test, whether the resistance value $3-20\,\Omega$) (Figure 2);
- C. If above are ok, replace a new massage hand PCB.

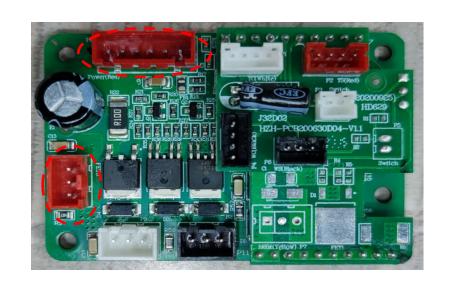
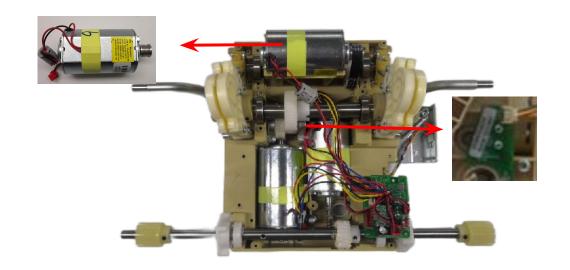
4.5 Tapping function does not work

- A. Check whether the plug on the massage hand has poor contact or plug-in fall off (Figure 1) (Figure 2);
- B. Check the width detection board (substitution method), tapping motor (multimeter to test, whether the resistance value $3-20\,\Omega$) (Figure 2);
- C. If above are ok, replace a new massage hand PCB.

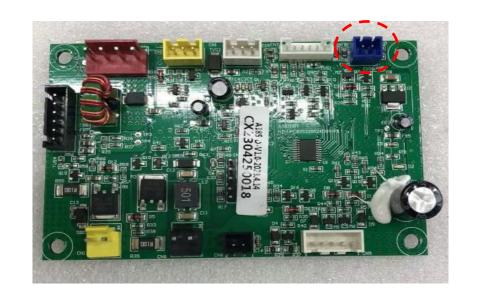
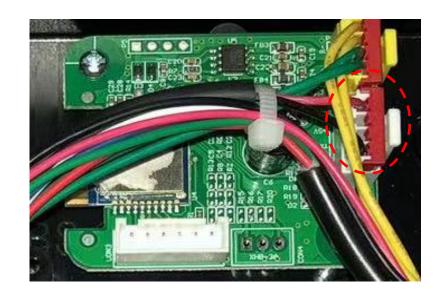
4. 6 Bluetooth does not work

- 1. Check whether Bluetooth has been connected to other devices;
- 2. Check whether the Bluetooth-related plug-in has fallen off (Figure 1) (Figure 2);
- 3. Check whether the Bluetooth plug-in of the main PCB has a voltage output, if no voltage output, replace a new PCB (Figure 1)
- 4. If there is voltage output, check whether the wire harness from the main PCB to the Bluetooth board is good or not, if the wire harness is good, then replace the Bluetooth board (Figure 2)
