EC-8638 massage chair service

Table of Contents

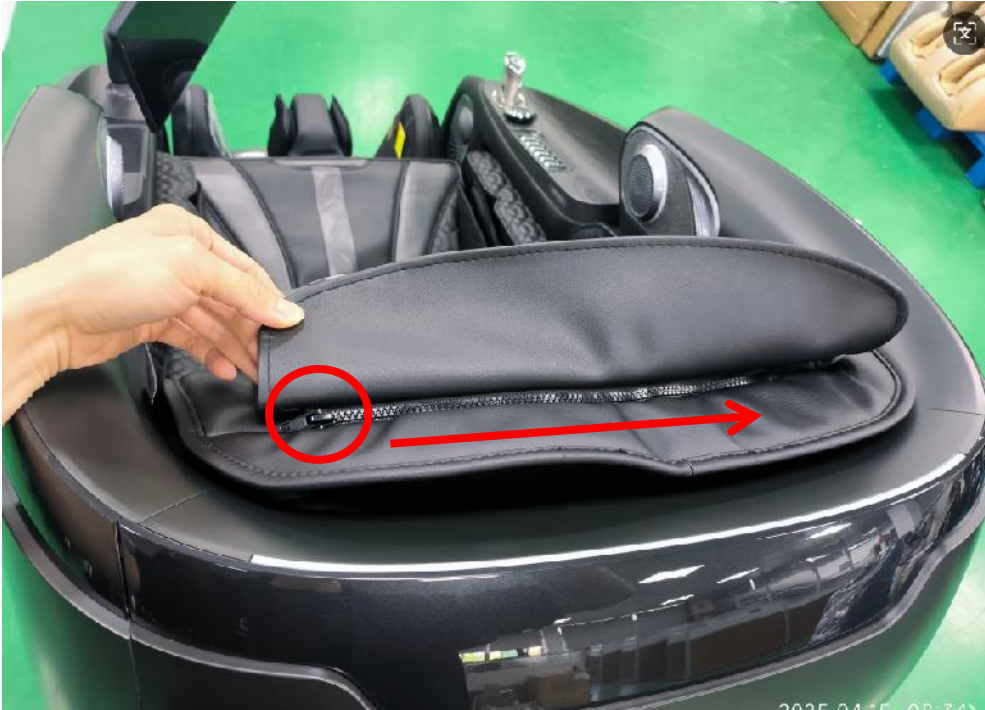
unzip the zipper

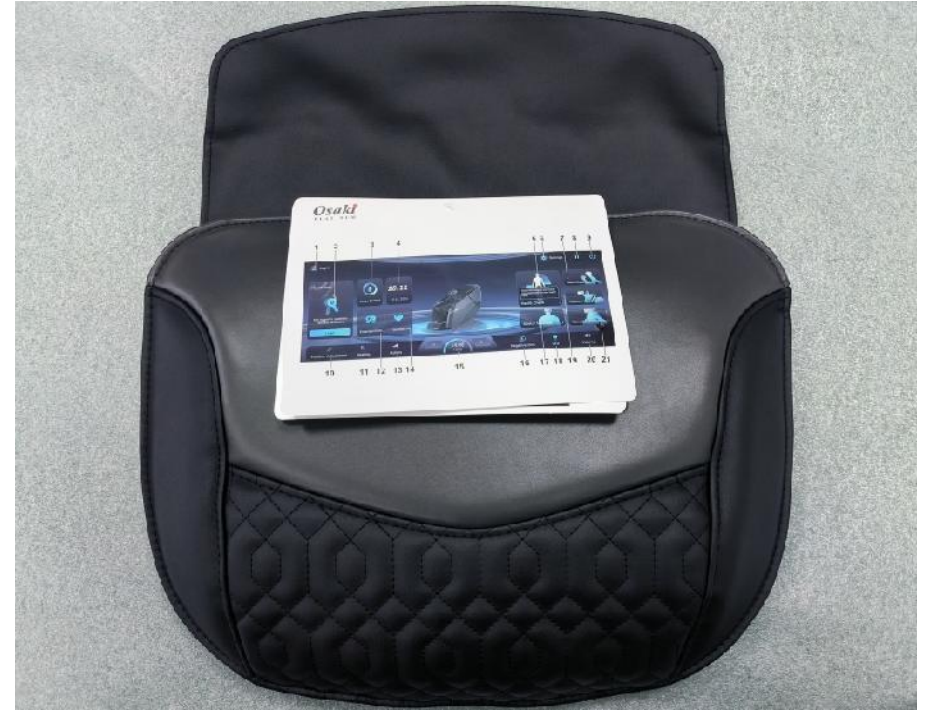
remove the pillow

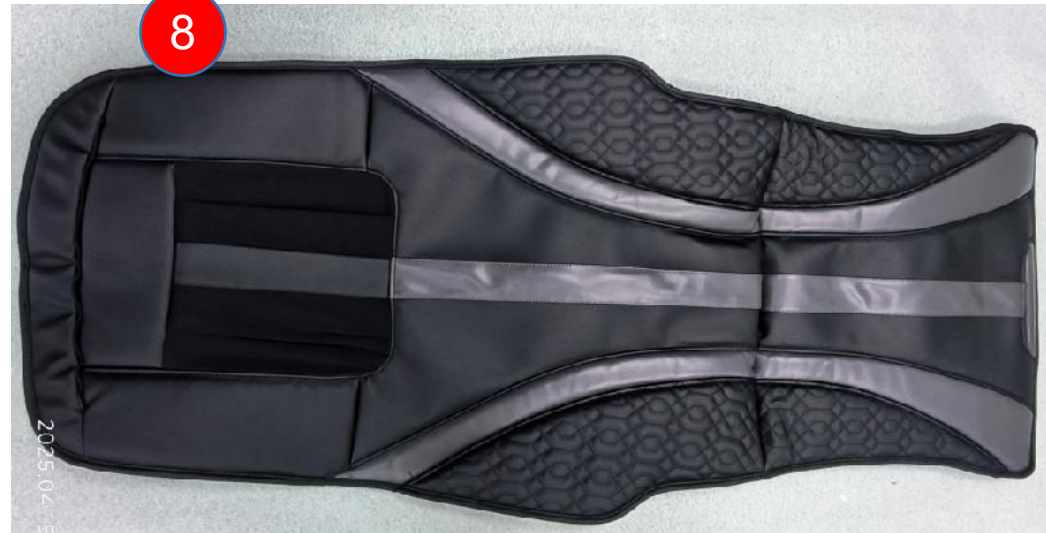
8

remove backrest pad

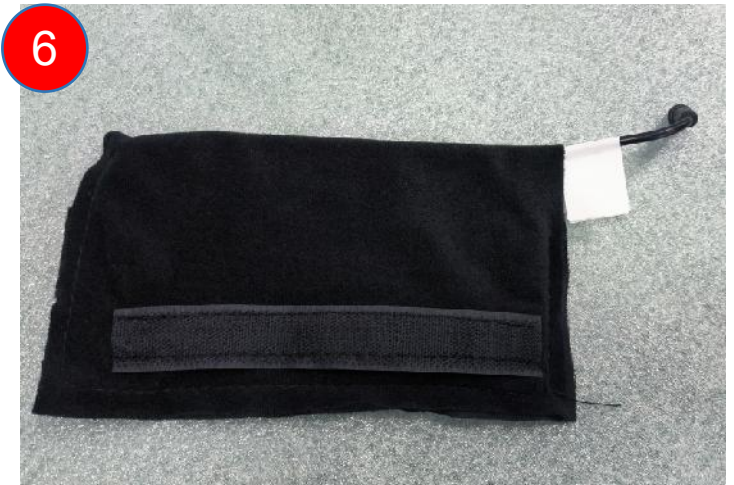
6

remove the waist heater

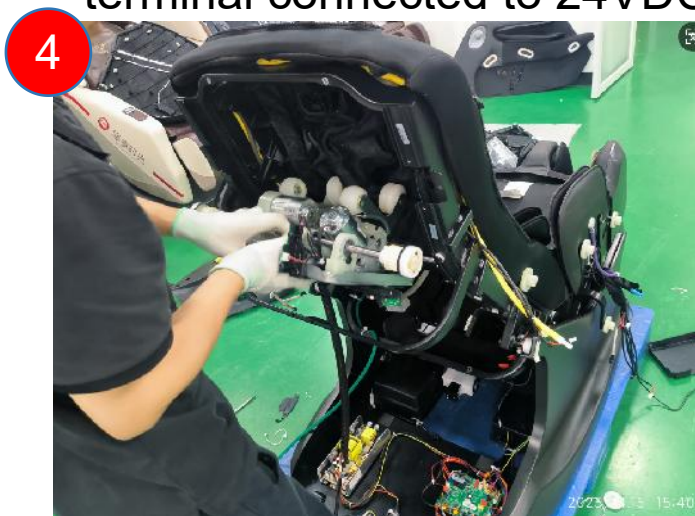
4
remove lower gear box

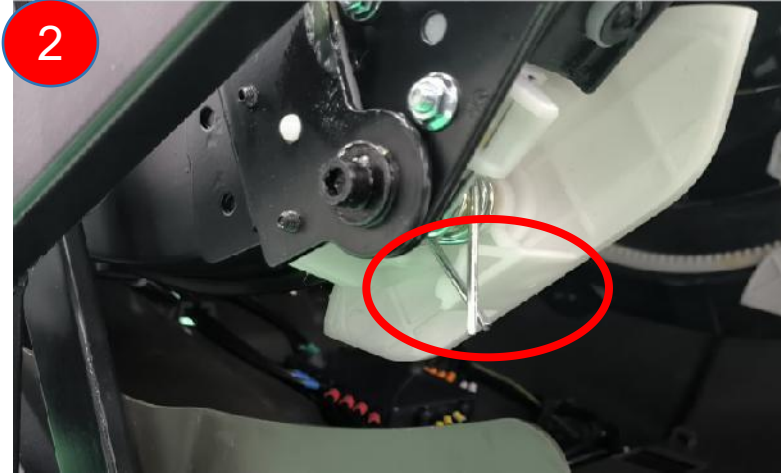
2
Spring released

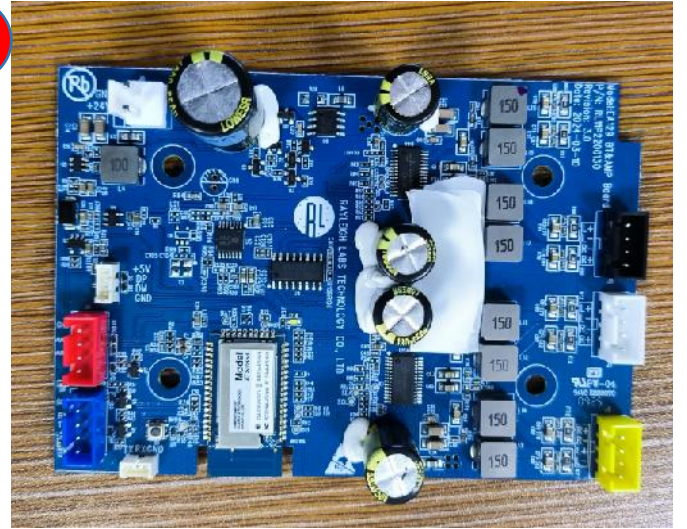
9

remove Bluetooth PCB

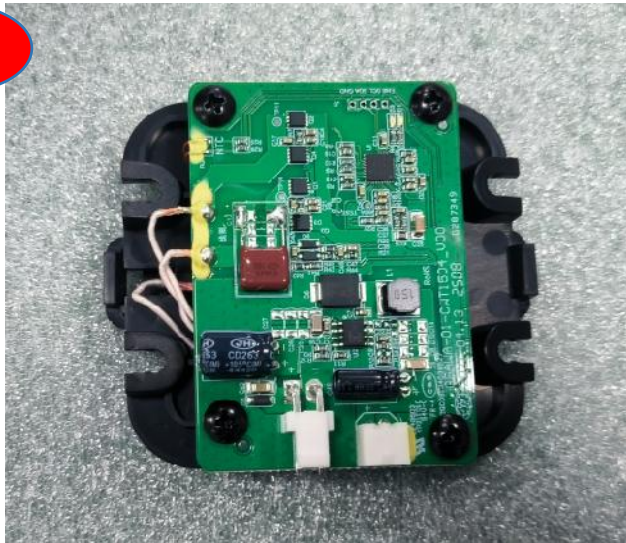
16

remove wireless charging unit

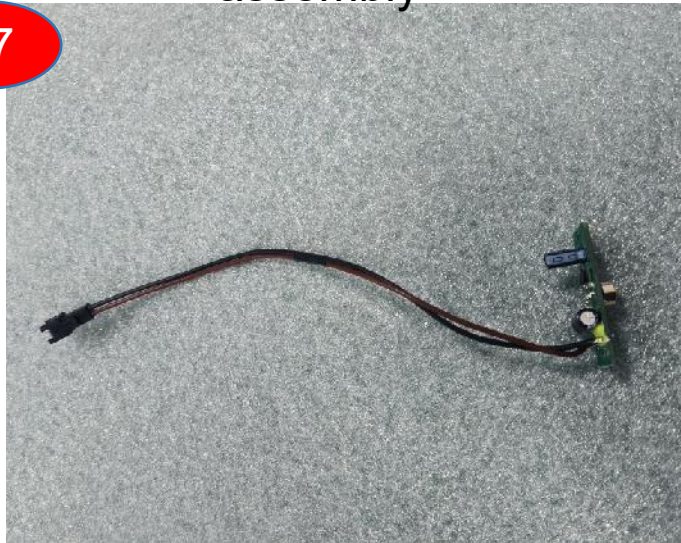
17

remove charging unit

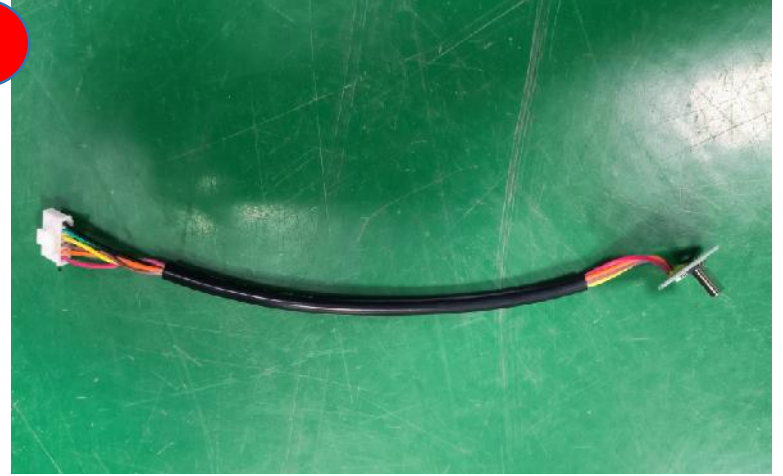
3

remove the type-C charging PCB

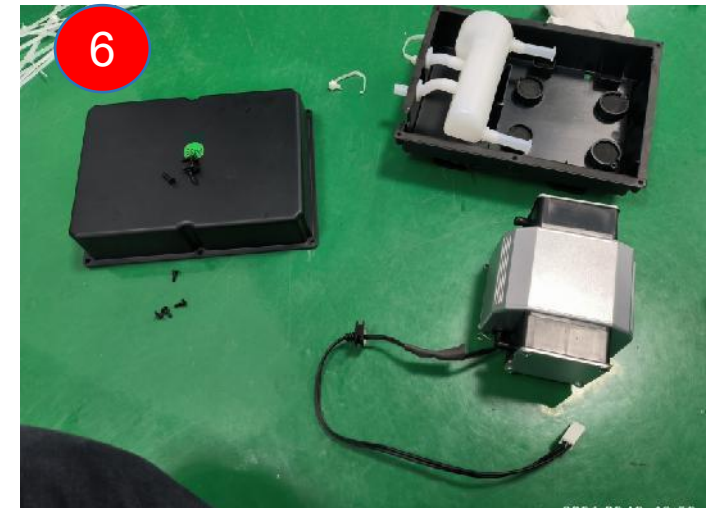
separate the air pump

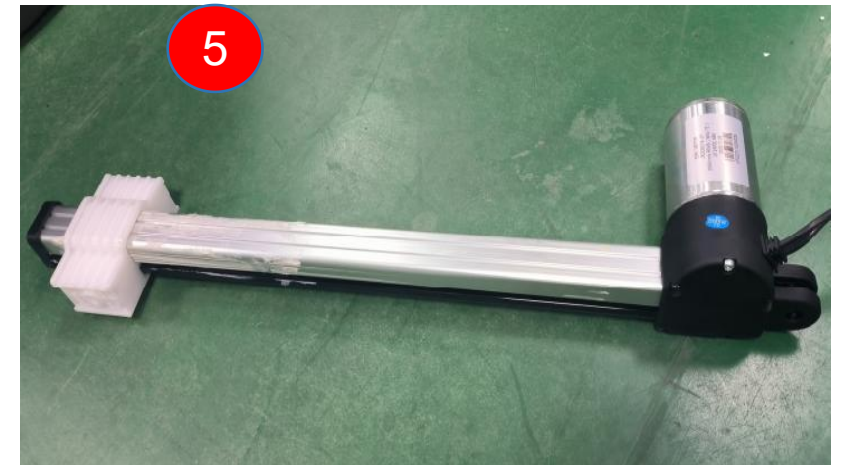
remove backrest actuator

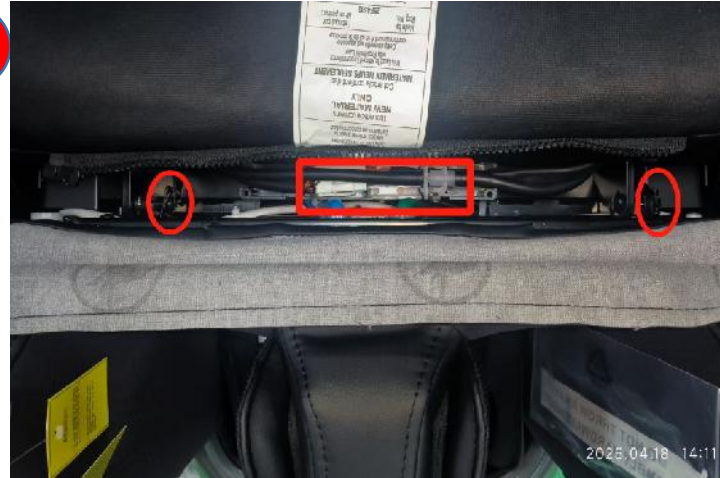
discontenttthe terminal and air hose, remove 2 catch pins
