# 产 品 维 修 手 册

## Maintenance Service Manual

产品型号/Model: EI-8602A-TIT

适用电压规格/ Voltage Specification: 110-120V~

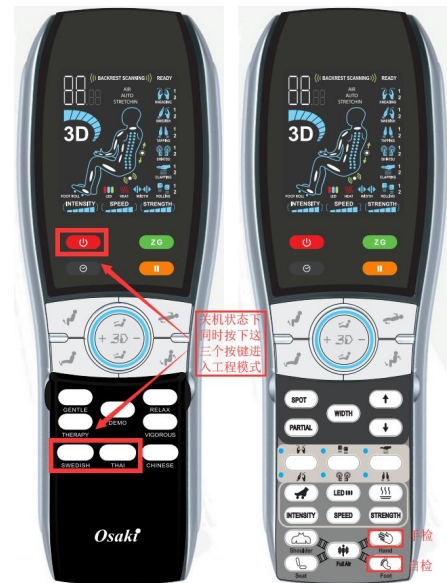
**open:** (1) Under the condition of shutdown, At the same time, hold down the three keys pointed to by the arrow, and you will hear a beep of the hand controller in a few seconds.

(2) Select one of the two project patterns shown in the following figure as needed

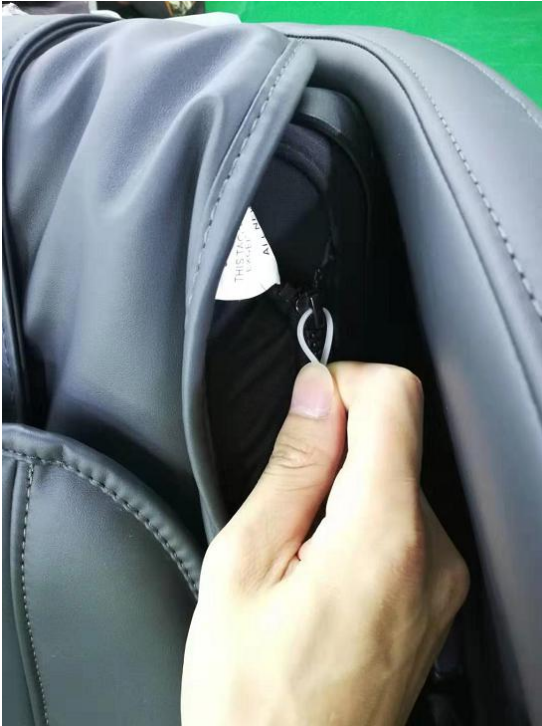
图 1

1. Pass through the zipper head with a small Cable Ties and pull it apart (figure 1), as shown in figure 2 after opening at 7<sup>th</sup> position

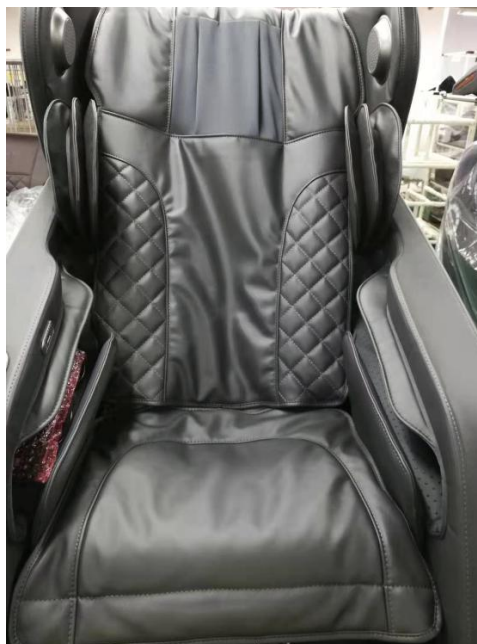
图 3

2. Put on the new cloak and zip up 7<sup>th</sup> position zippers as shown in figure 3 below

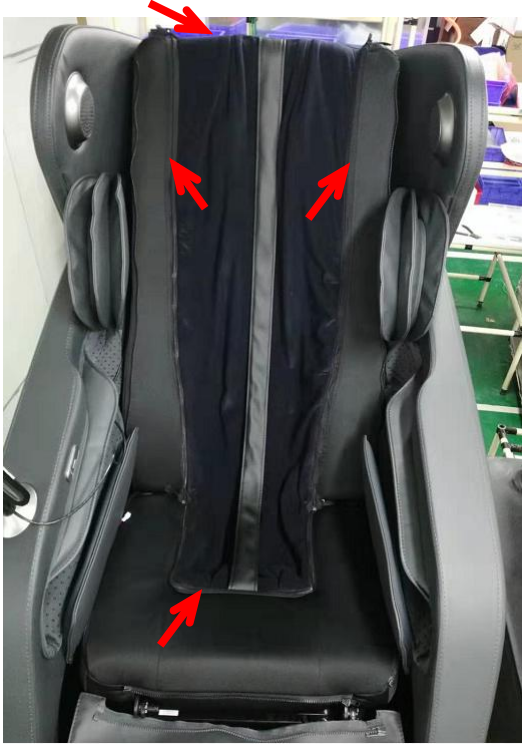
图 1

1. Press P6 to remove the cloak in the first step
2. Open 4 zippers of flannelette according to figure 1

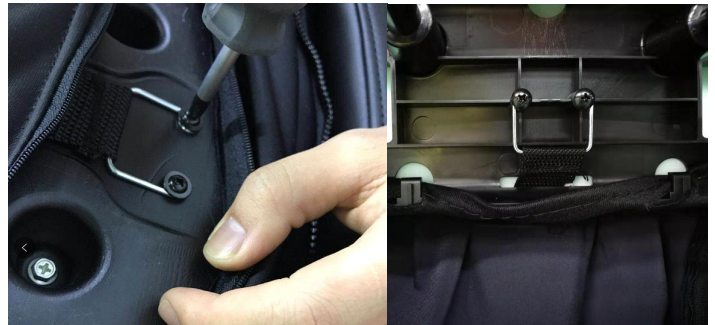
图 2

3. Remove the two screws behind the back and the two screws under the pedestal As shown in figure 2
4. Replace the new flannelette with the steps in figure 2 and figure 1 to return to the operation.

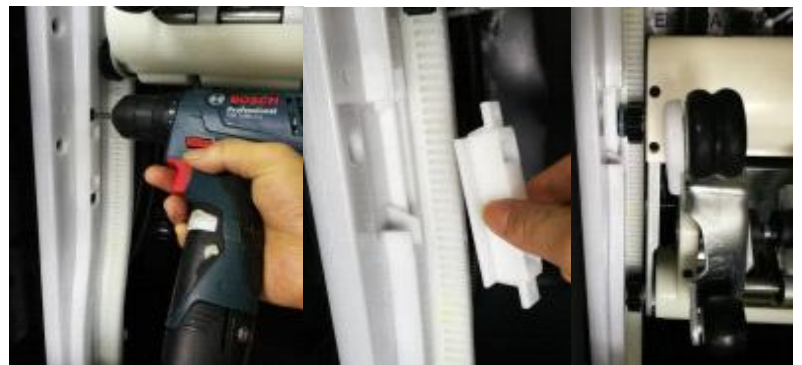
2. Use a screwdriver to revolve the worm through the repair hole to move the machine core away from the guideway to remove the baffle area, If the machine core does not block the baffle area of the guideway, jump directly to the next step.

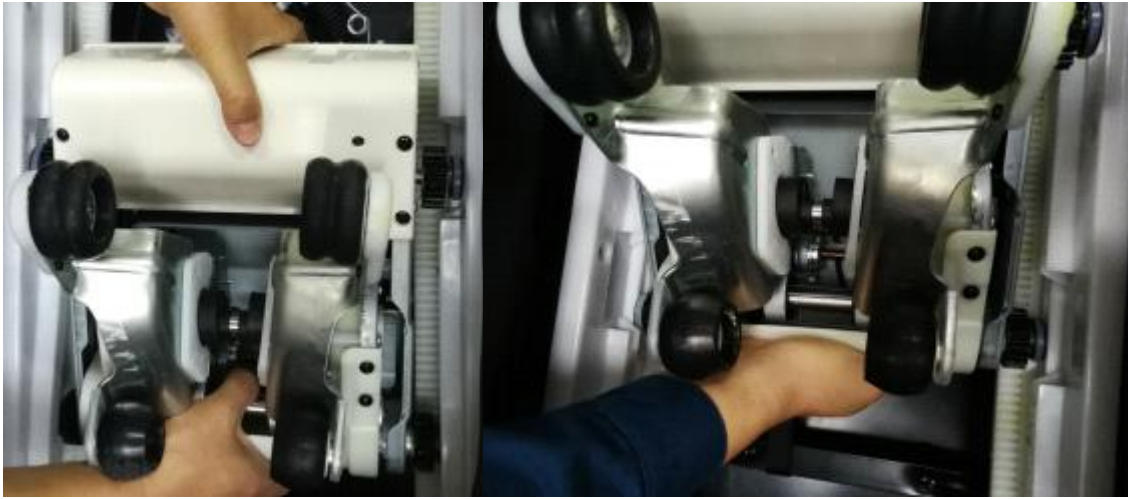
3. Remove the baffle from the left and right guideway with a screwdriver, Move the machine core to the position of the left and right guideway disassembly baffle

4. The walking gear comes out first and the front gear comes out again.

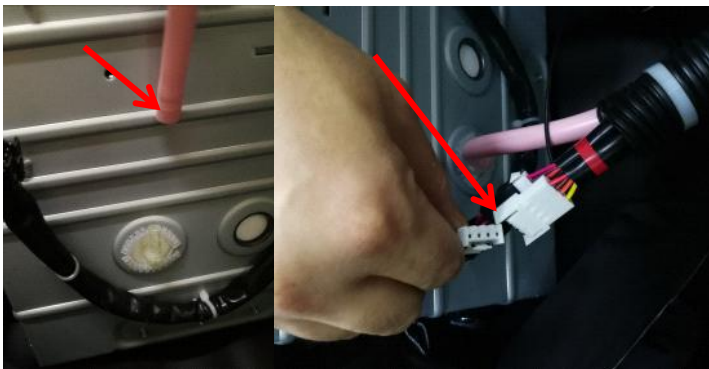
7. Pull out the trachea and terminal

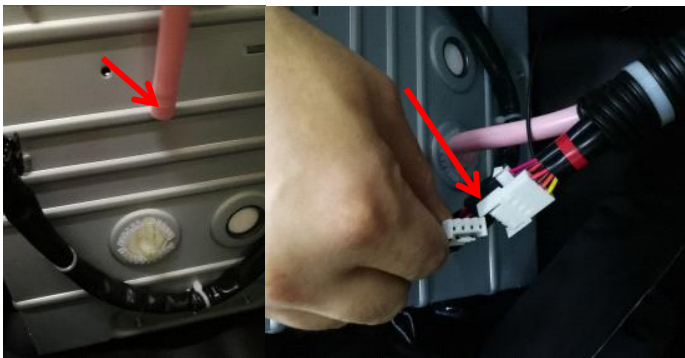
8. Connect the trachea to the terminal with a new machine core

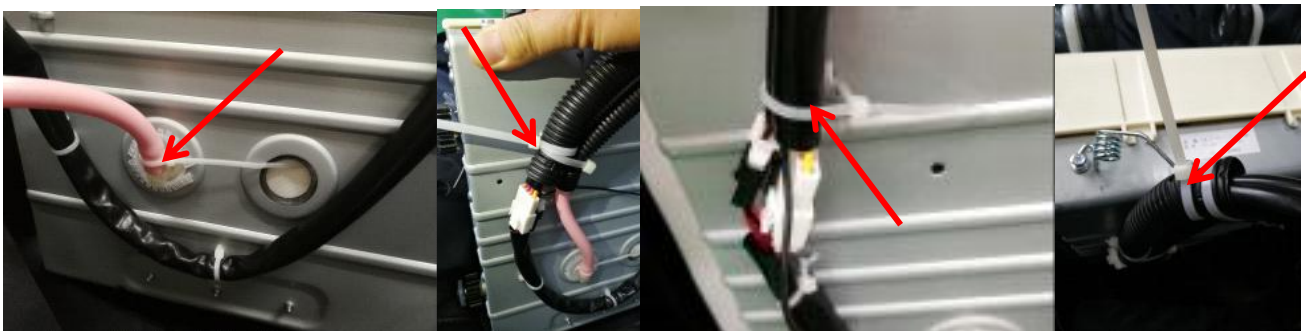
10. Tie a Cable Ties on the trachea and dorsal rack line

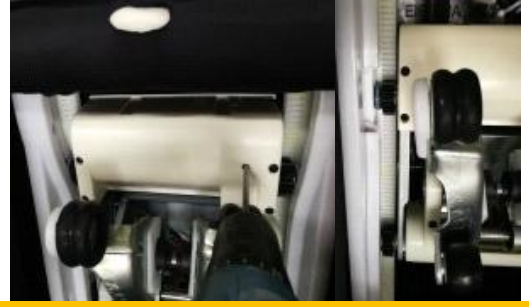
12. The screwdriver removes the machine core away from the baffle area of the left and right guideway through the repair hole

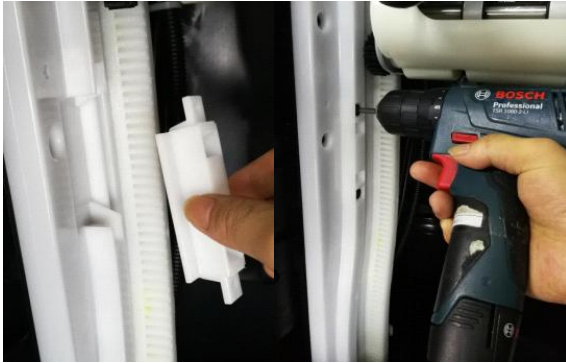
13. install the Remove baffle of the left and right guideway on the guideway

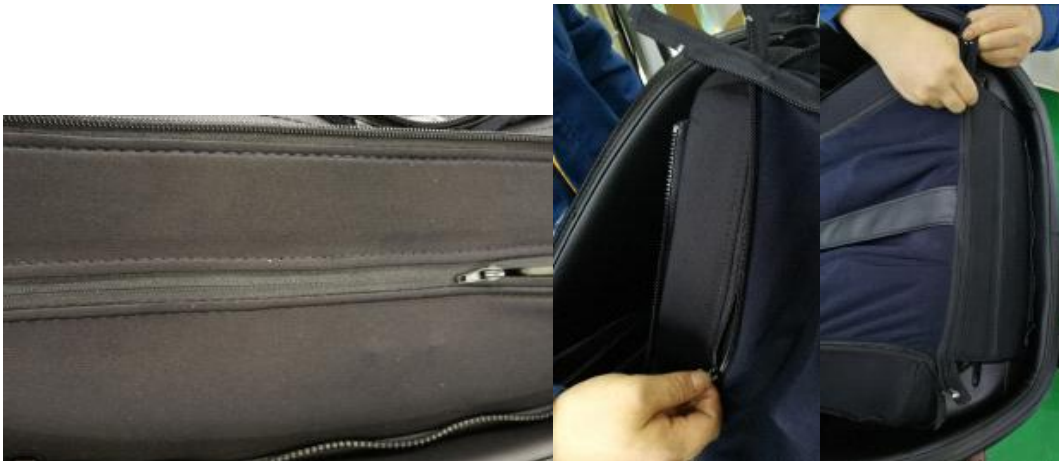
15. Pull 4 zippers.

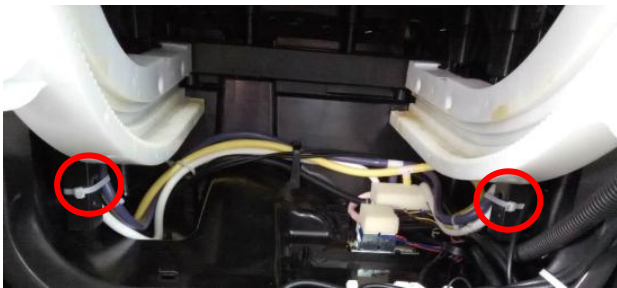
图 1

1. Run the massage chair to its original state, then cut off the power supply and unplug it;
2. Press P11 to remove the rear cover and cut the inner band of the lower cover with oblique pliers, as shown in figure 1;

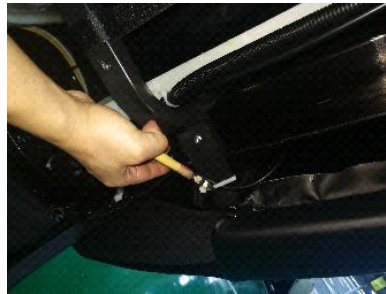
图 2

3. Cut off the tie belt that binds the hand controller to the side board, as shown in figure 2
4. Remove the two screws on the back rack, as shown in figure 3;

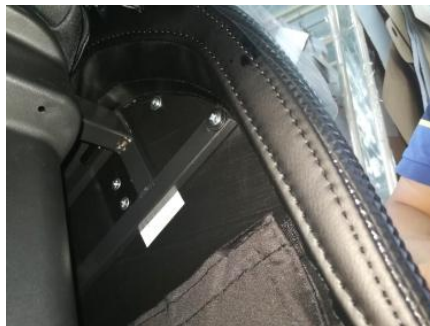
图 5

5. Unzip the shoulder air bag and remove the air bag screw with a screwdriver, as shown in figure 4;
6. Connect the power supply, run the massage chair to the back state, remove the screw at the front end of the side plate from below the calves as shown in figure 5, and then run the massage chair to the initial state and cut off the power supply

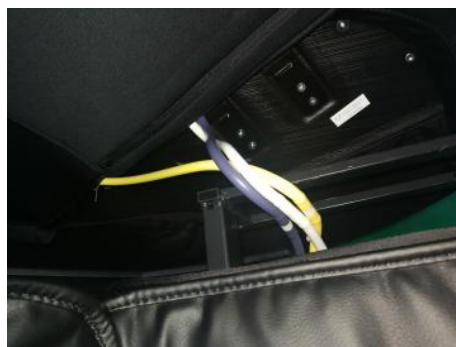
图 8

8. Lift the front end of the side plate up  $20 \times 30$  mm so that the side plate hook is detached from the back frame as shown in figure 8;
9. Remove three connecting trachea from the side plate, as shown in figure 8.

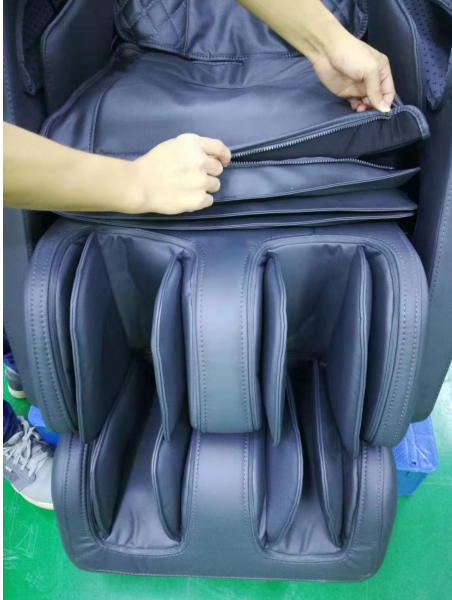
图 1

1. Unzipper as shown in figure 1;
2. Break the DK Card bolt open with your fingers or pliers and take it up, as shown in figure 2;
3. Remove the trachea and power cord connector, as shown in figure 3

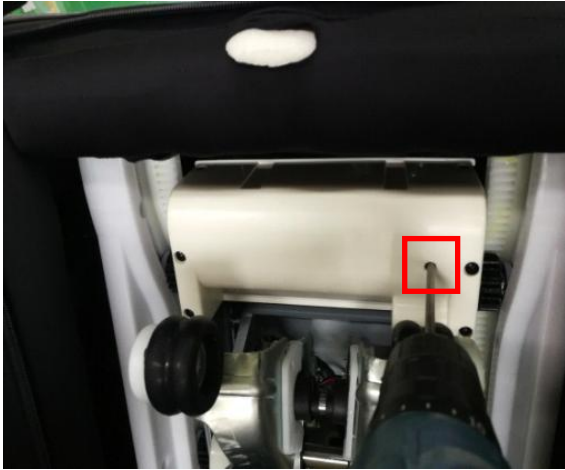
1. Adjust the center position of the Movement Backrest center position through the maintenance hole through the screwdriver for removing the cloak and velvet through P7 step 1 / 3;

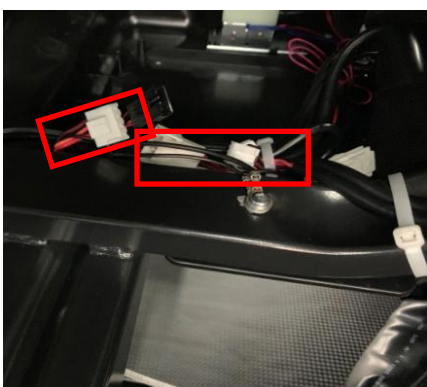
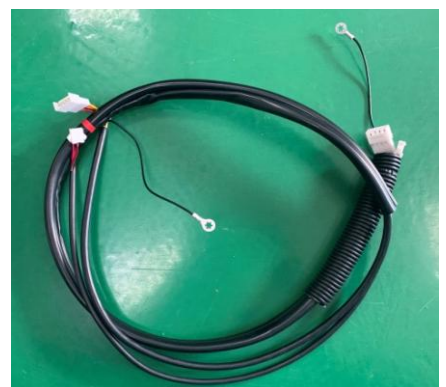
3. Pull out the docking terminal of the back frame of the lower cover of the seat and remove the backrest bus, as shown in the following figure.

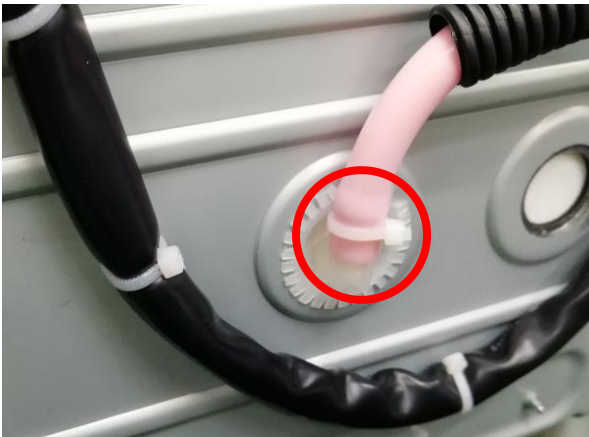
图 5

Connect the air duct assembly of the lower cover of the seat to the movemet, The trachea is inserted with alcohol, and the tie is fixed

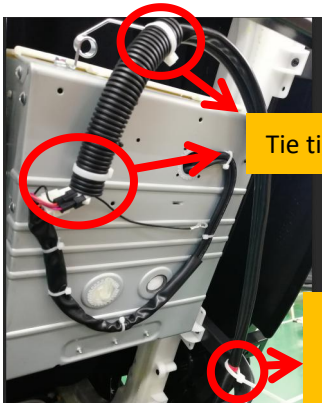
图 2

Tie tight in two places

The reserved position here is not tight.

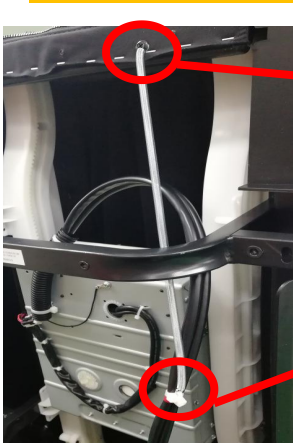
图 4

Fastening of core spring and nine-core connecting wire (3 places)

Pull spring of walking wire with lock

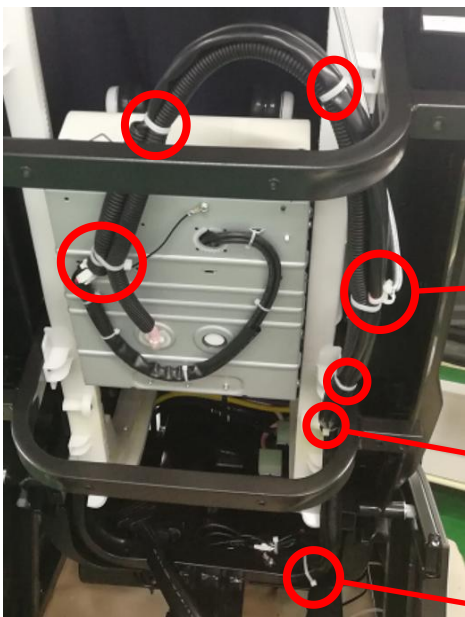
One end of the tension spring is attached to the head cover ST5\*10

One end of the spring is pierced into the buckle and fixed with the reserved band.

Band fixation (7 places)

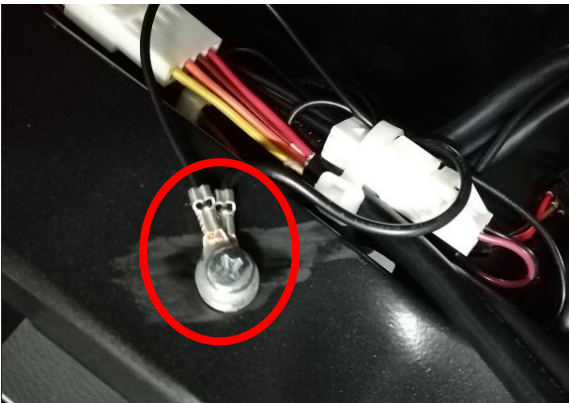
图 9

Nine-core connecting wire and 32 core wire earth wire with lock

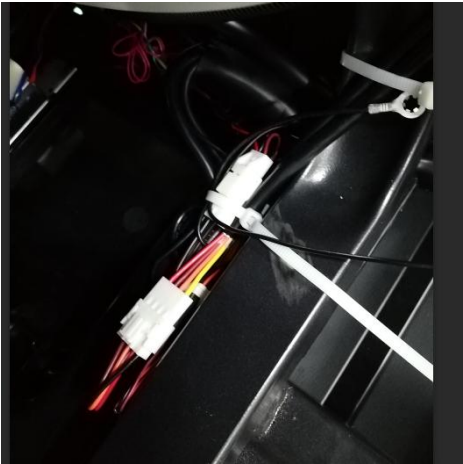
图 8

Straighten the line, tie the belt and fix it.

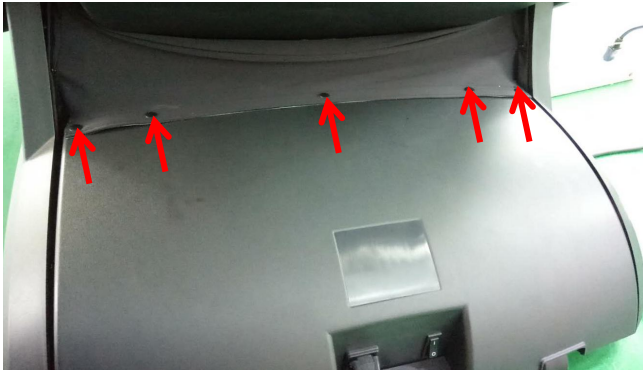
1.Remove 5 cloth sleeve pins on the top cover of the central box

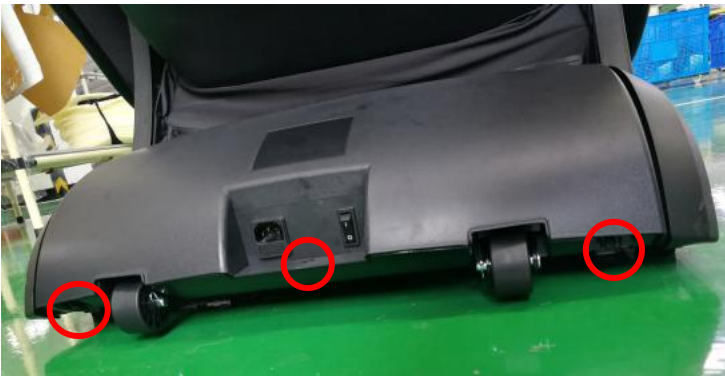
2.Remove 3 screws

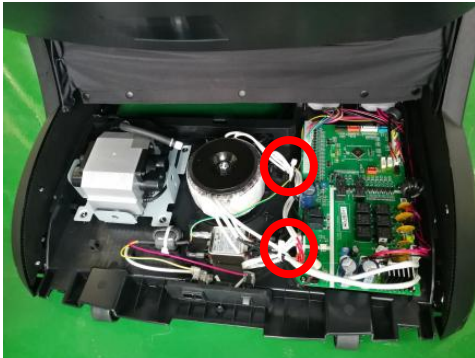
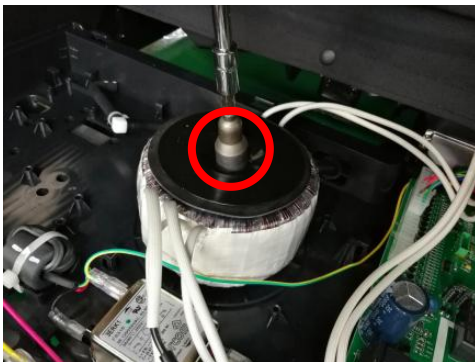
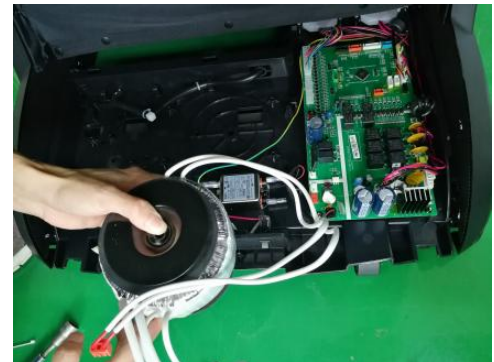
1. Transformer replacement: Cut the tie、 Unplug the terminal、 Remove the fixing screw from the transformer、 Remove transformer

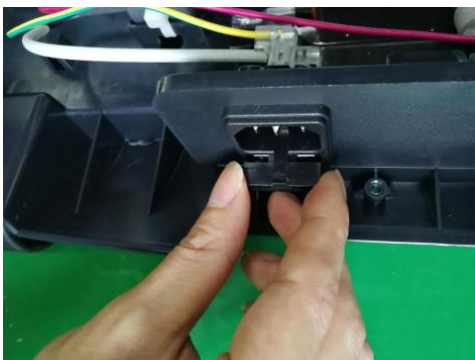
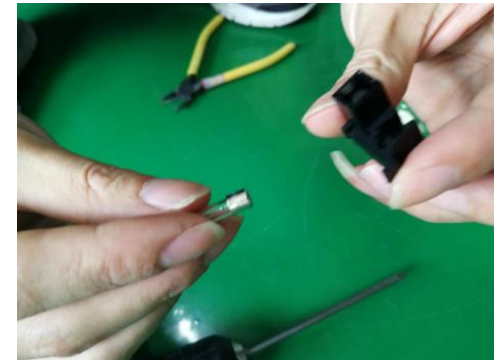
3.Fuse replacement: Remove insurance from socket, You can replace the fuse.
