# EC-8638 massage chair service

- 一、 Product introduction
- 二、 Massage chair tools and use
- 三、 Circuit working principle
- 四、 Massage chair removal instructions
- 五、 Massage chair fault judgment

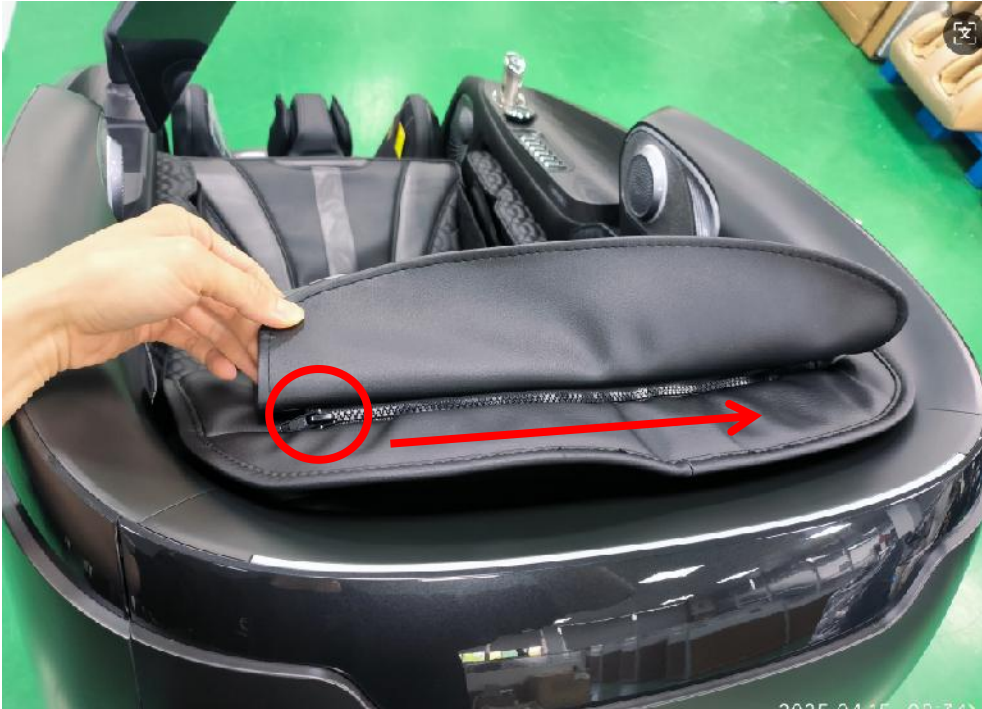
unzip the zipper

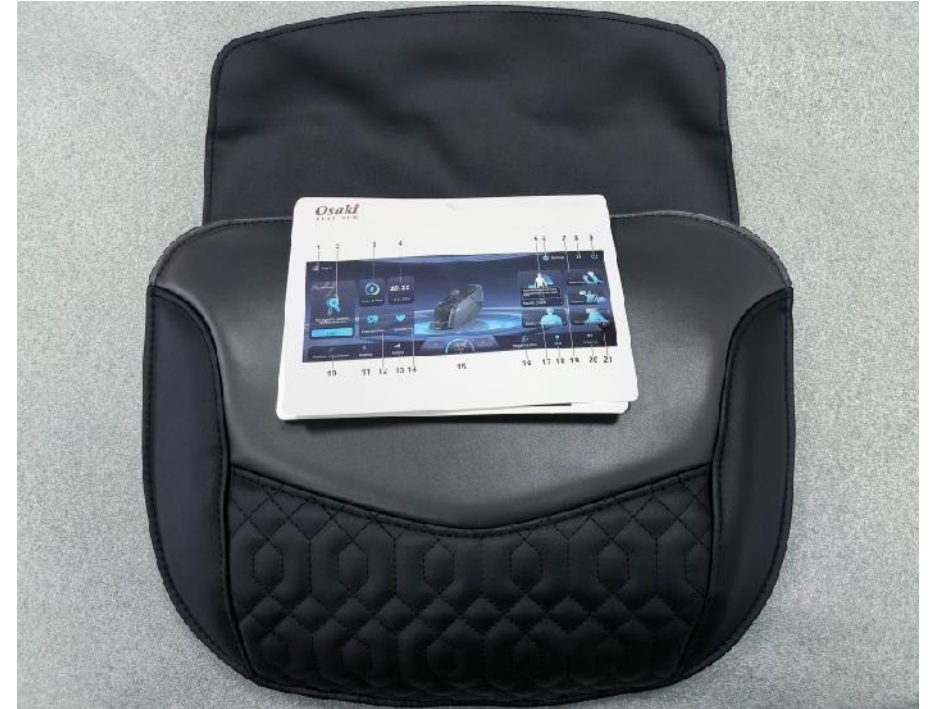
remove the pillow

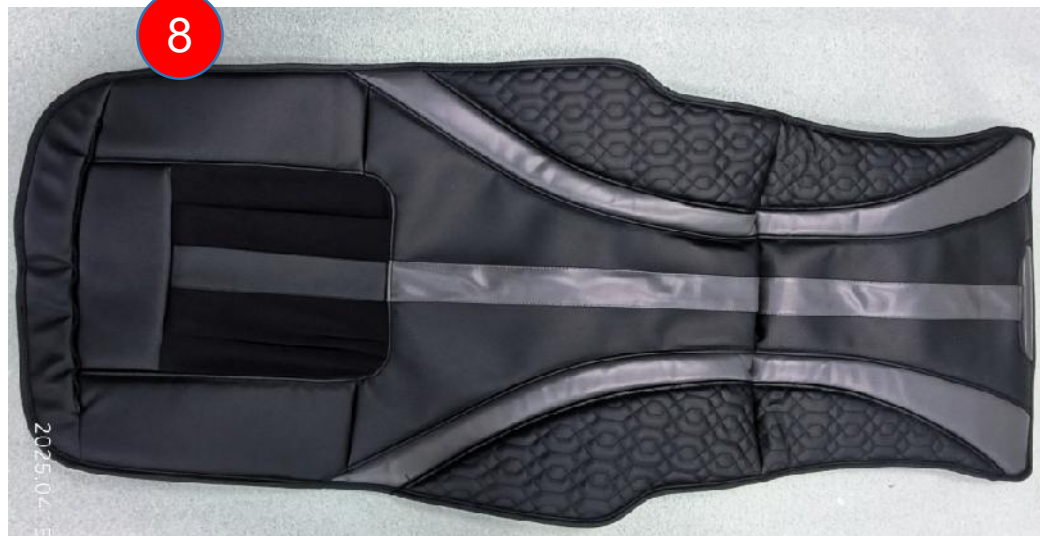
8

remove backrest pad

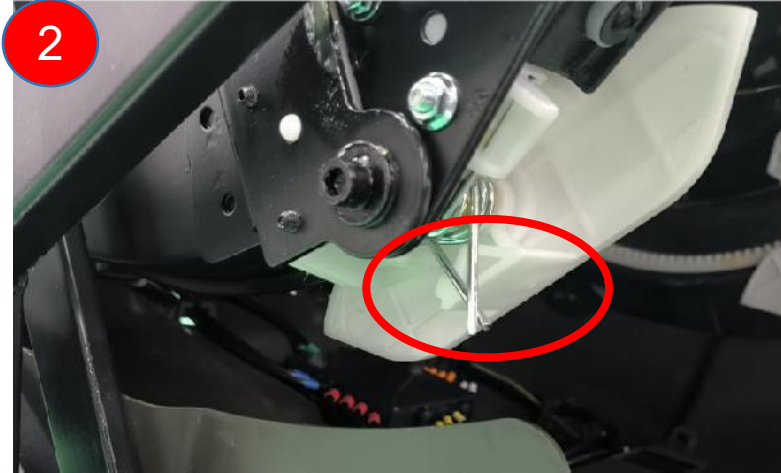
clamp the spring open with  
apointed nose pliers

Spring released

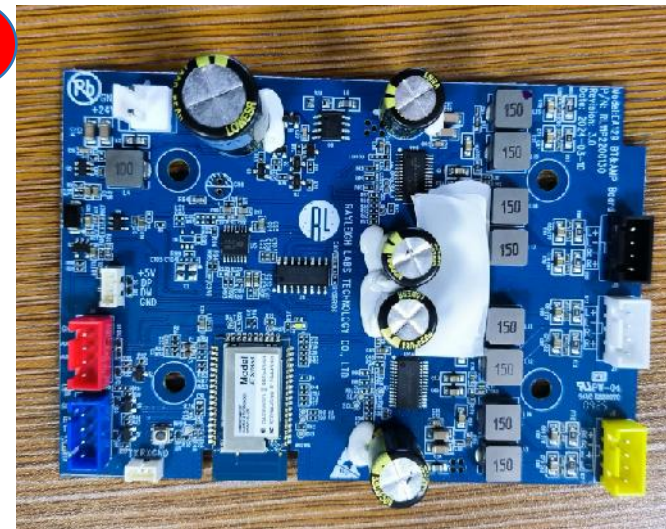
9

remove Bluetooth PCB

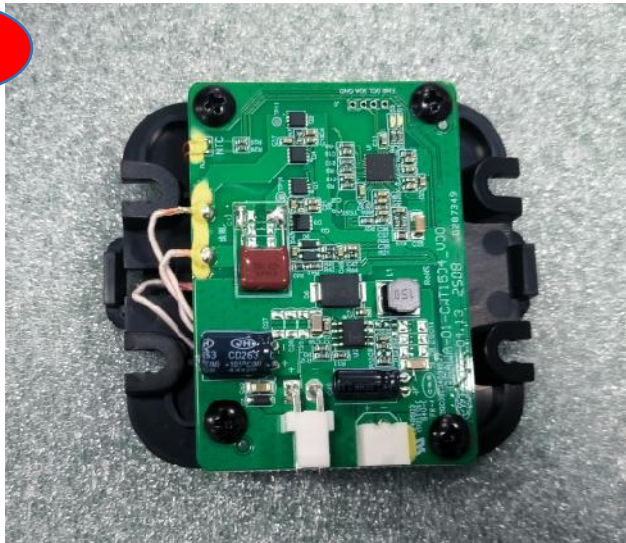
16

remove wireless charging unit

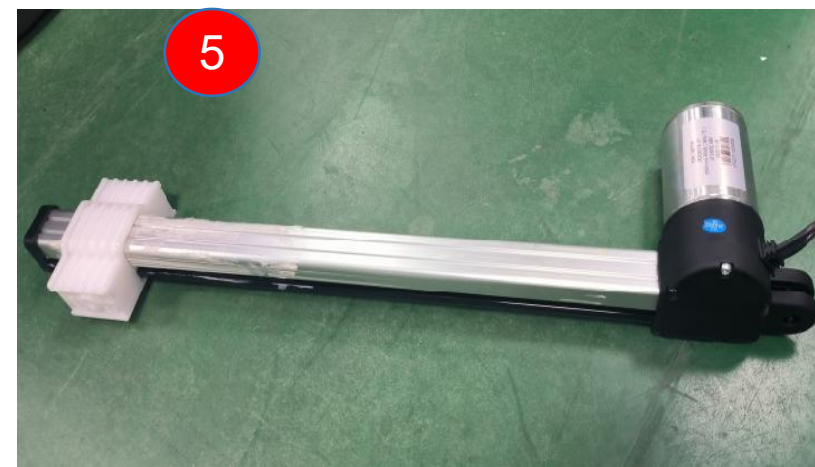
remove backrest actuator
