EASEPAL 厦门蒙发利电子有限公司客户服务部

EC-8639 massage chair service

一、Product introduction

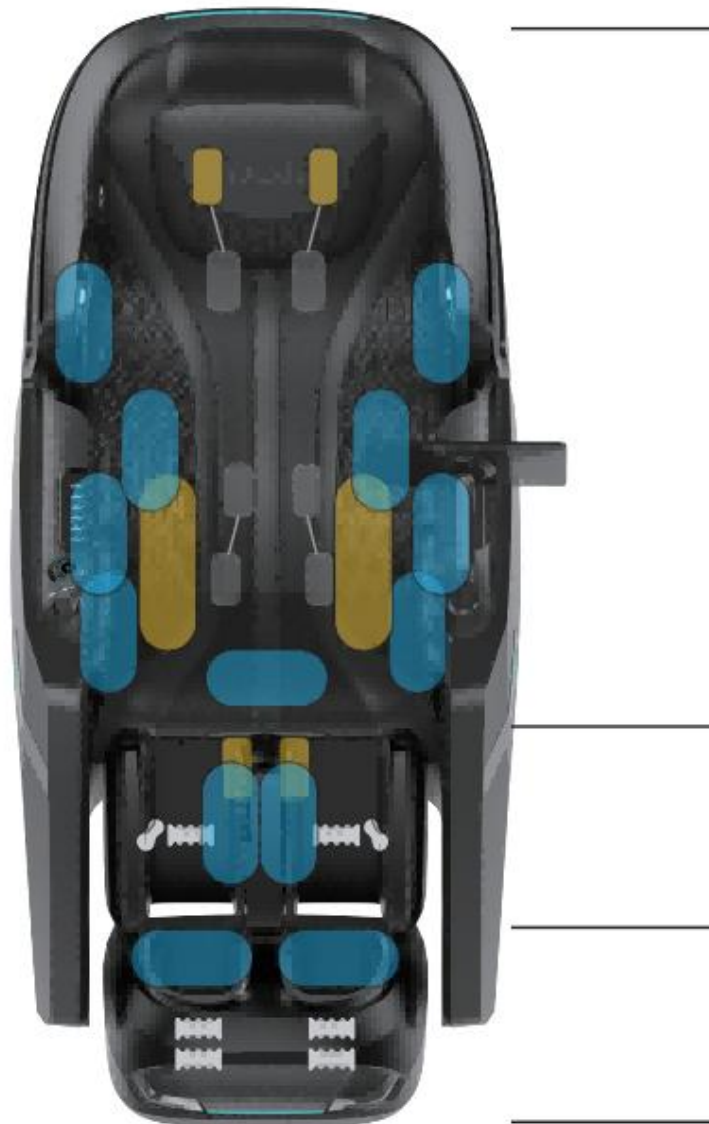
4、 Internal Structure:

33 Air Bags -
Shoulders 2
Arms 22
Lumbar 4
Seaside 4
Seat 1

Calves - 8 Air Bags

Feet - 16 Air Bags

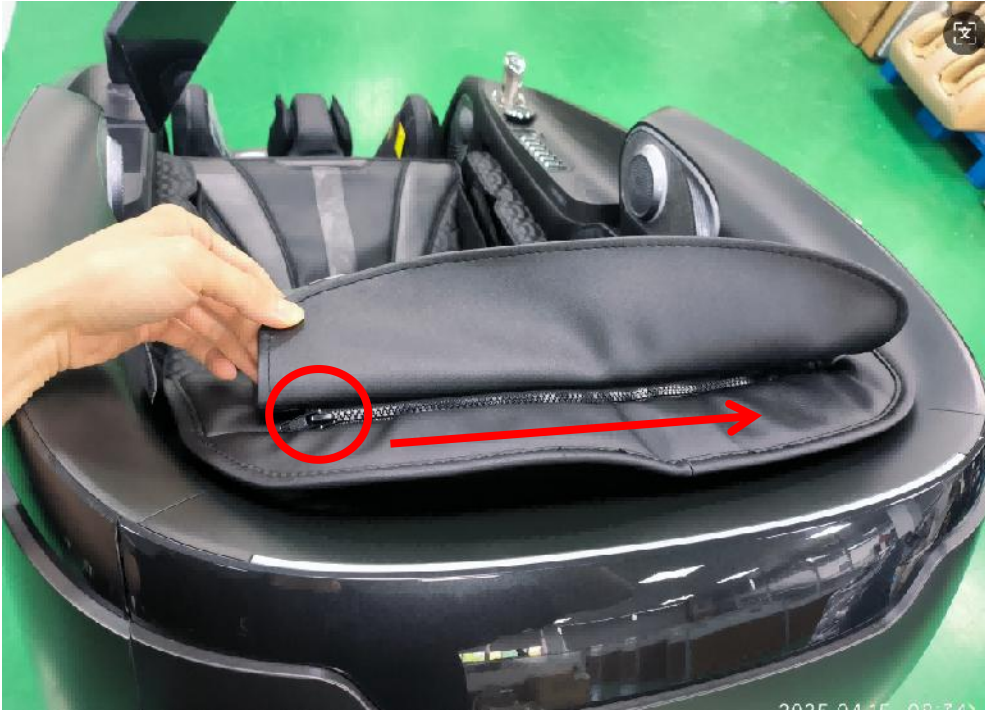
unzip the zipper

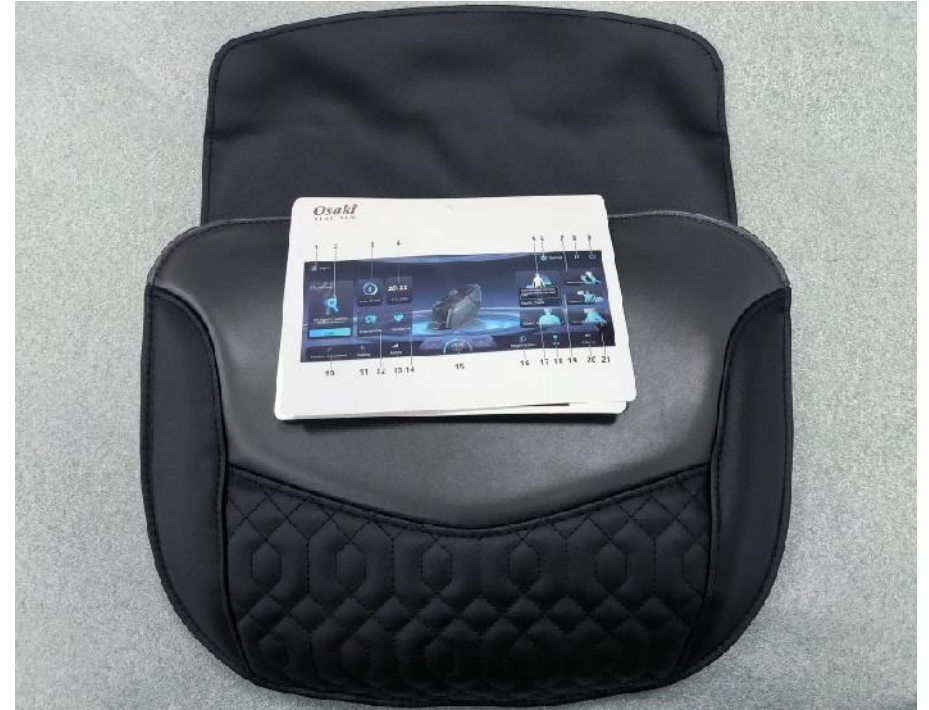
remove the pillow

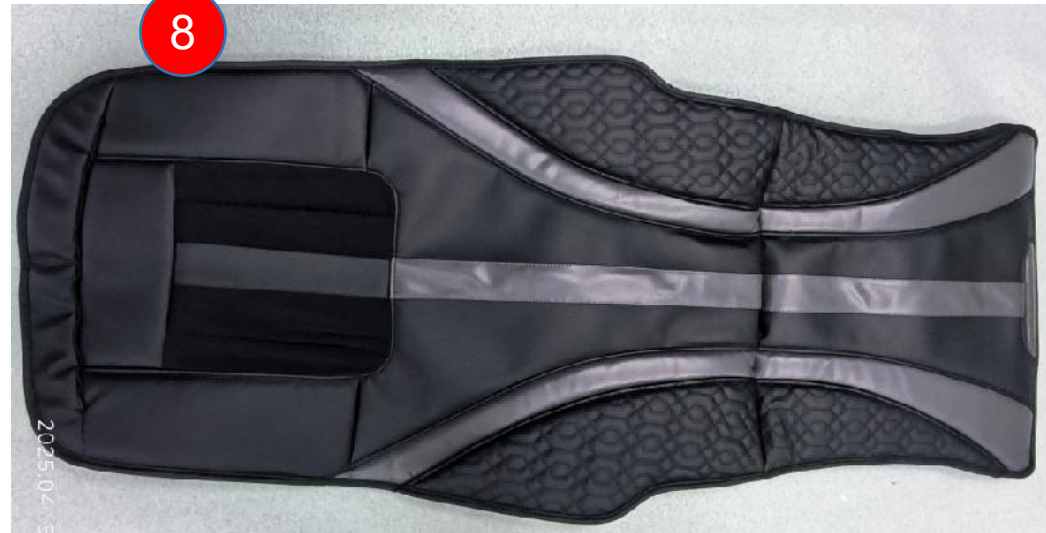
8

remove backrest pad

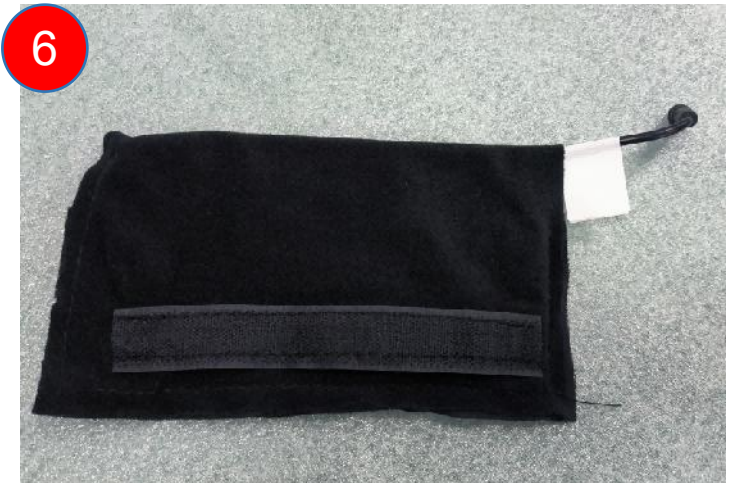
6

remove the waist heater

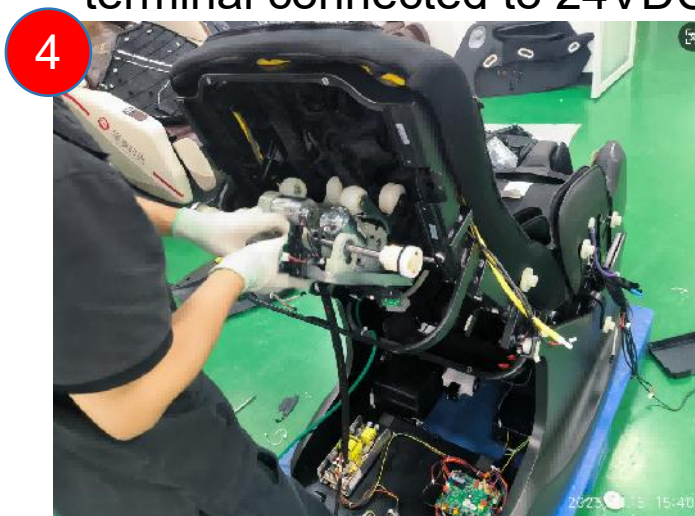
4
remove lower gear box

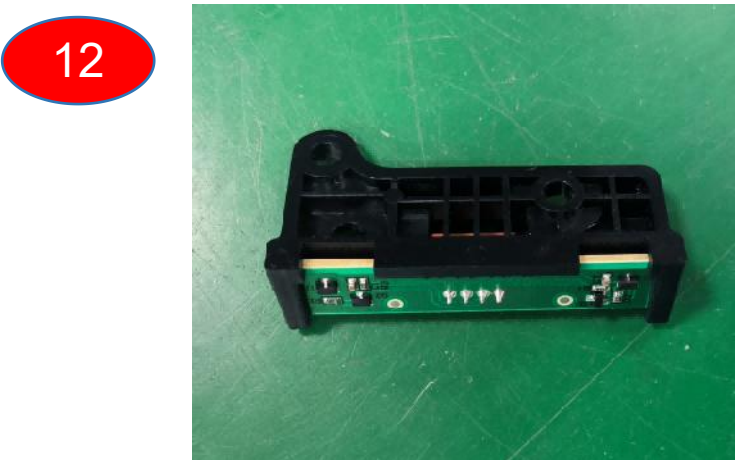
remove up&down limitsesor

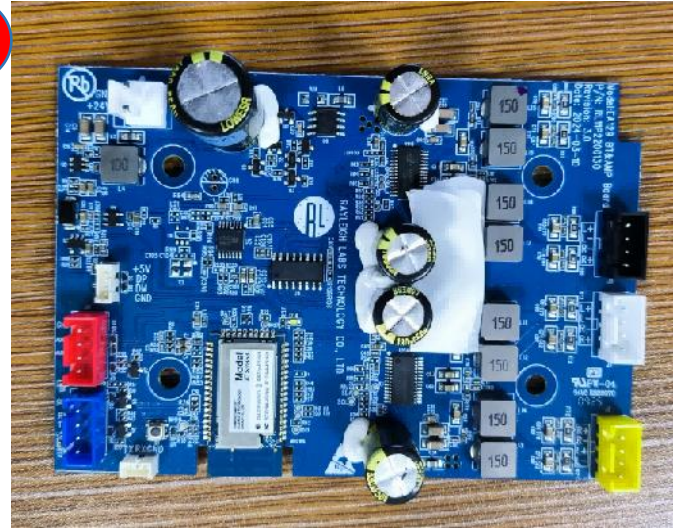
9

remove Bluetooth PCB

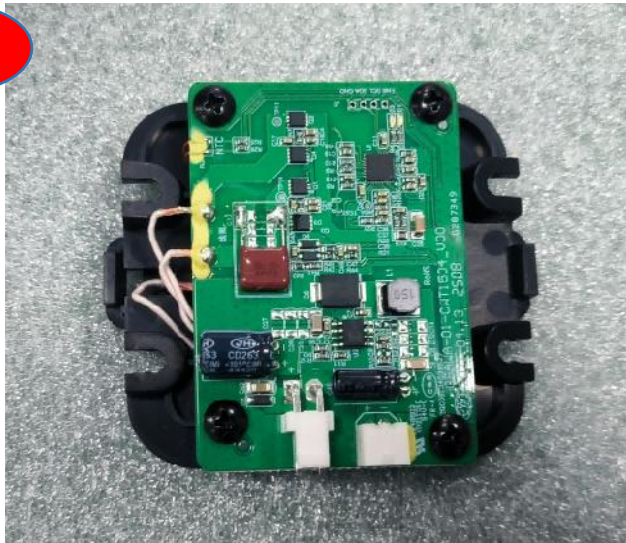
16

remove wireless charging unit

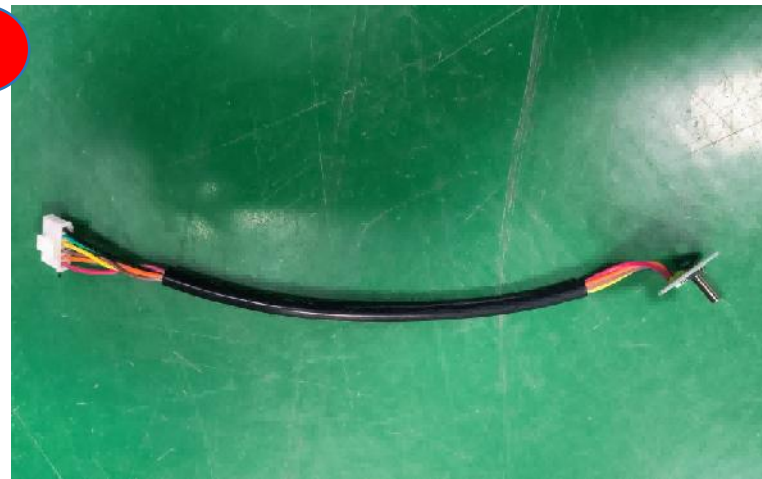
3

remove the type-C charging PCB

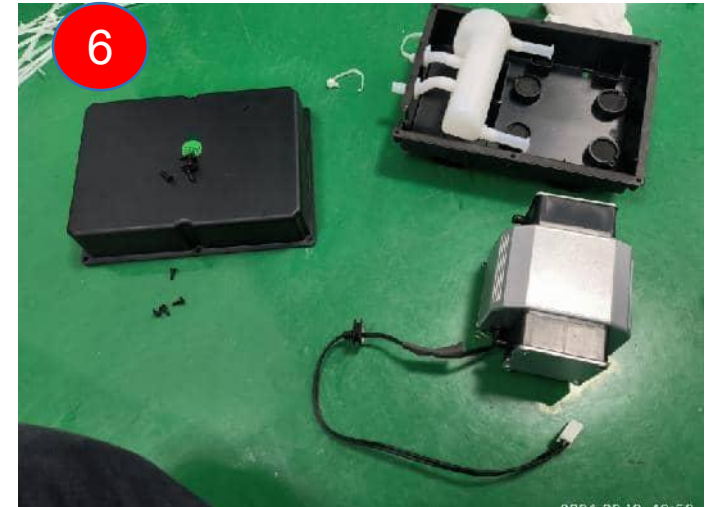
separate the air pump

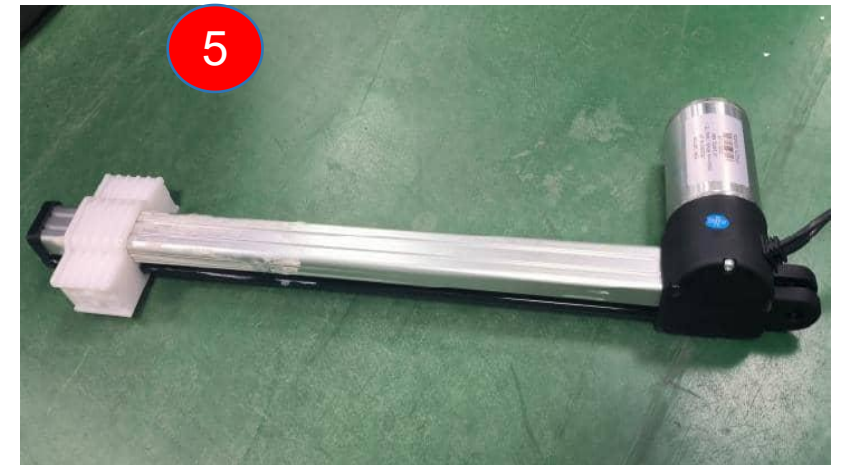
remove backrest actuator

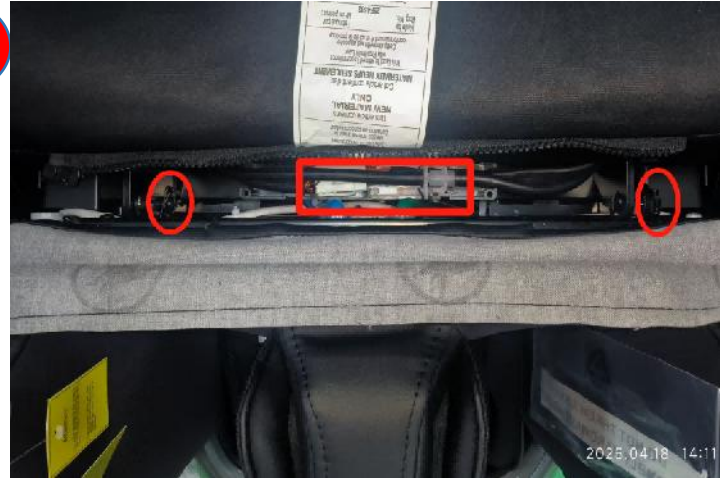
discontenttthe terminal and air hose, remove 2 catch pins
