FUJIAN YIHE ELECTRONICS CO.,LTD

Maintenance Service Manual

Factory mode	YH-7235	YH-7231	YH-7232	YH-7236
Sku#	AM-R7 LE	Ti Regal	Ti Royale	TI H7
Picture

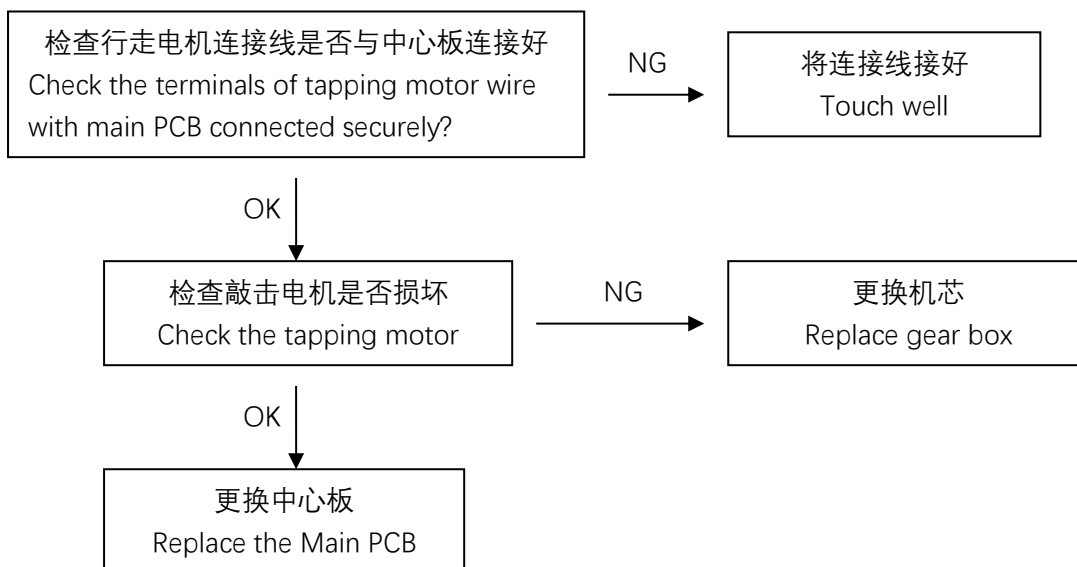
5、不敲击/ NO TAPPING

Trouble No.	Phenomenon	Description	Maintenance Method
05	No tapping	① The terminals on main PCB and wires are poorly connected ② Tapping motor failed ③ Main PCB failed	① Plug the terminal well ② Replace gear box ③ Replace main PCB

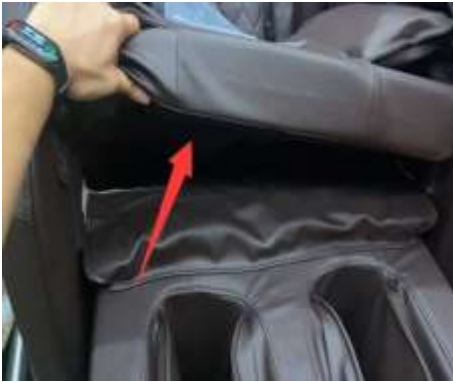
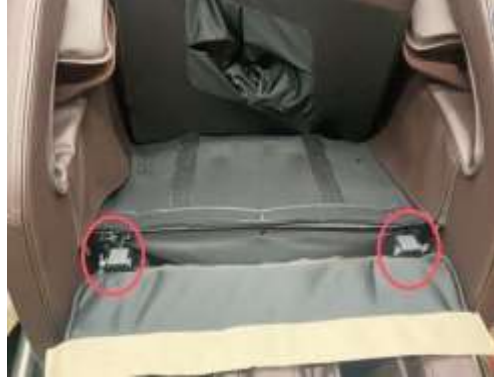
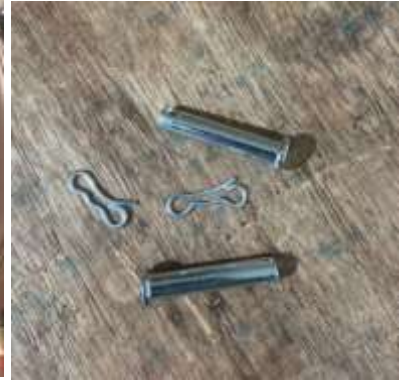
1-1 Lift the seat cushion up (Figure 1). There is one cotter pin on each left and right side of the calf rest (Figure 2). Remove the two cotter pins with long nose pliers (Figure 3) to separate the calf rest from the seat frame.

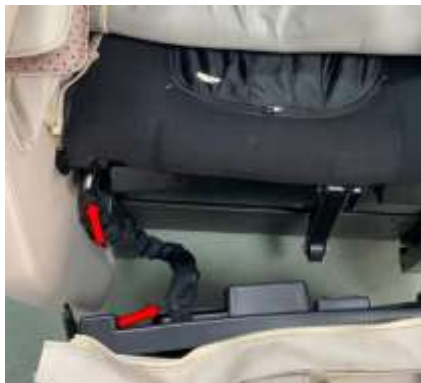
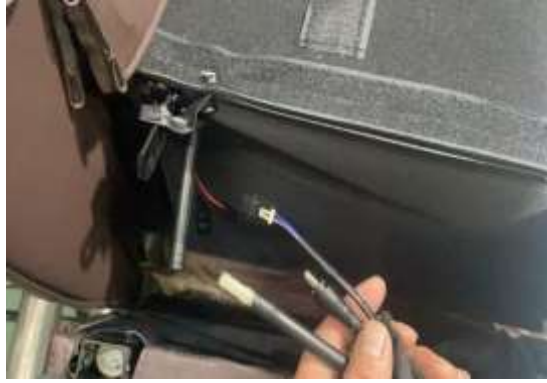
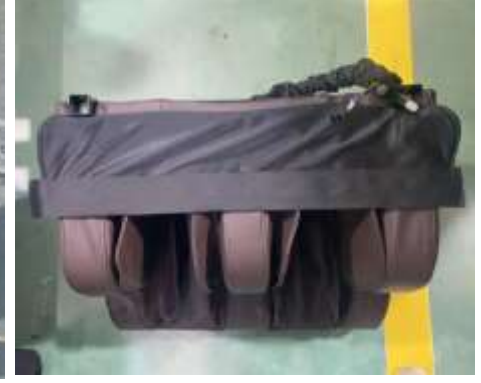
1-2 Cut the cable ties fixing the protective cloth cover of the calf rest wiring harness with diagonal pliers and open the protective cloth cover (Figure 4). Unplug the male-female connector of the calf rest power cord and the air pipe interface (Figure 5) to remove the calf rest (Figure 6). Replace the calf rest with a new one if it is damaged.

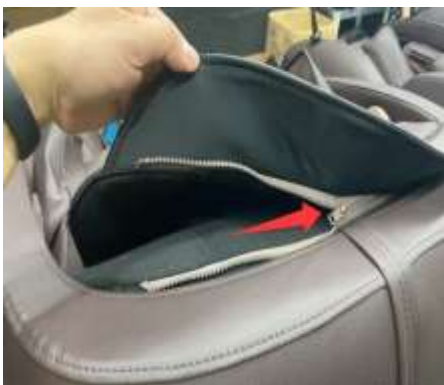
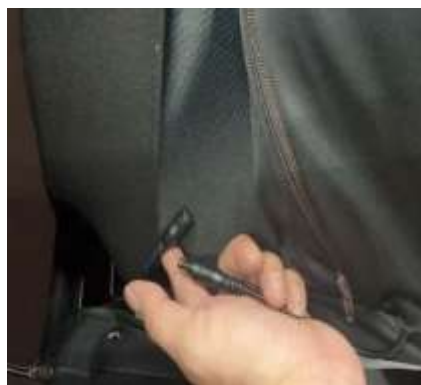
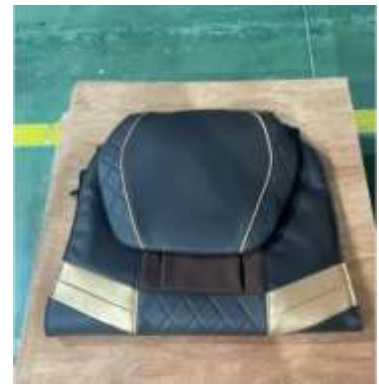
2-1 Lift the top end of the cape and unzip it (Figure 7). Lift the bottom right corner of the shawl and unplug the power connection male-female connector (Figure 8) to remove the cape (Figure 9). Replace the cape with a new one if it is damaged.

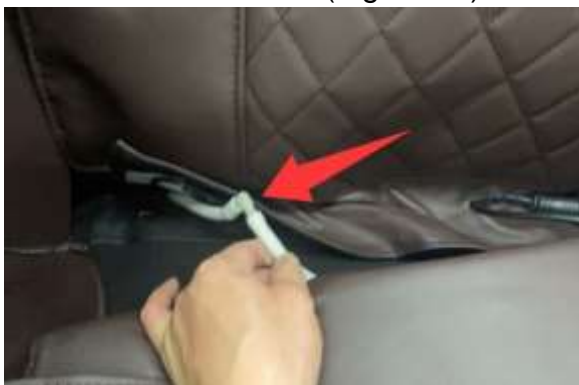
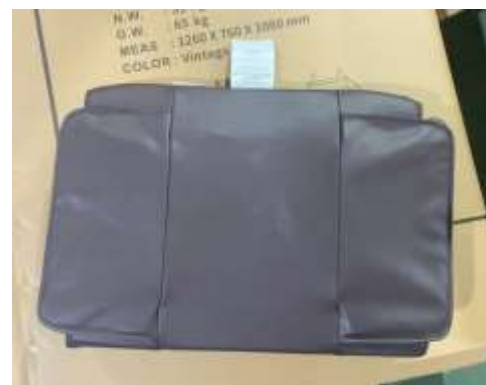
2-2 Unplug the air pipe connector between the seat cushion and the main unit (Figure 10) to remove the seat cushion (Figure 11).

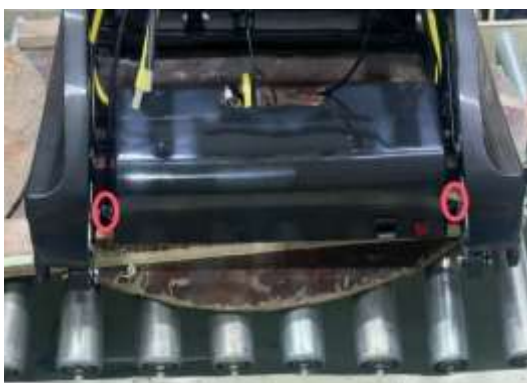
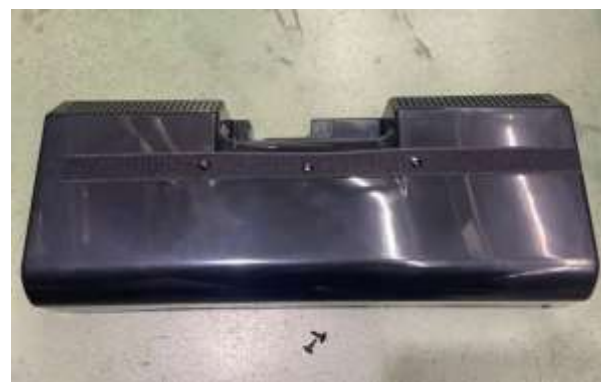
3-1 Remove the two screws fixing the central box (Figure 12) and lift the central box cover up (Figure 13).

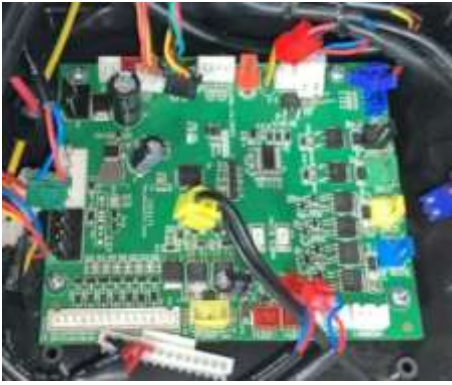
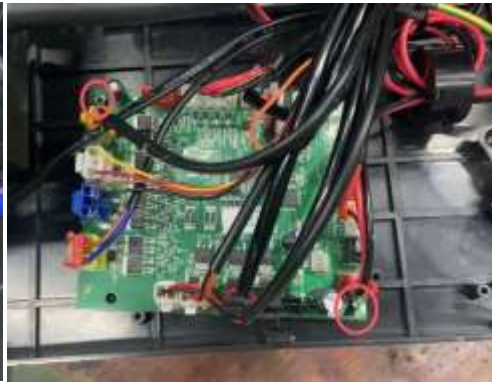
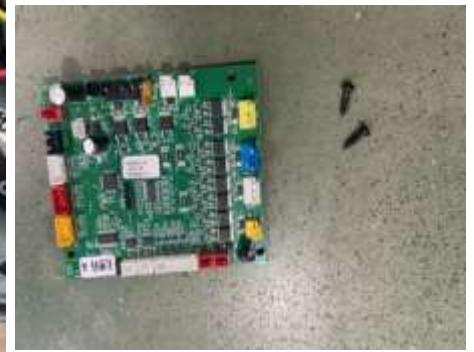
3-2 Unplug all wiring terminals on the main PCB (Figure 14) and remove the two screws fixing the main PCB (Figure 15) to take out the main PCB (Figure 16). Replace the main PCB with a new one if it is damaged.

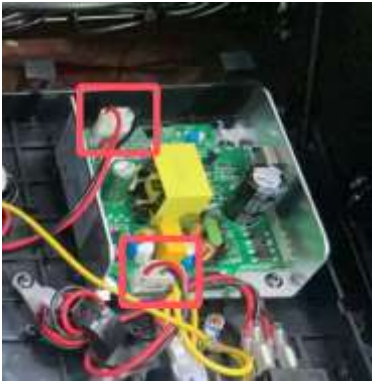
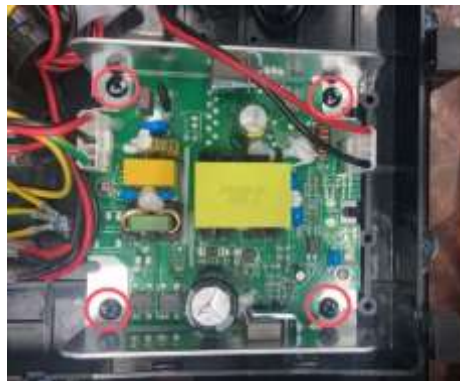
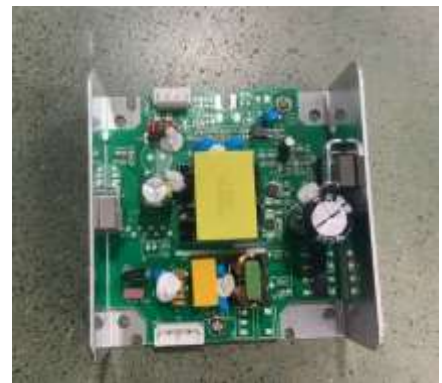
3-3 Unplug the two male-female terminals on the power PCB (Figure 17) and remove the four screws fixing the power PCB (Figure 18) to take out the power PCB (Figure 19). Replace the power PCB with a new one if it is damaged.

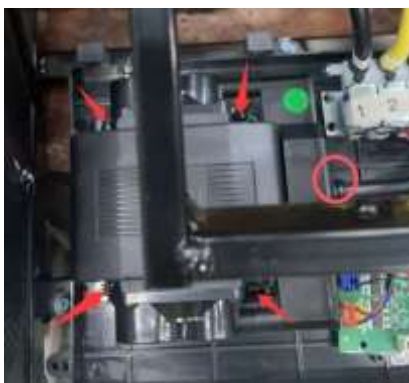
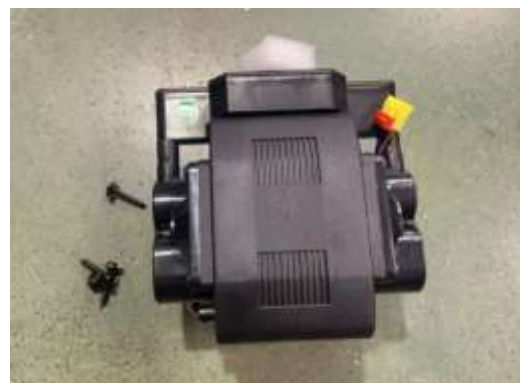
3-4 Cut the cable ties fixing the air pump wiring harness with diagonal pliers, unplug the air pump male-female terminal on the main PCB, remove the four screws fixing the air pump, cut the cable ties fixing the air pipe, and unplug the air pipe connection (Figure 20) to take out the air pump (Figure 21). Replace the air pump with a new one if it is damaged.

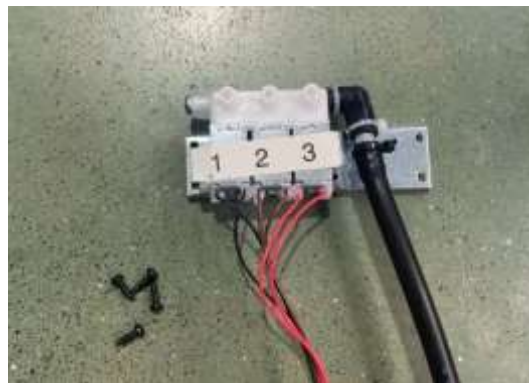
3-5 Cut the cable ties fixing the air valve wiring harness with diagonal pliers, unplug the air valve male-female terminal on the main PCB, remove the four screws fixing the air pump, and unplug

the air pipe connection (Figure 22) to take out the air valve (Figure 23). Replace the air valve with a new one if it is damaged.

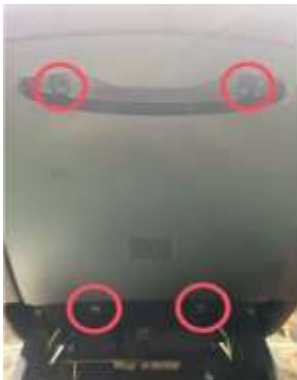
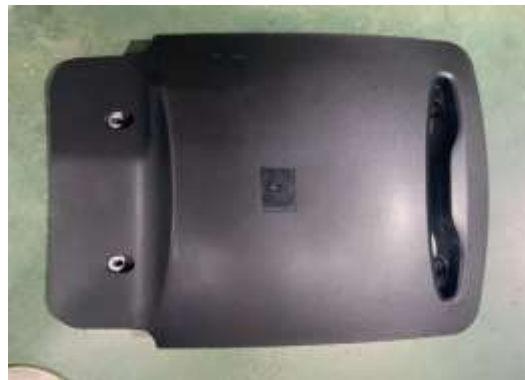
4-1 Remove the four screws fixing the rear cover with a screwdriver (Figure 24) to take off the rear cover (Figure 25).

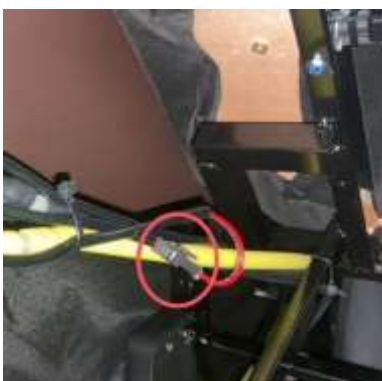
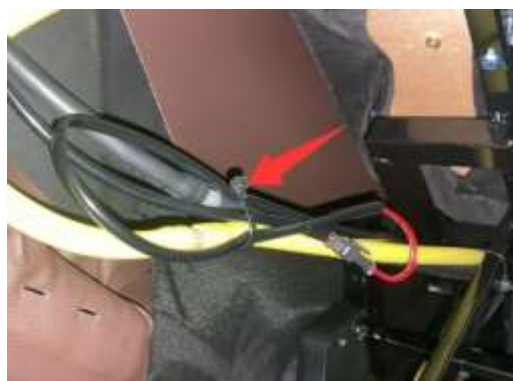
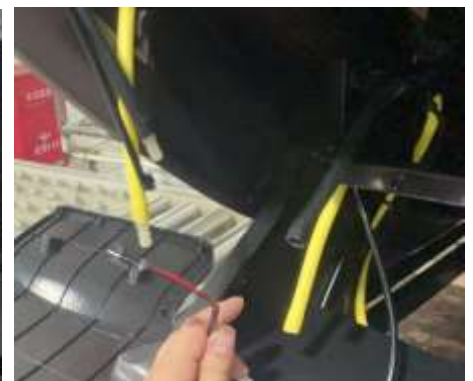
4-2 Cut the cable ties fixing the Bluetooth speaker power cord with diagonal pliers and unplug the male-female terminal (Figure 26). Cut the cable ties fixing the air pipe with diagonal pliers and unplug the air pipe connector (Figure 27, 28).

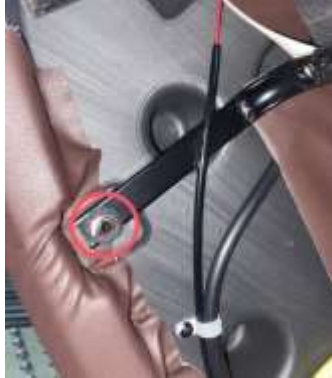
Figure 29

4-3 Remove the fixing screws at the rear of the side panel with an Allen Key set (Figure 29).

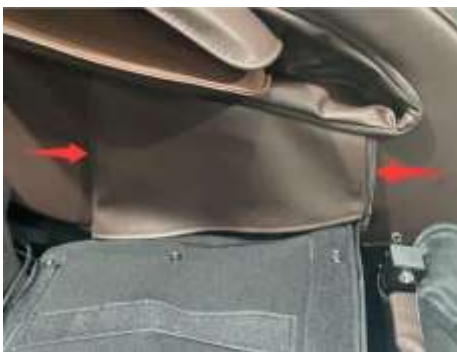
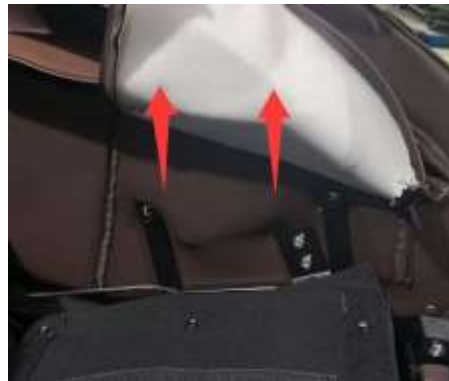
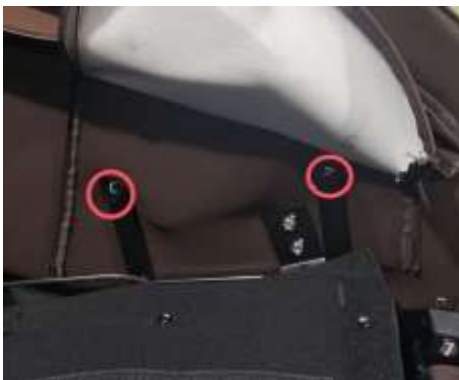
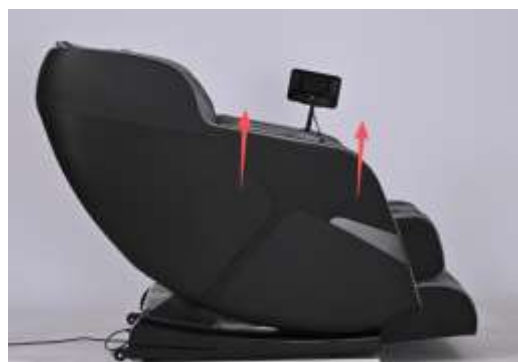
4-4 Unzip the zippers on both sides of the seat side baffle cloth (Figure 30), lift the baffle cloth (Figure 31), remove the two fixing screws of the right side panel with a screwdriver (Figure 32), and lift the front and rear ends of the right side panel up (Figure 33) to remove the side panel. Replace the side panel with a new one if it is damaged.

Note: When reinstalling the side panel, first hook the lower hook of the side panel on the seat frame and snap the upper hook into the groove, then follow the above steps in reverse order for the rest. The replacement method for the left side panel is the same as that for the right one.

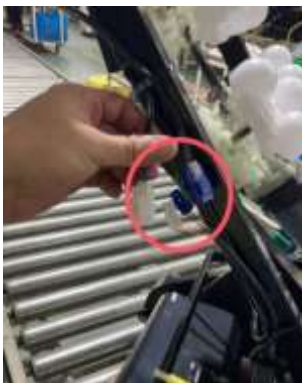
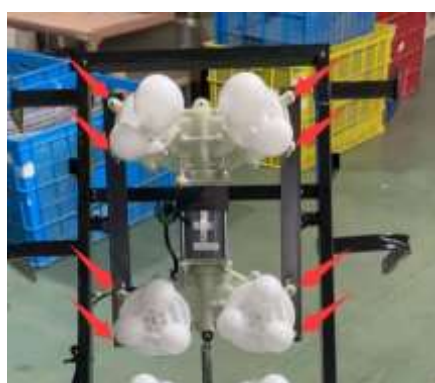
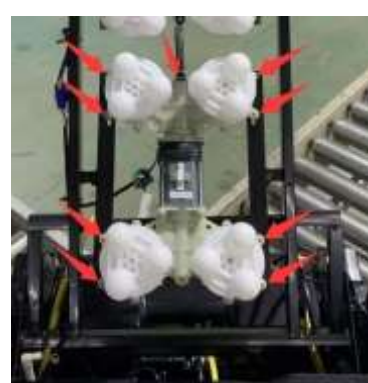
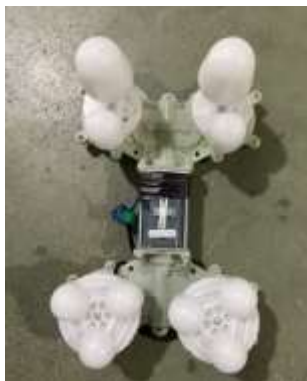
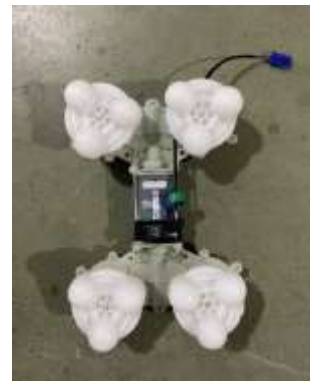
5-2 Unplug the male-female terminals of the upper and lower assemblies, remove the screws fixing the upper and lower assemblies with a screwdriver and spanner (Figure 35, 36, 37) to take out the assemblies (Figure 38, 39). Replace the upper/lower assemblies with new ones separately if they are damaged.

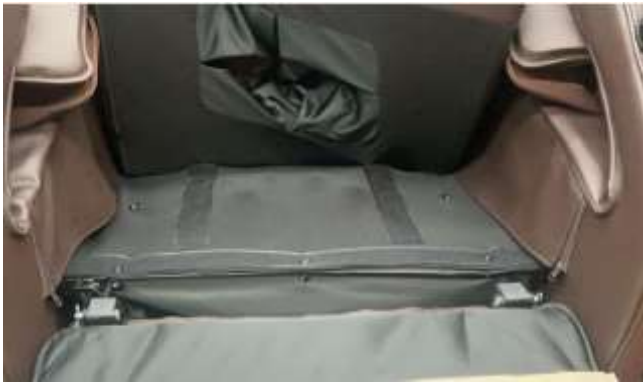
6-1 To disassemble the seat mechanical core, first remove the seat cushion (Figure 40).

6-2 Remove the eight screws fixing the seat oxford cloth with a screwdriver (Figure 41), then lift the oxford cloth up.

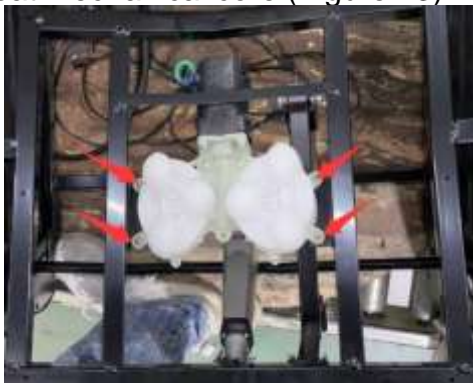
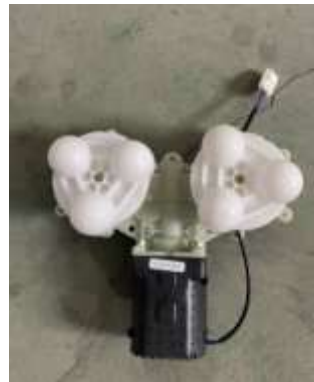
6-3 Remove the four screws fixing the seat mechanical core with a screwdriver (Figure 42) to take out the seat mechanical core (Figure 43).

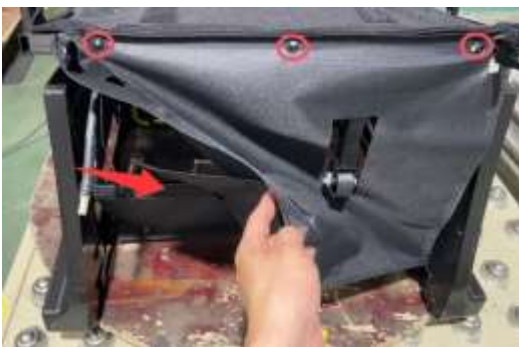
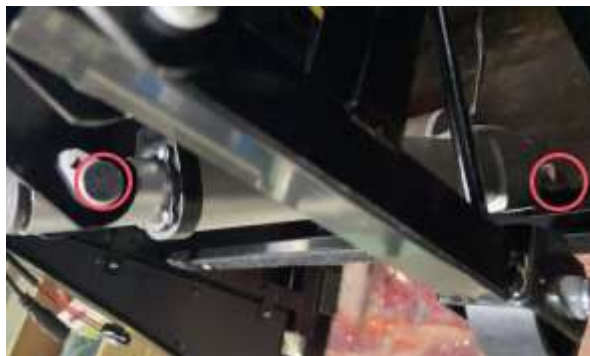
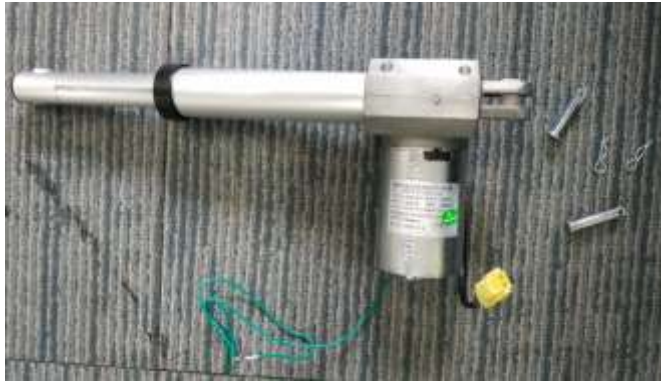
7-1 First disassemble the calf rest according to the calf rest disassembly process, open the Velcro of the front baffle cloth, then loosen the three screws (Figure 44).

7-2 Remove the wave-shaped split pins on both sides of the push rod with long nose pliers and take out the pin shaft (Figure 45) to remove the calf rest push rod (Figure 46). Replace the backrest push rod with a new one if it is damaged.

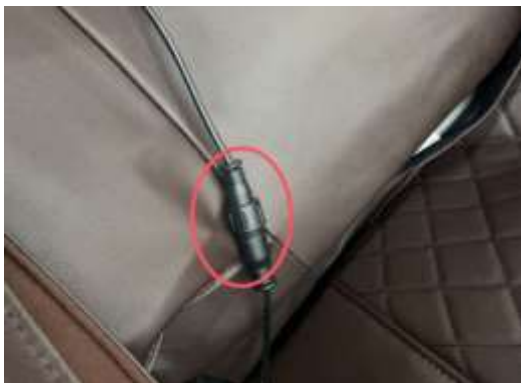
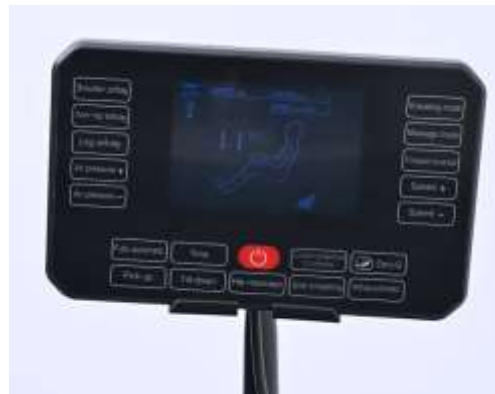
8-1 Under the left side cape of the massage chair (Figure 47), unscrew the male-female connector of the hand controller to remove the hand controller (Figure 48). Replace the hand controller with a new one if it is damaged.
