EASEPAL 厦门蒙发利电子有限公司客户服务部

EC-626E massage chair service

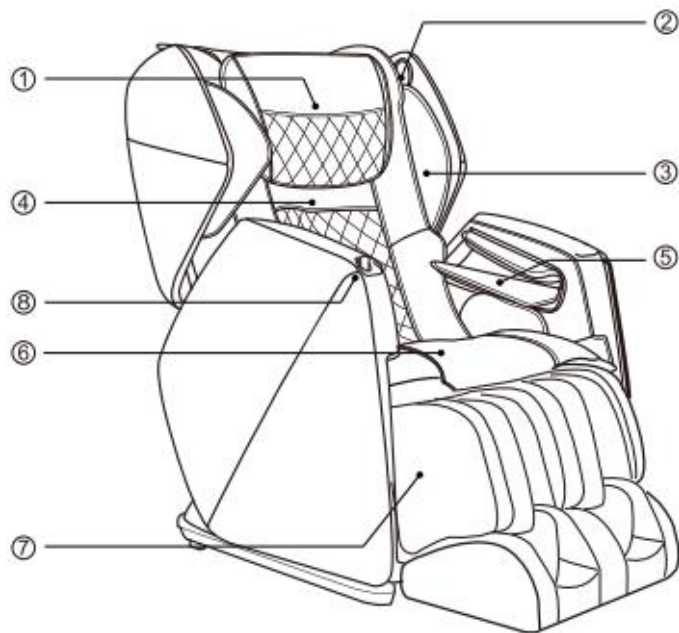
Front

① Pillow Pad

③ Shoulder side massage section

⑤ Hand and arm massage section

⑦ Legrest

② Bluetooth Speaker (See Page 5)

④ Backrest Pad

⑥ Seat

⑧ Controller Storage Compartment

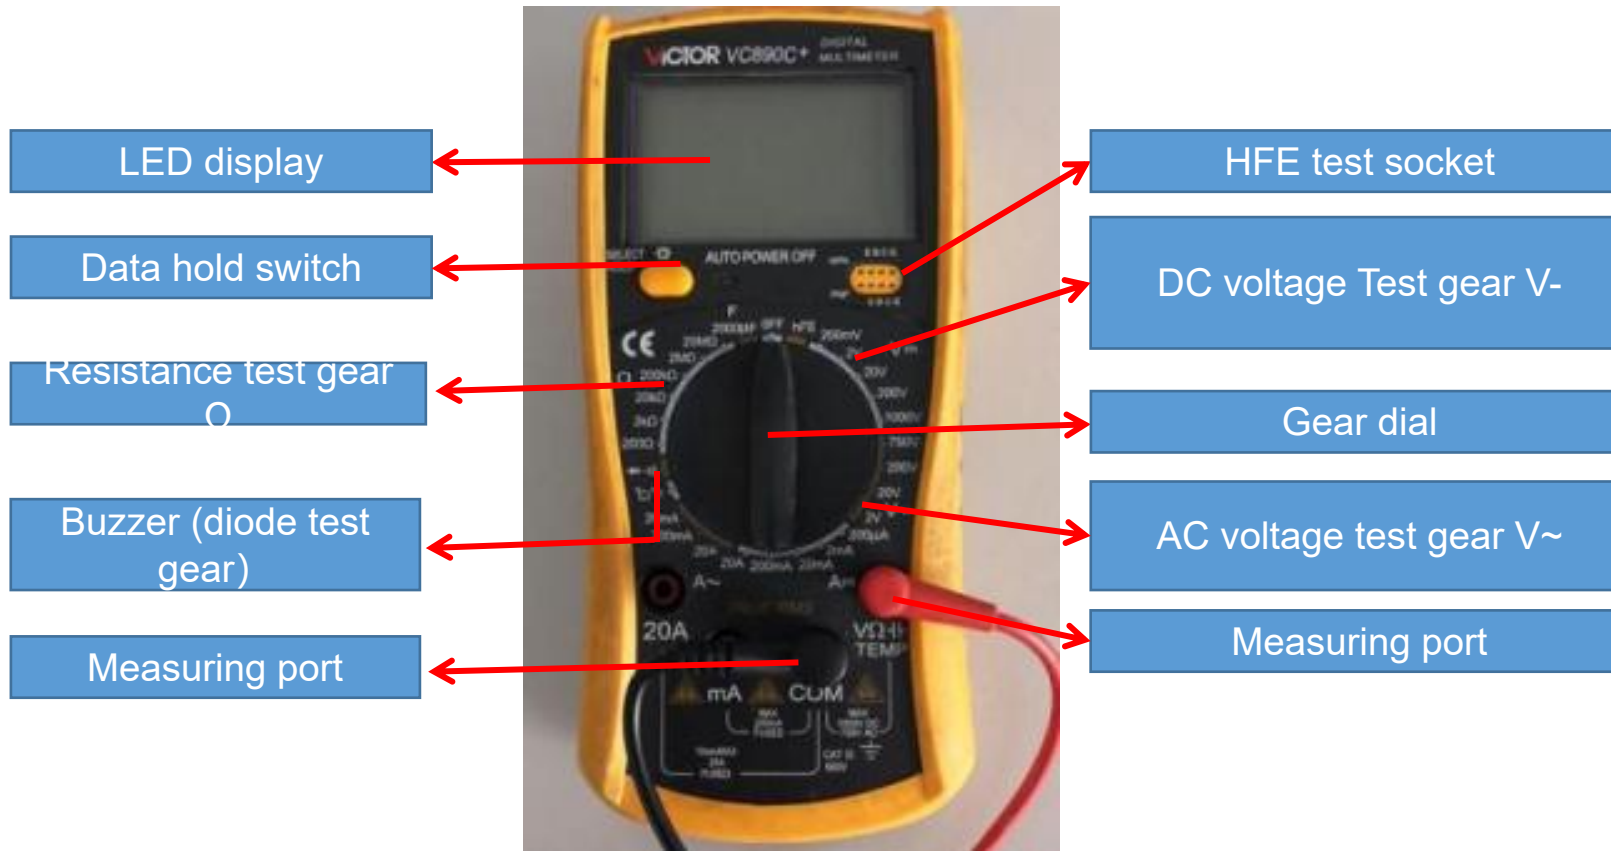
2.Usage of multimeter

2.1、 Function of the test gears

Data hold switch: Memorize the measured data for comparison。

Buzzer (diode test gear) : Measure the quality of diode, the on-off and alarm function of circuit

Resistance gear test gear: Measure the quality and value of resistance

DC voltage Test gear V-: Measure DC voltage

AC voltage test gear V~: Measure AC voltage

VΩ / COM: VΩ Red pen port (+ pole) during test, black pen port (- pole) during com test

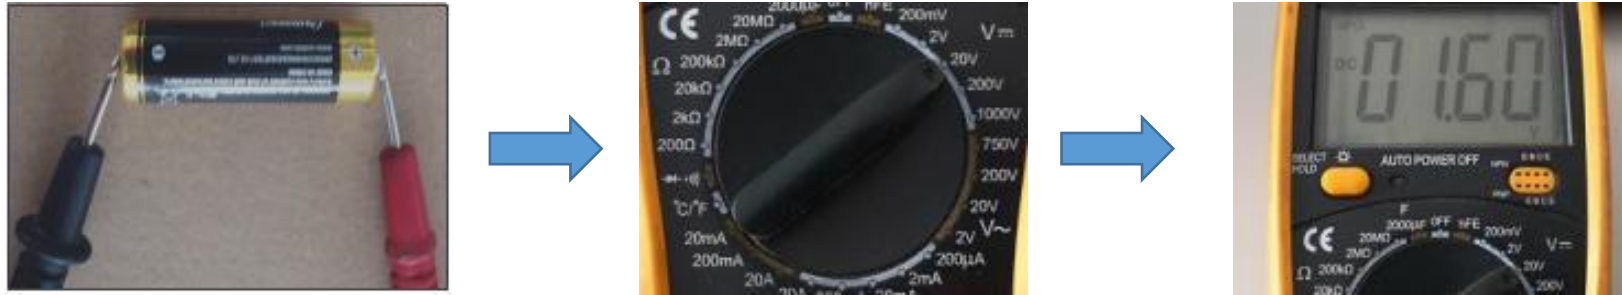
As shown in the picture above: the test result is "1.58", indicating that the voltage at both ends of the battery is 1.58v, and the red lead is connected to the "+" pole of the battery, and the black lead is connected to the "-" pole of the electromagnetic.

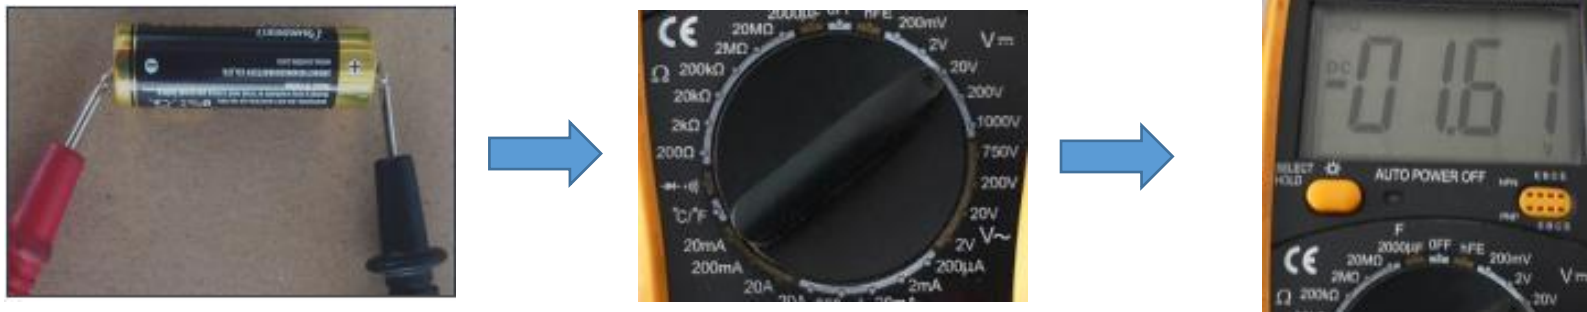
As shown in the above picture: the test result is "- 1.58", indicating that the voltage at both ends of the battery is 1.58v, and the red lead is connected to the "-" pole of the battery, and the black lead is connected to the "+" pole of the electromagnetic

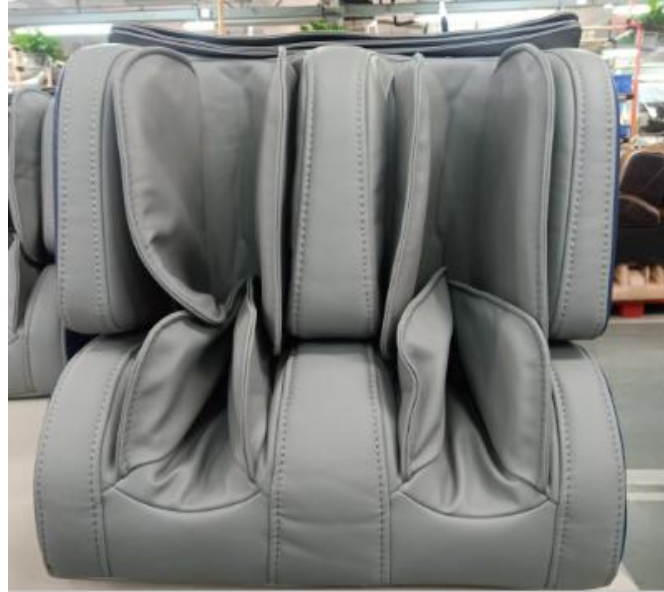
Legrest hardware and foot roll assembly

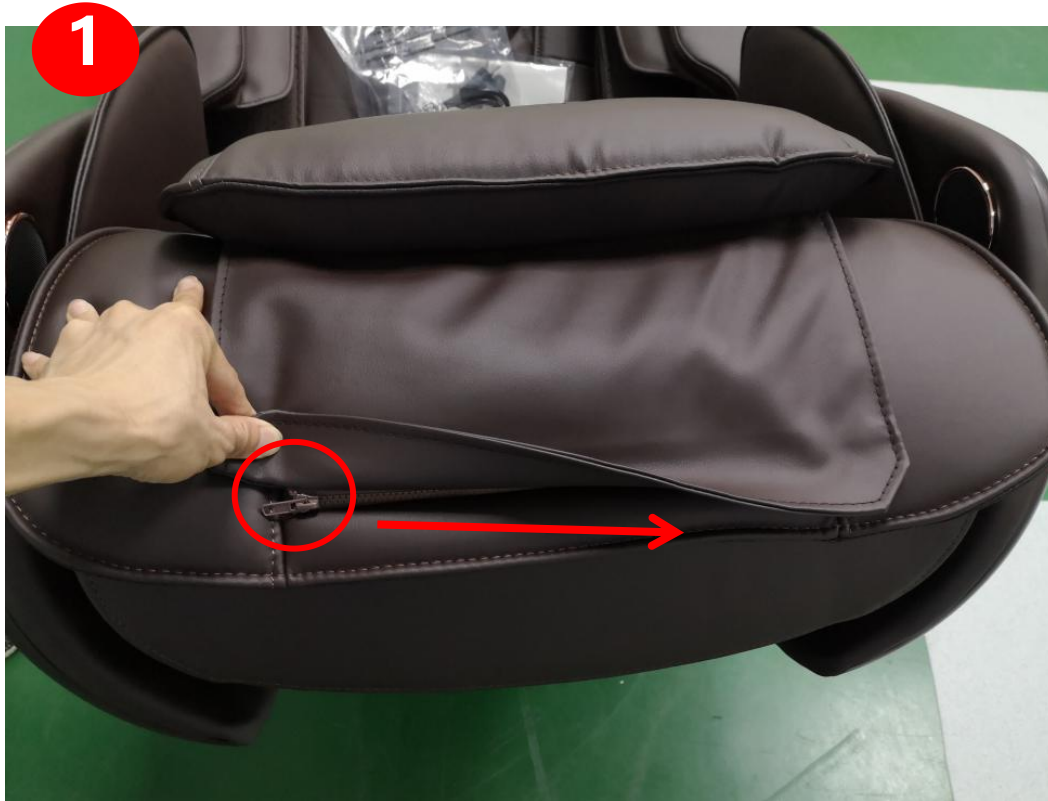
3.1、Disassembly of the pillow:

unzip the zipper, remove the pillow

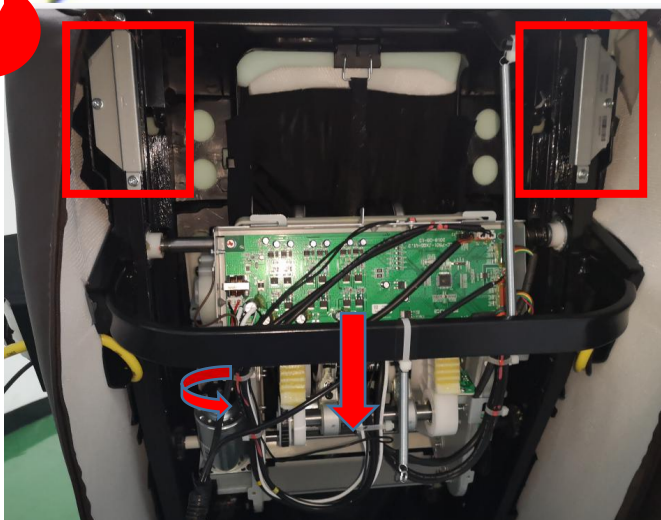
7

Rotate the encoder counter clockwise, mechanism go down

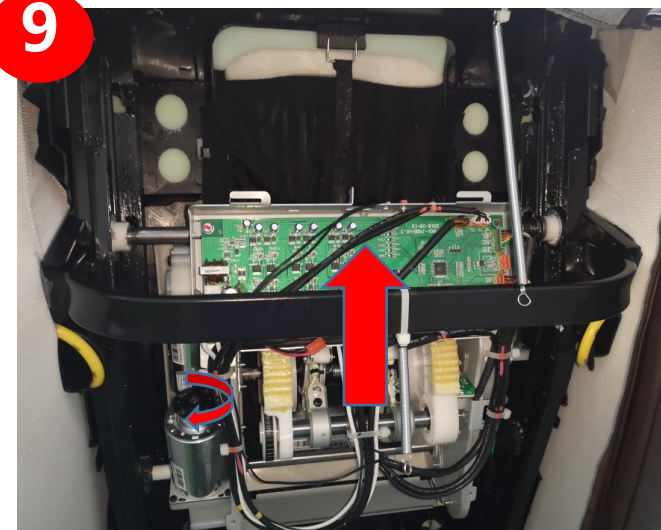
9

Rotate the encoder clockwise

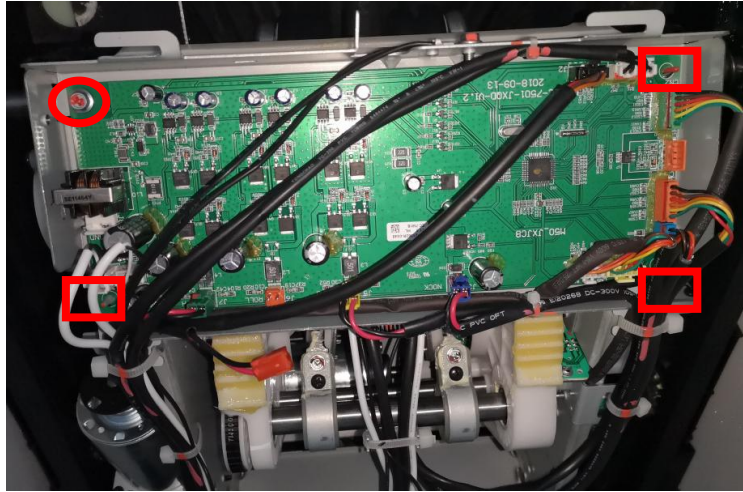
disconnected the terminals,
remove 1 screw, then separate
3D PCB from the plastic holder

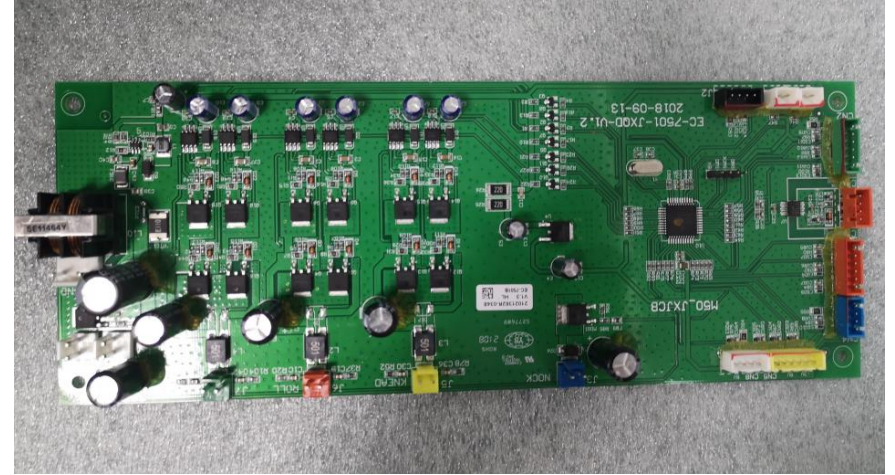
3D PCB had been taken down

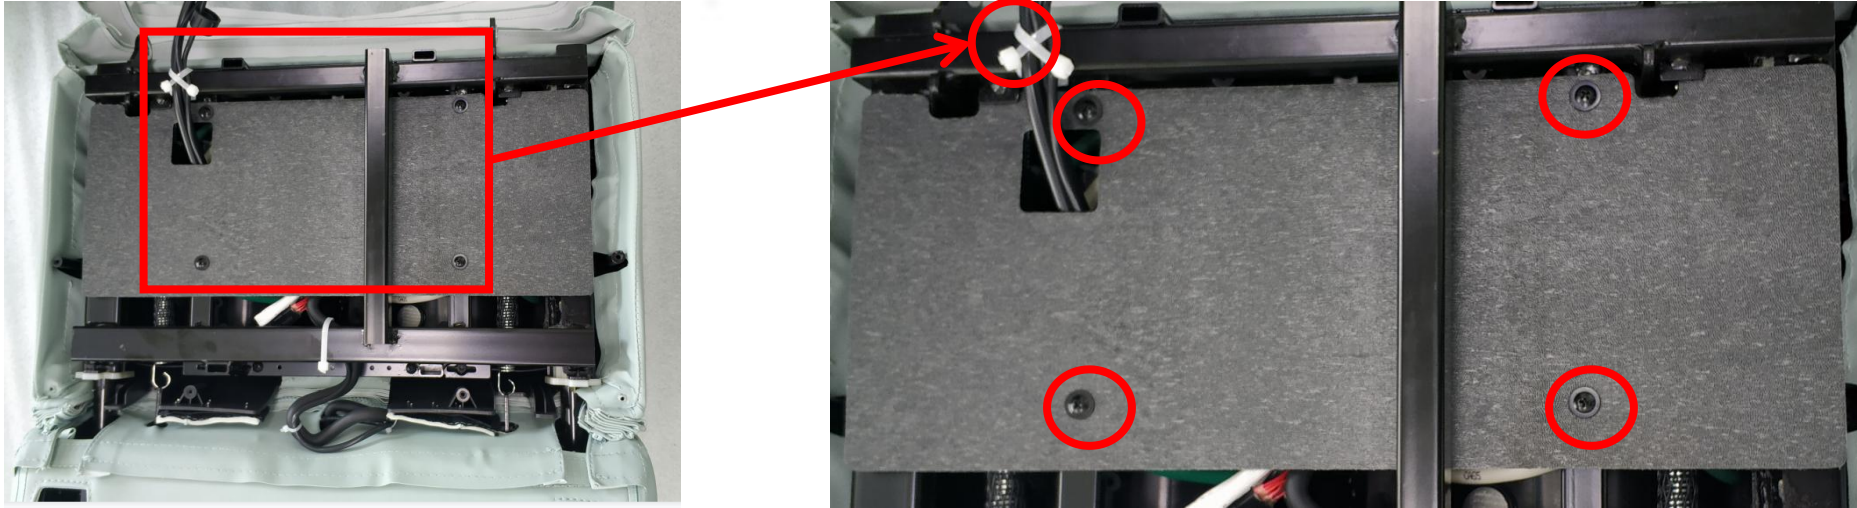
cut the cable tie and remove 4 screws, remove the PE board

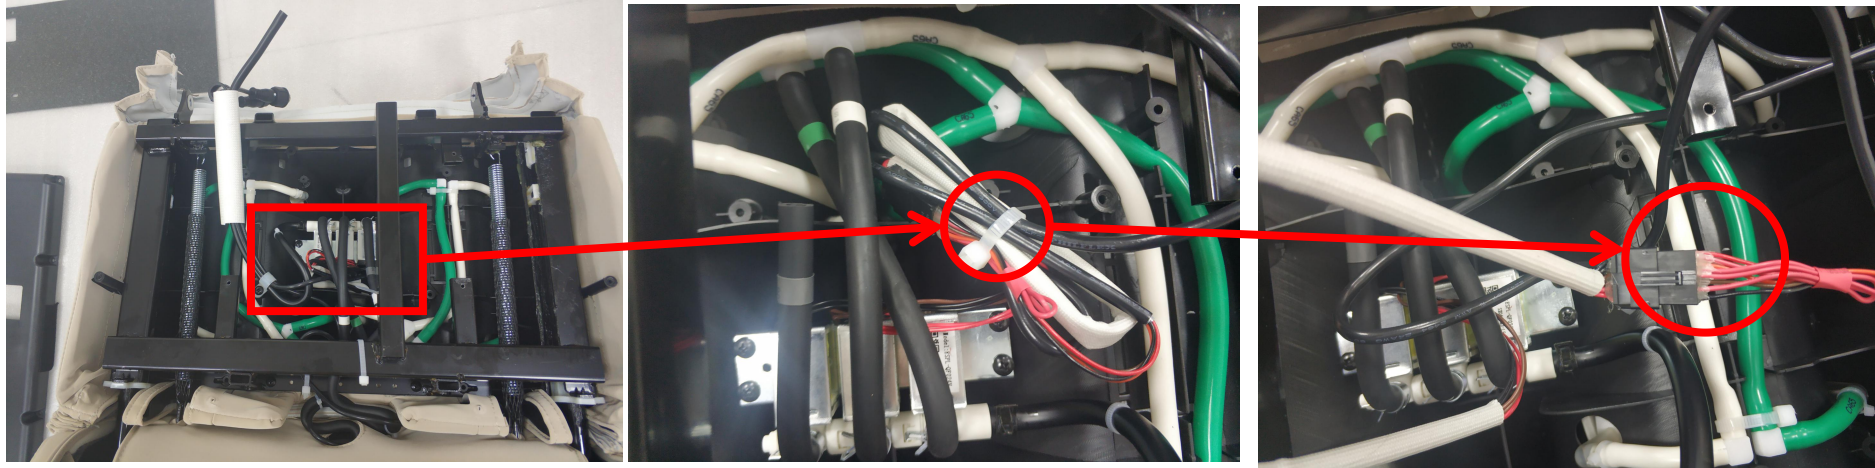
cut the cable tie, disconnected the terminals
