EASEPAL. 厦门蒙发利电子有限公司客户服务部

EC-7513A massage chair service guide

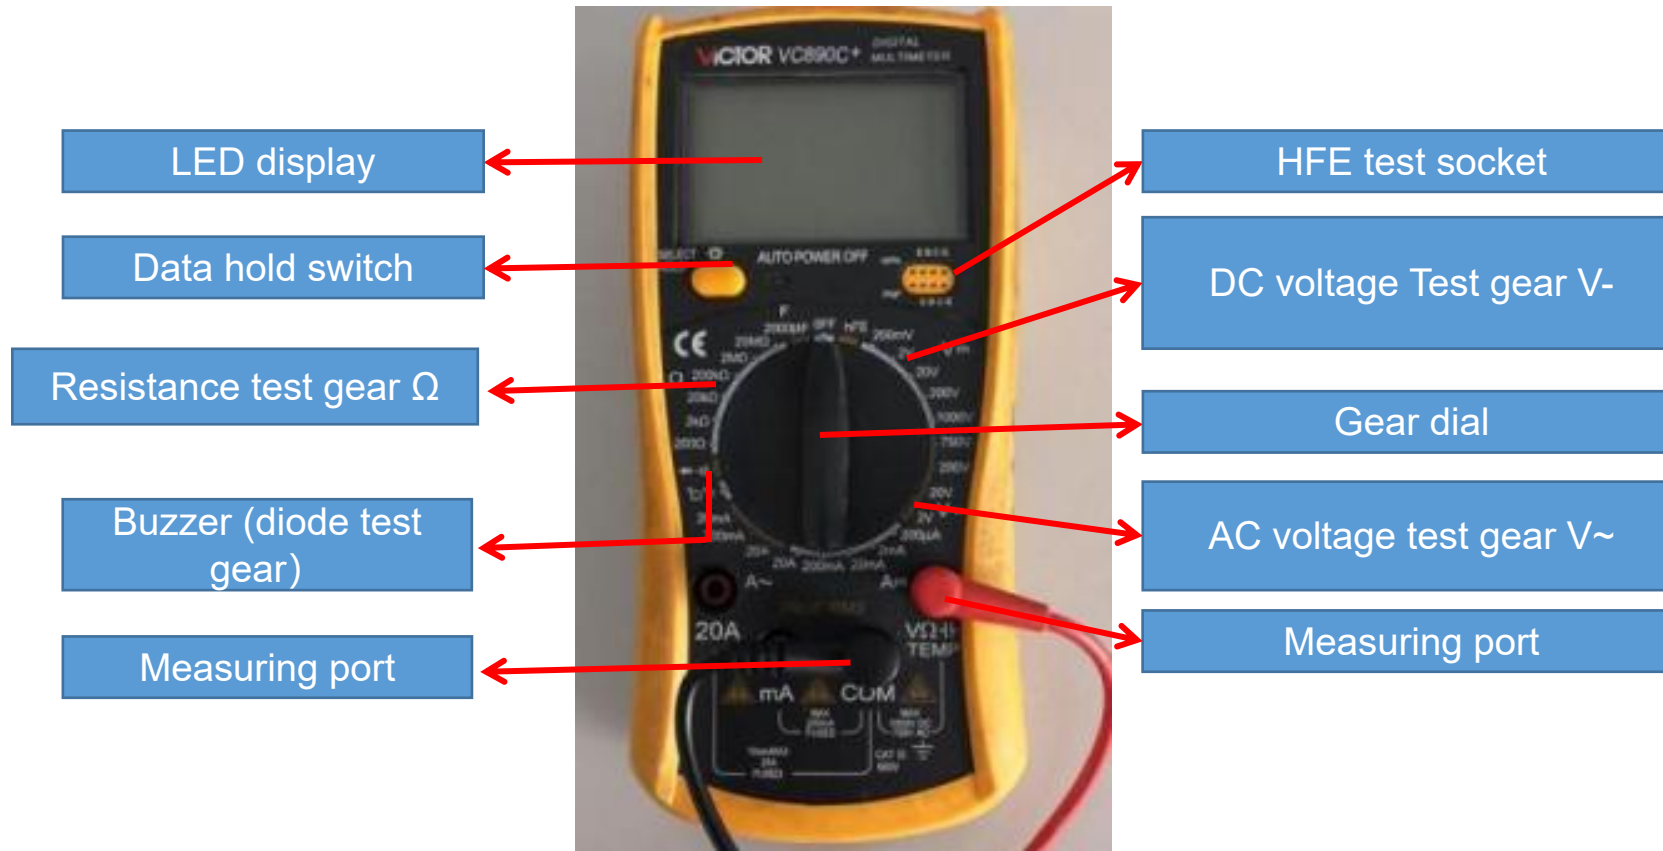
2.Usage of multimeter

2.1、 Function of the test gears

Data hold switch: Memorize the measured data for comparison.

Buzzer (diode test gear) : Measure the quality of diode, the on-off and alarm function of circuit

Resistance gear test gear: Measure the quality and value of resistance

DC voltage Test gear V-: Measure DC voltage

AC voltage test gear V~: Measure AC voltage

VΩ / COM: VΩ Red pen port (+ pole) during test, black pen port (- pole) during com test

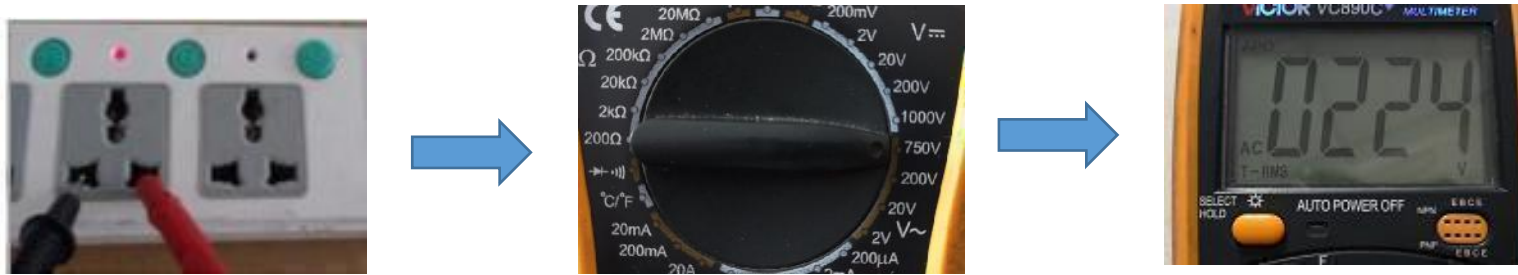
As shown in the picture above: measure the household plug-in board power supply (220V), select the range of 750, and the test result shows "224", indicating that the actual voltage of this group of sockets is 224v at the moment (the switch is pressed down, so there is power, and the light is on).

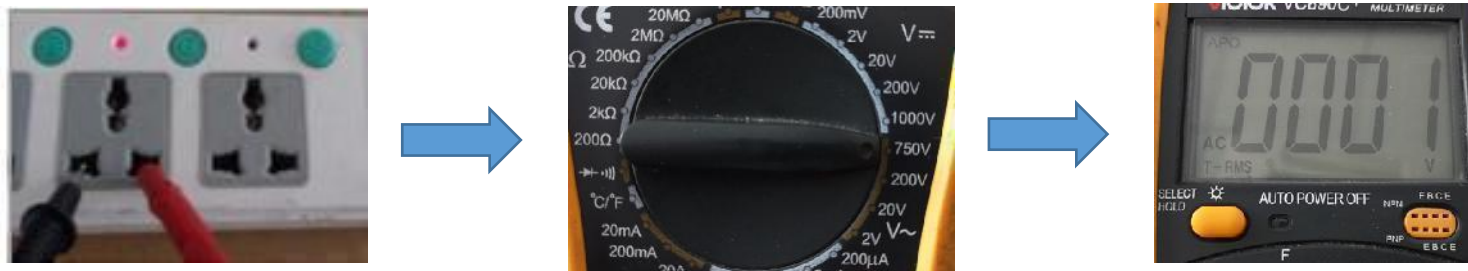
As shown in the above picture: measure the power supply (220V) of our household plug-in board, select the range of 750, and the test result is displayed as "001", indicating that the actual voltage of this group of sockets is 0V at the moment (the switch is not pressed down, so there is no power, and the light is not on).

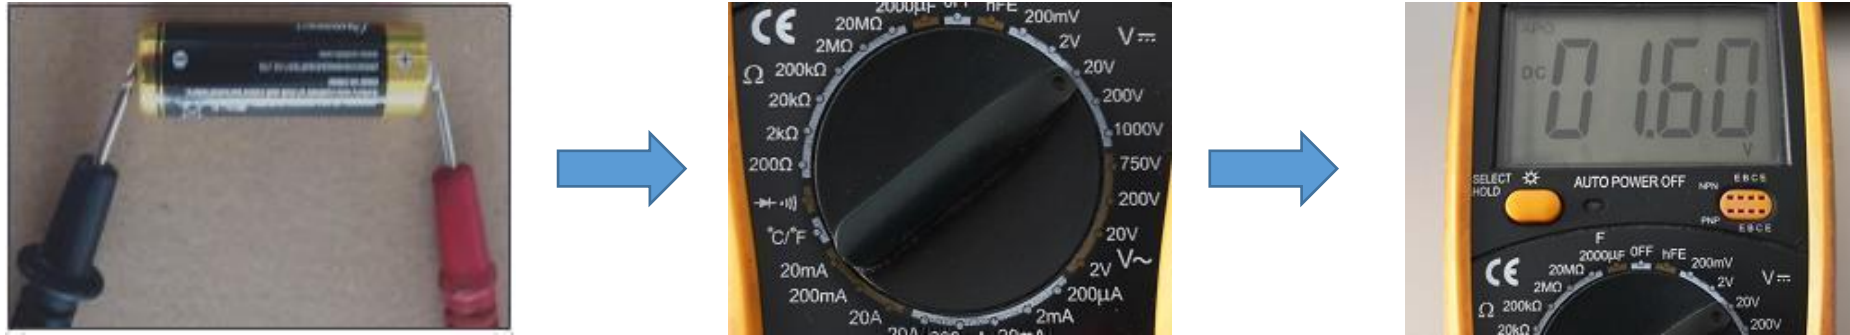
As shown in the figure above: the test result shows "1.58", indicating that the voltage at both ends of the battery has 1.58V, and the red watch pen is connected to the battery's "+" pole, while the black pen is connected to the electromagnetic "-" pole.

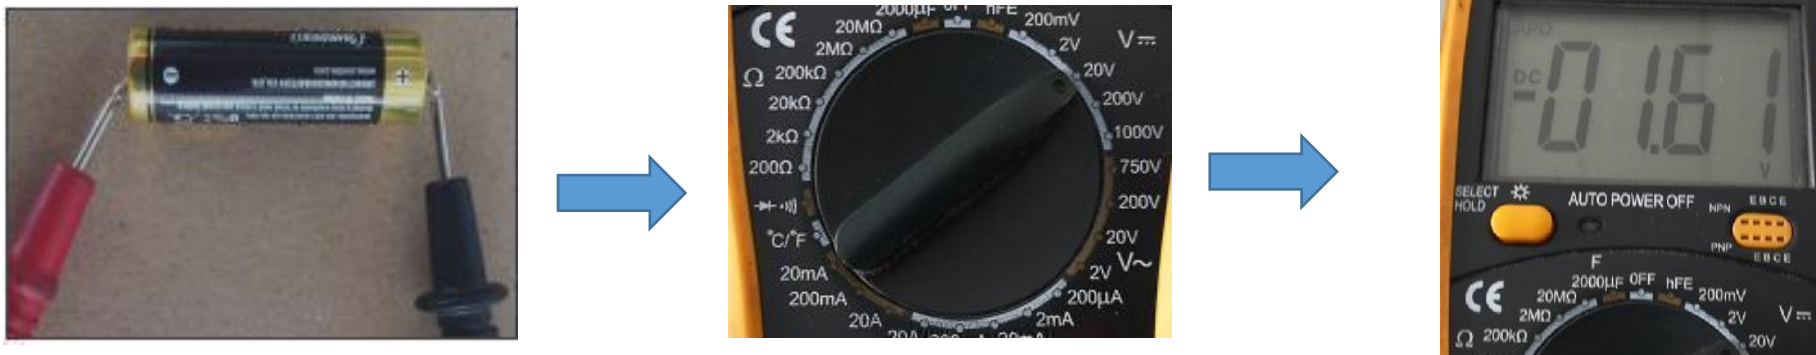
As shown in the figure above: the test result shows "-1.58", indicating that the voltage at both ends of the battery has 1.58V, and the red watch pen is connected to the battery "-" pole, and the black pen is connected to the electromagnetic "+" pole.

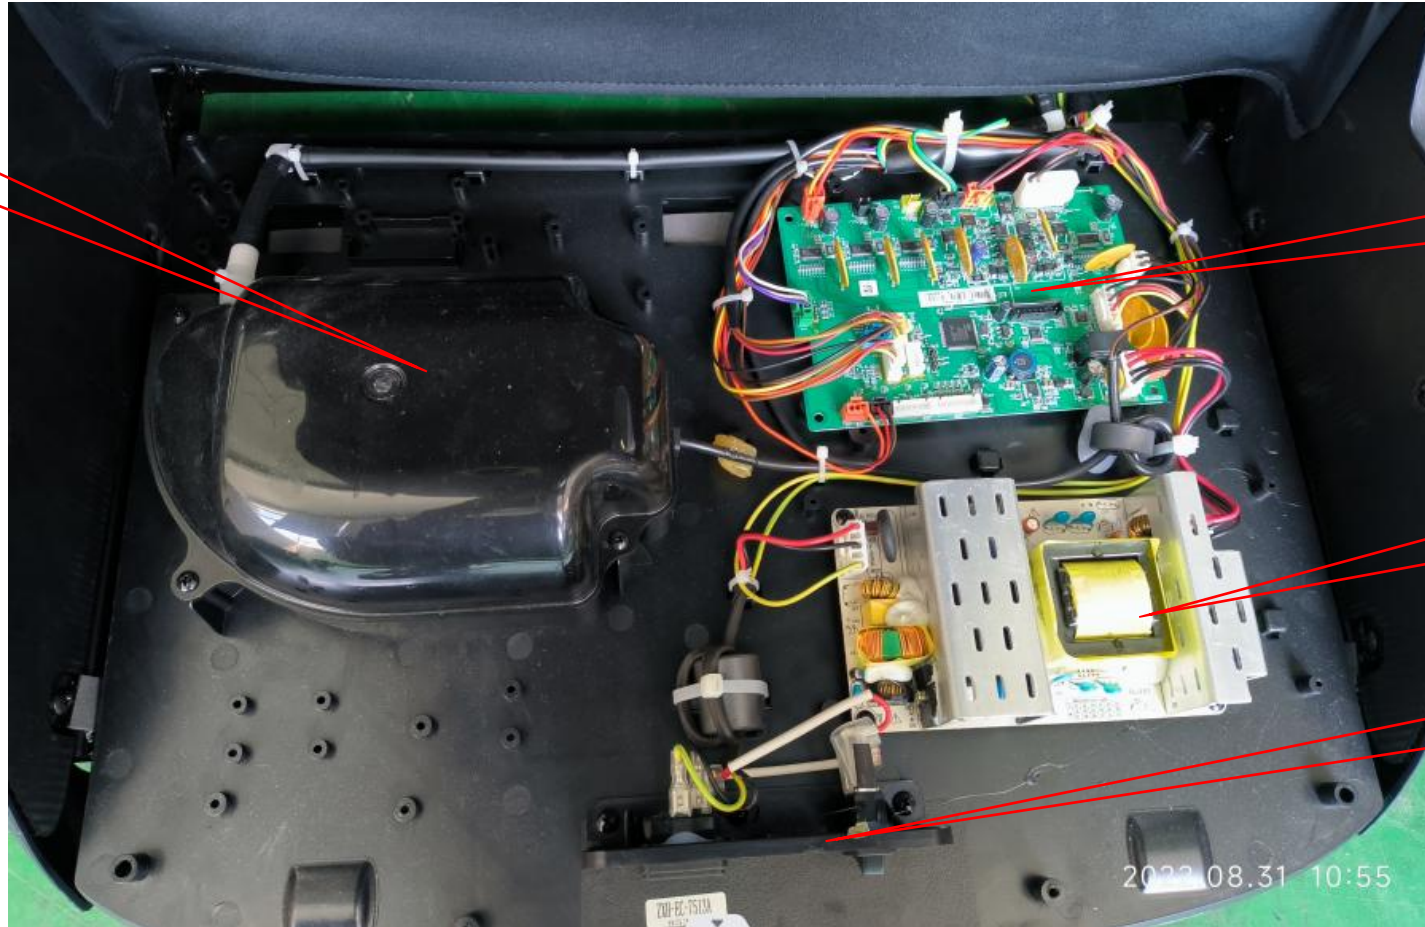
1、main PCB box:

air pump

main PCB

power PCB

power switch

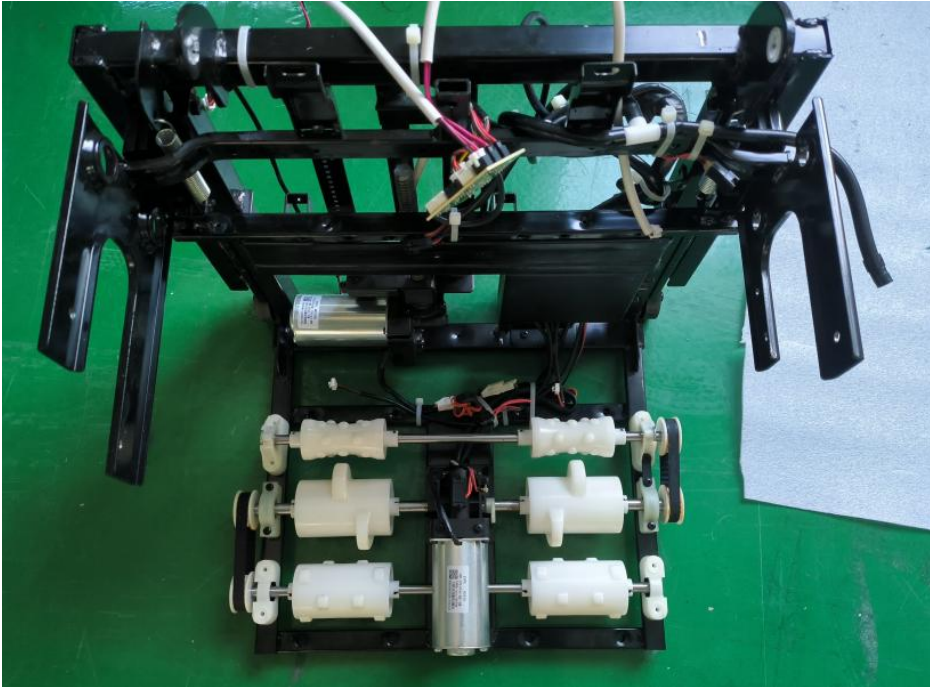
2、legrest:

Iron frame of legrest

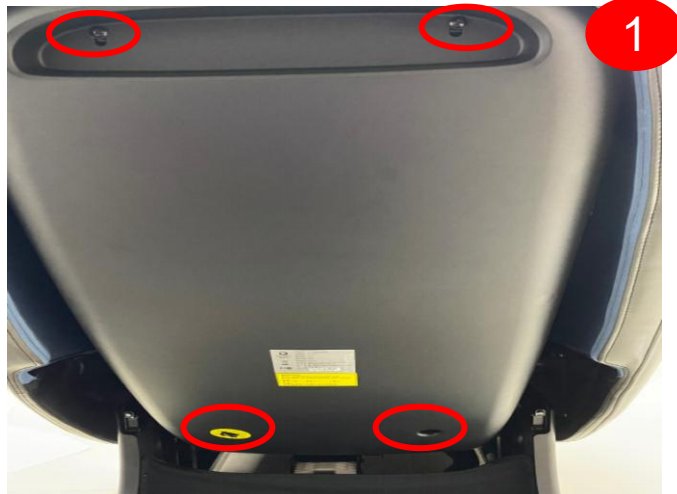
remove rear cover

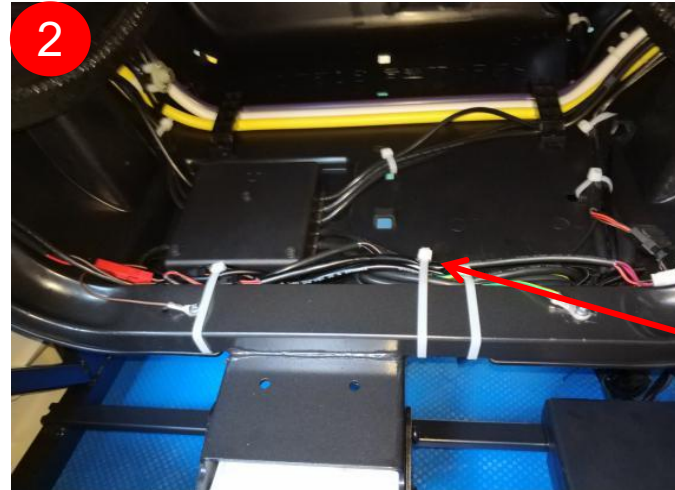
remove 4 screws and take down the cover

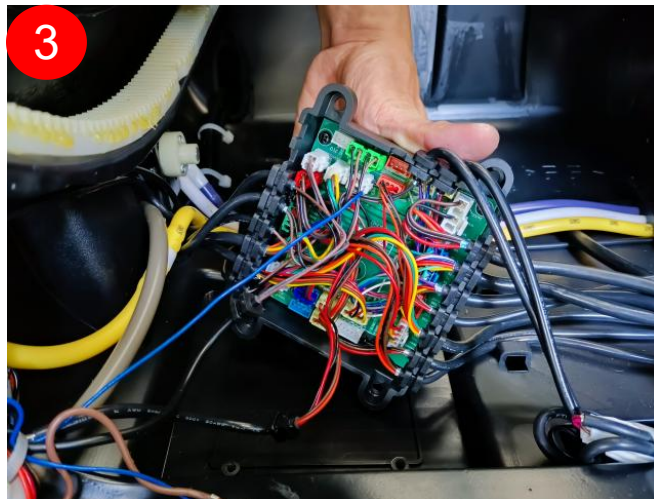
discontent all terminals

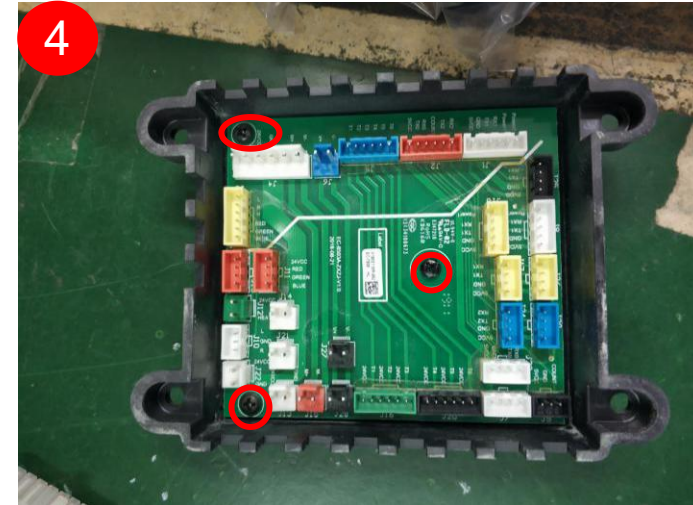
remove 3 screws and remove the PCB

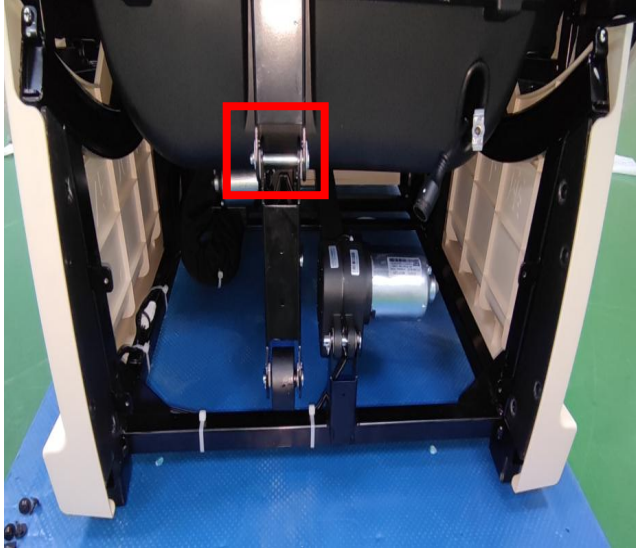
remove the pin and shaft fixing legrest actuator

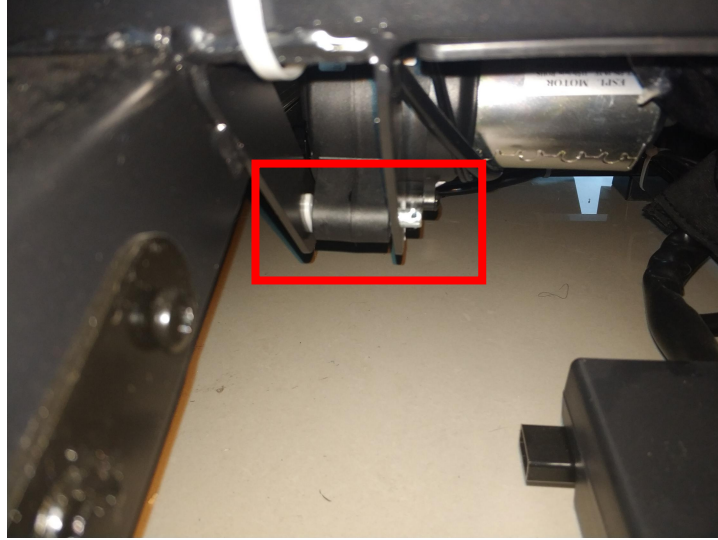
legrest actuator
