产品维修手册

Maintenance Service Manual

产品型号/Model: EI-8502A-TIT, Maxim 3D LE

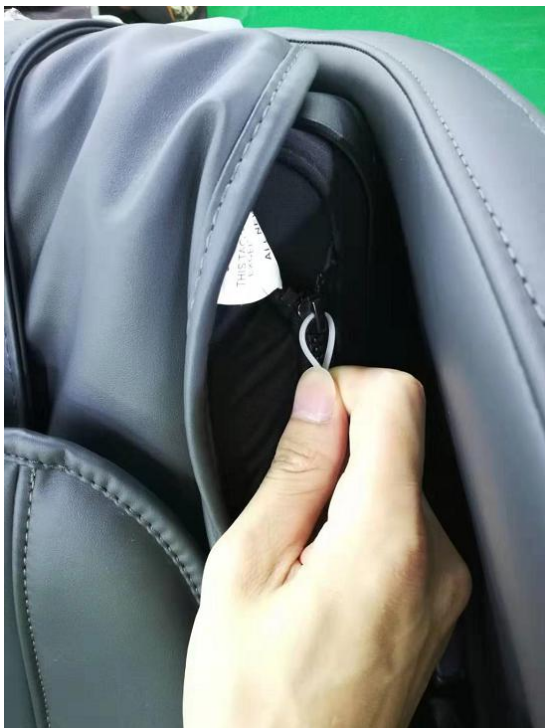
figure 1

1. Pass through the zipper head with a small Cable Ties and pull it apart (figure 1), as shown in figure 2 after opening at 7th position

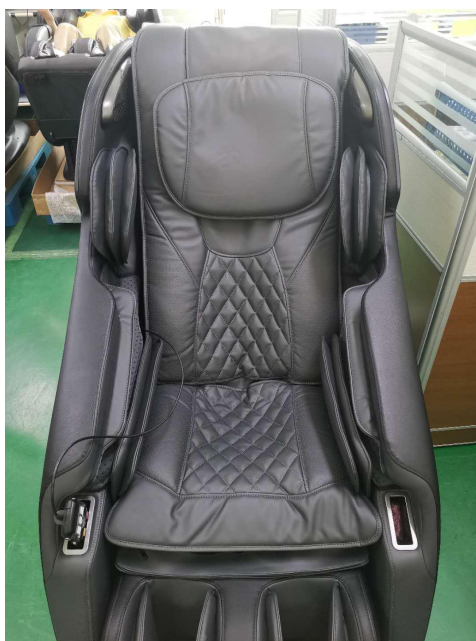
2. Put on the new Backrest and zip up 7th position zippers as shown in figure 3 below

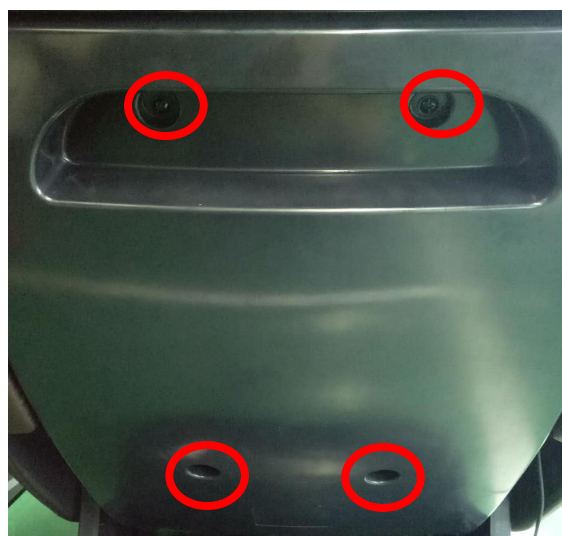
1. Run the massage chair to its original state, and then cut off the power supply.
2. Pull out the cloth pin on the back cover vertically as shown in figure 1 and remove the four screws in figure 2.
3. Press down, pull the back cover backward and pull out a certain angle, and then pull it out toward the top of the slope, as shown in figure 4.

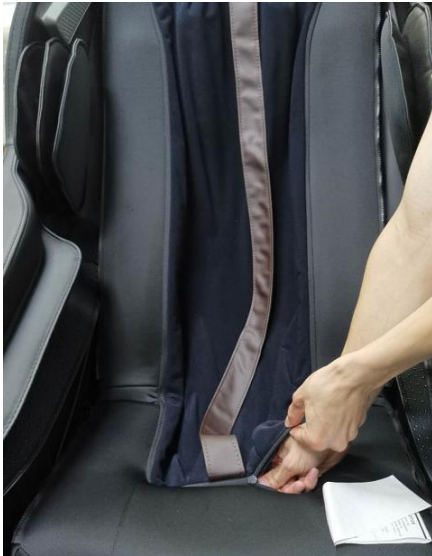
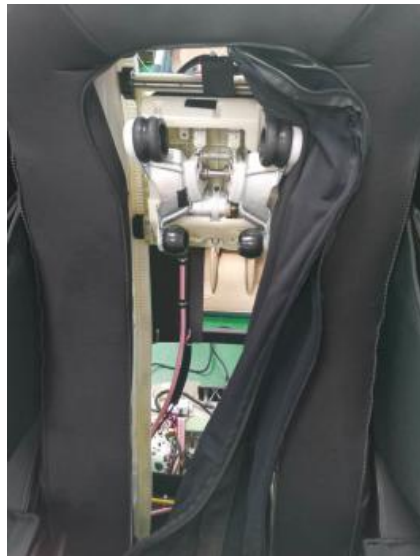
- 1.Press P4 to remove the backrest.
- 2.Remove the flannel fabric (figure 1-2)
- 3.Remove the left and right baffle on the guideway (figure 3)
- 4.Remove the back cover, push the rolling mechanism down firmly, push the rolling mechanism to the left and right baffle on the guideway position (figure 4)

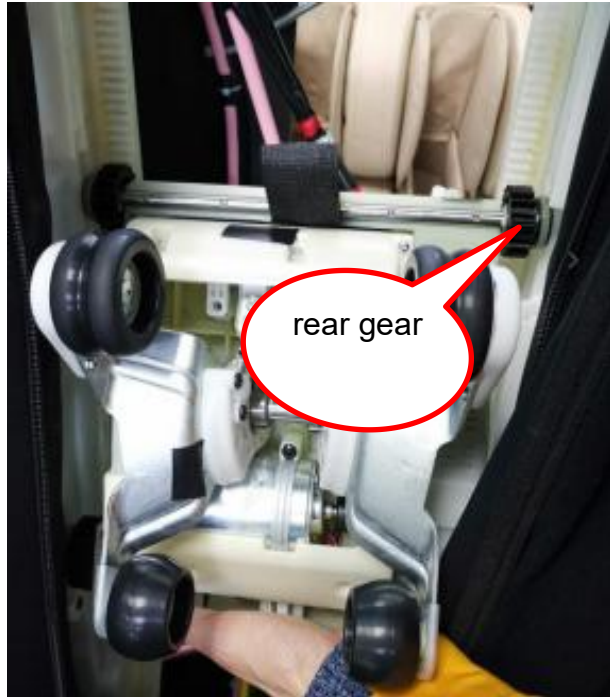
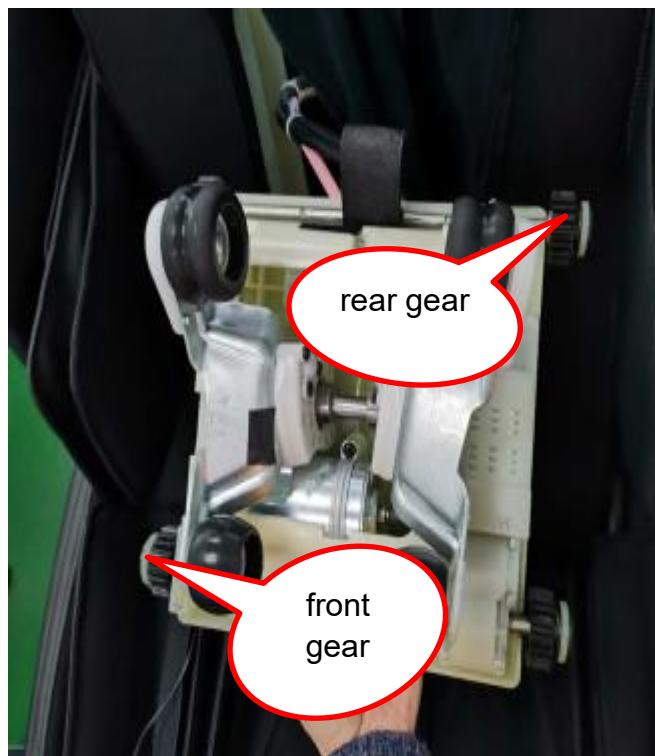
1. Front gear first out, then rear gear out (figure 1-2), you can take out the rolling mechanism from the guideway (figure 3)

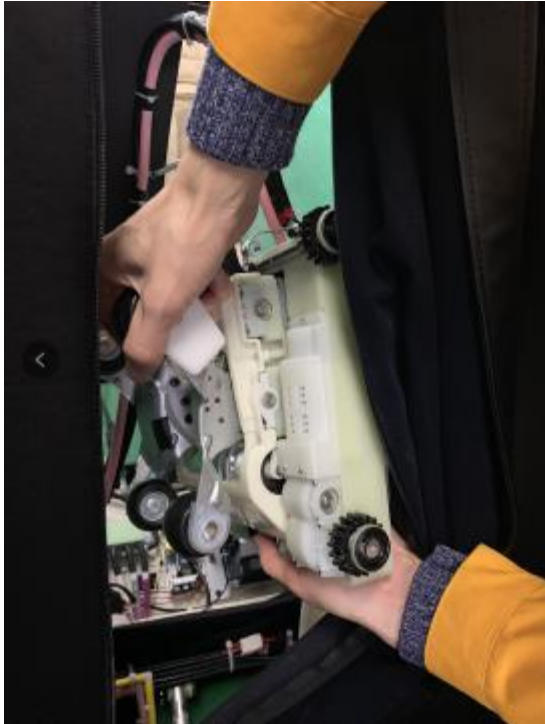
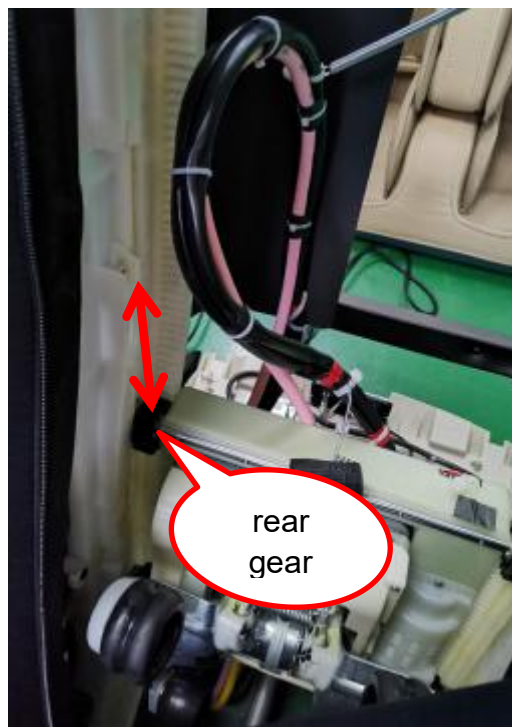
- 1.The rolling mechanism side is stuffed in (figure 1)
- 2.The rear gear is put into the guide rail from the position where the baffle is removed, and then the front gear is put into the guide rail (figure 2)
- 3.After putting it in, the movement should be pushed down, and the rear gear should be under the position of the guide rail removal baffle to lock the baffle (figure 3)

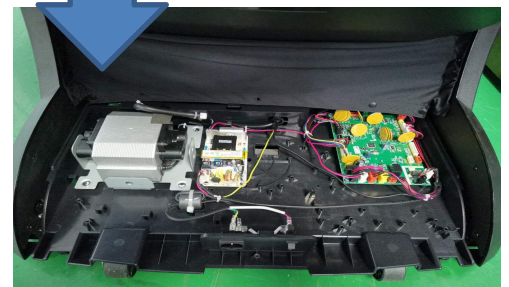
- 1.Run the massage chair to the initial state, then cut off the power supply and unplug the plug;
- 2.Pull out 5 cloth pins in turn perpendicular to the direction of the upper cover, as shown in figure 1;
- 3.Remove the screws as shown in figures 2 and 3
- 4.Hold the inner side of the top cover of the center box on the left hand, hold the outer edge of the upper cover on the right hand, gently drag it out and remove the upper cover, as shown in figure 4

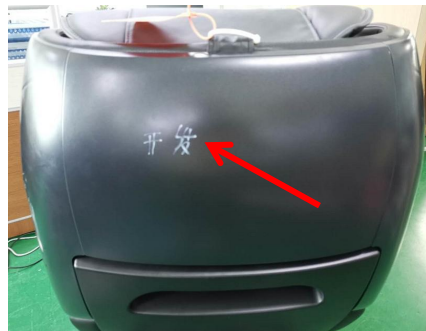
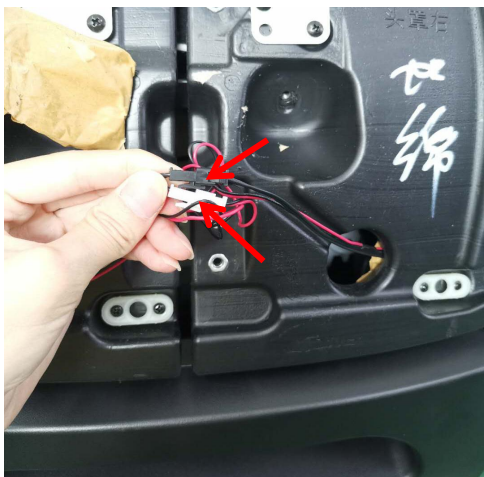
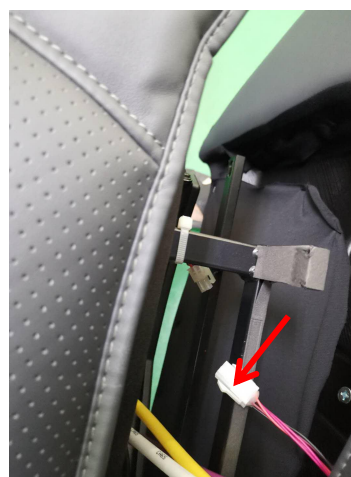
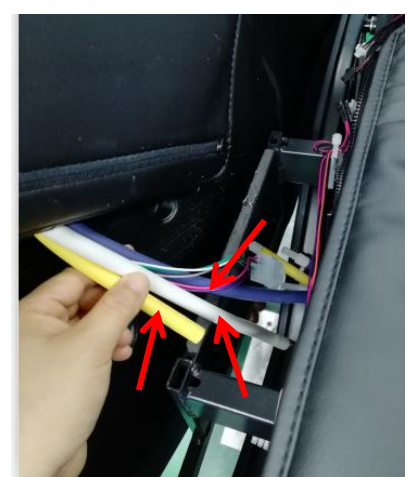
1. Run the massage chair to its original state, then cut off the power supply and unplug it;
2. Press P5 to remove the back cover and cut the inner band of the lower cover with oblique pliers, as shown in figure 1;
3. Cut off the tie belt that binds the hand controller to the side board, as shown in figure 2
4. Remove the two screws on the back rack, as shown in figure 3;
5. Remove the screw at the front end of the side plate from below the Leg Rest as shown in figure 4;
6. Remove the hood cover, as shown in figure 5;
7. Remove 7 screws on the hood, as shown in figure 6;
8. Unplug the 2 connection terminals on the hood, as shown in figure 7;
9. Remove the side plate and remove 3 connecting air pipe and 1 connection terminals from the side plate, as shown in figure 8-9.

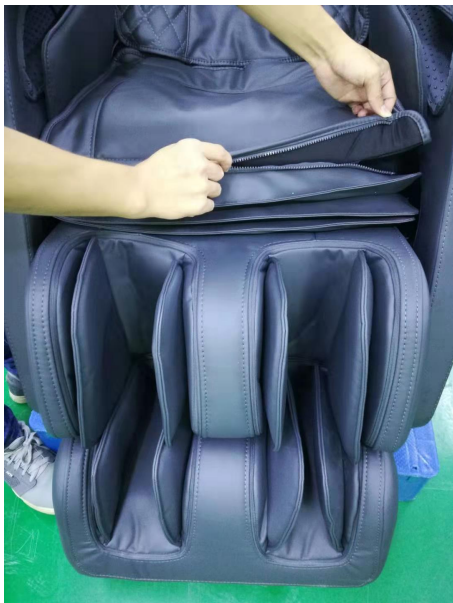
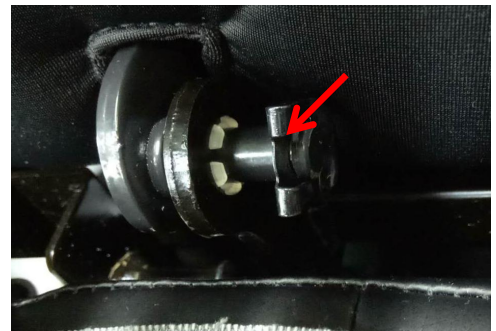
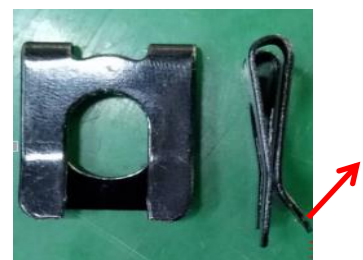
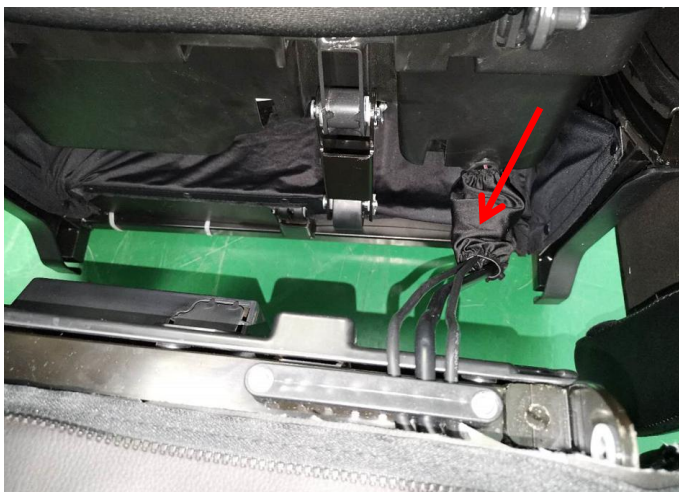
1. Unzipper as shown in figure 1;
2. Break the DK Card bolt open with your fingers or pliers and take it up, as shown in figure 2;
3. Pull the black cloth up, remove the air pipe and power cord connector, as shown in figure 3-4

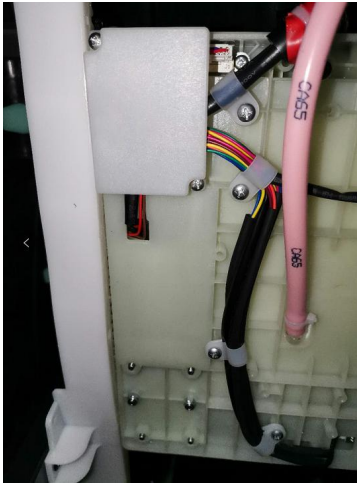
Figure 1

1. Press P5 to remove the back cover, let the rolling mechanism come down a little, and remove the two screws as shown in Figure 1.

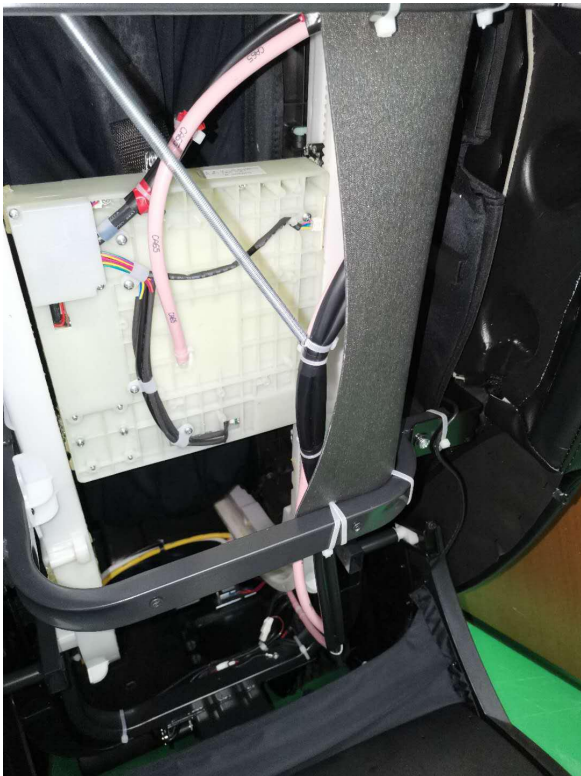
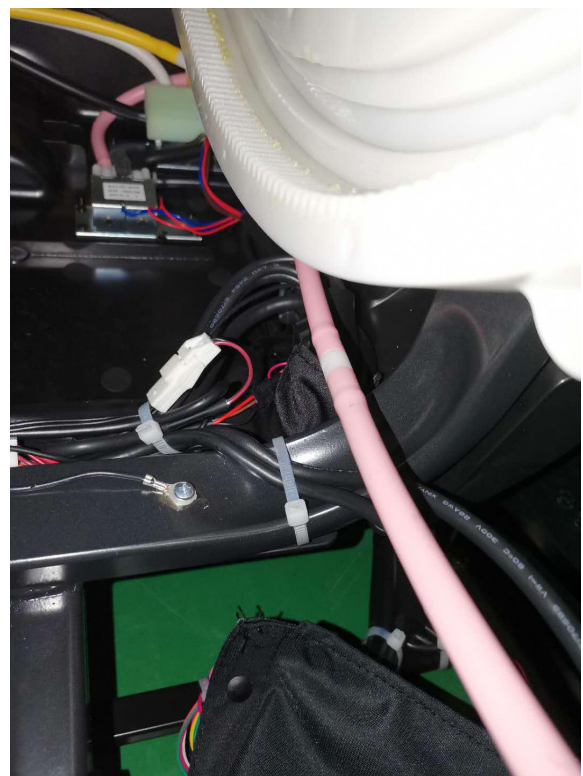
3. Cut off the two cable ties as shown in Figure 3, and pull out the air pipe and butt terminal as shown in Figure 4, cut off the cable ties.

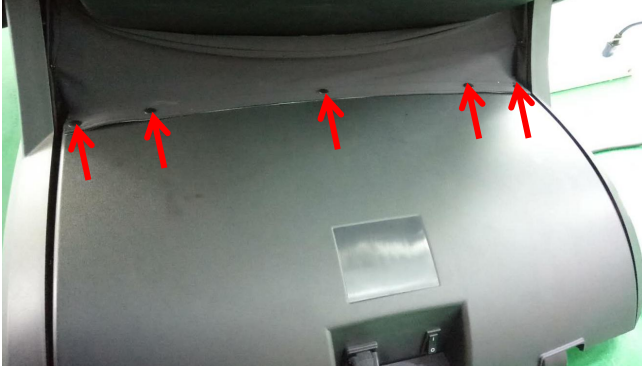
1.Remove 5 cloth sleeve pins on the top cover of the central box

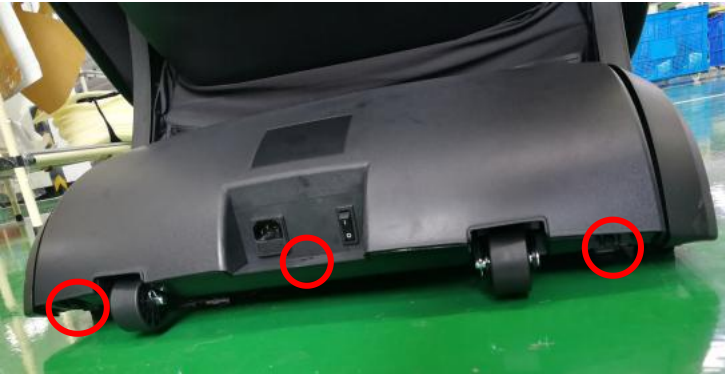
2.Remove 3 screws

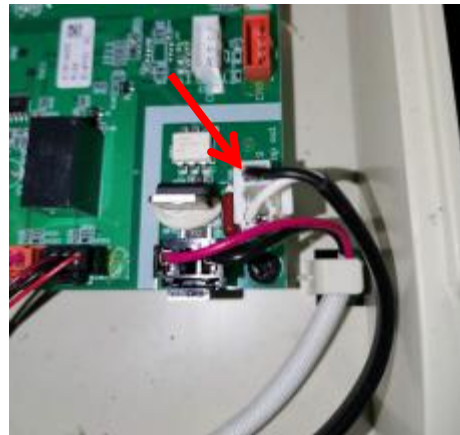
3.Remove 4 screws of the air pump, then cut off the cable tie to pull out the air pipe, and pull out the plug terminal on the main PCBA.

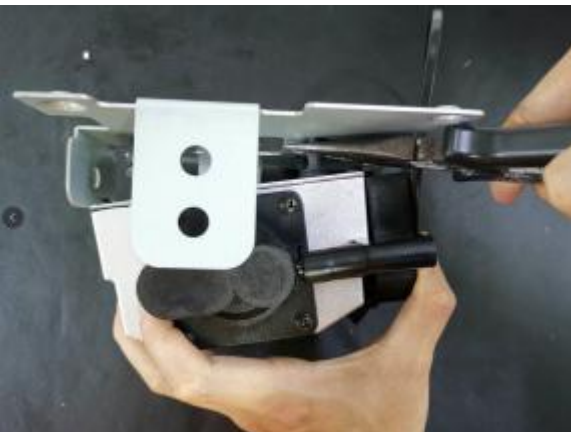
4.Use needle-nose pliers to pull out the 4 rubber feet on the iron frame to remove the air pump.

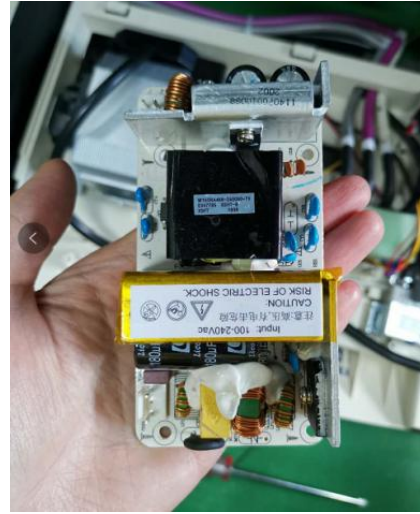
1.Replacement of Switching Power Supply: Remove the 3 screws on the switching power supply board and unplug the 2 connecting terminals on the switching power supply board

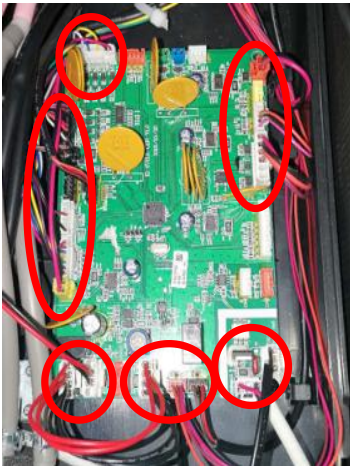
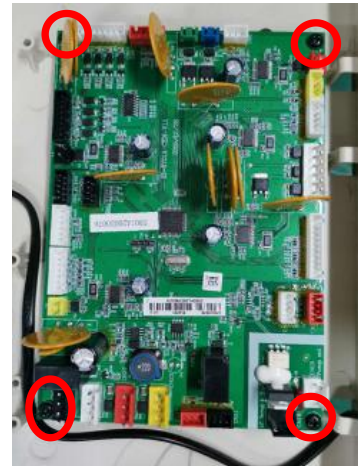
2.Replacement of Main PCBA: Unplug the terminal on the Main PCBA and remove 4 screws to remove the Main PCBA.

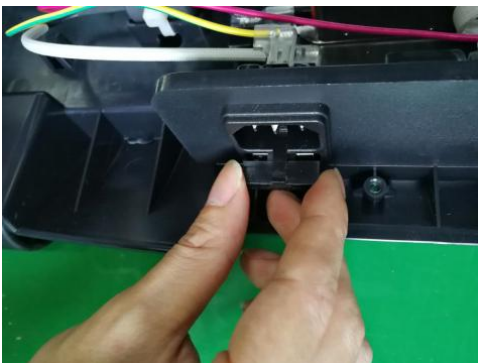
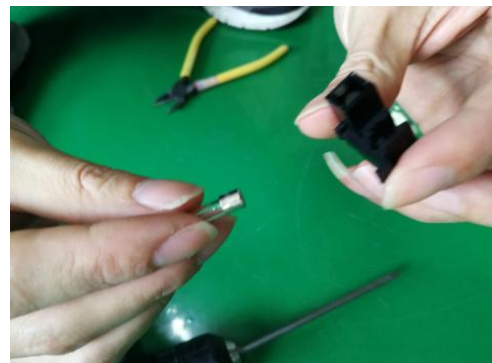
3.Replacement of Fuse: Remove the fuse holder from the socket, then you can replace the fuse.
