# **A502S-2 Massage Chair After-sale Maintenance**

## **Acro massage chair after-sale service product internal structure**

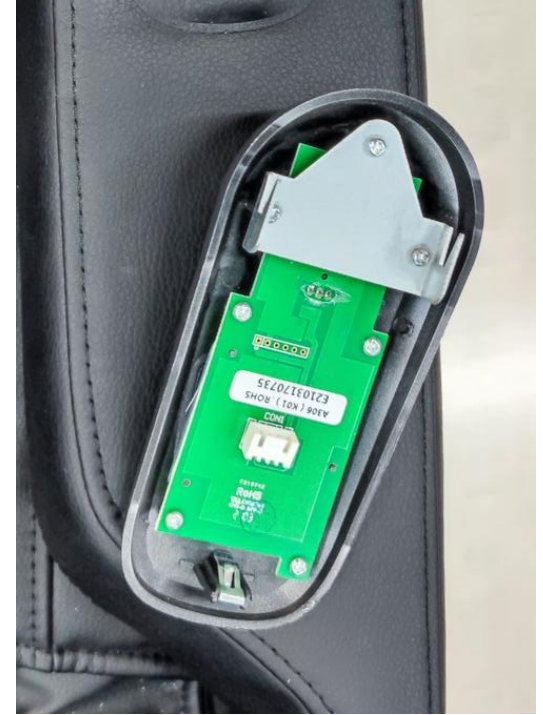
## 5.11. Disassembly Schematic Diagram of Shortcut Key Assembly

- A. Tilt the inner side of the decorative strip with a straight screwdriver slightly**
- B. Separate the key board plug-in**
- C. Remove the armrest shortcut button**

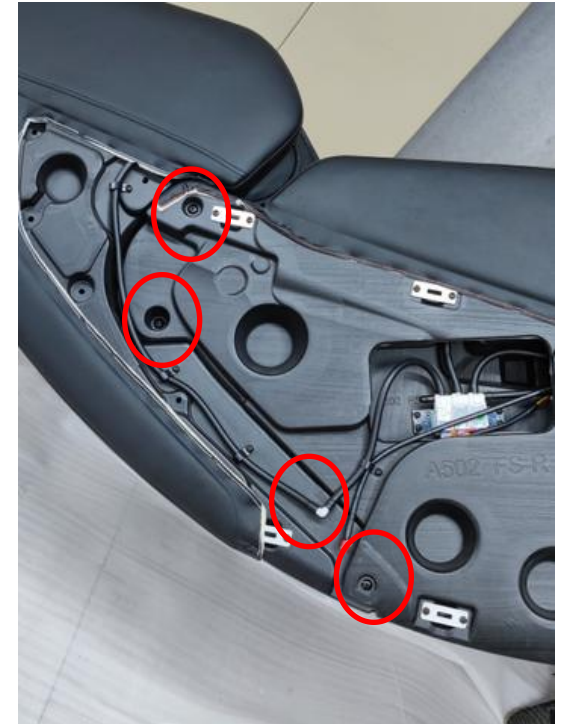
**C**

**C. Separate the air hose and remove fixing screws on the armrest to separate it**

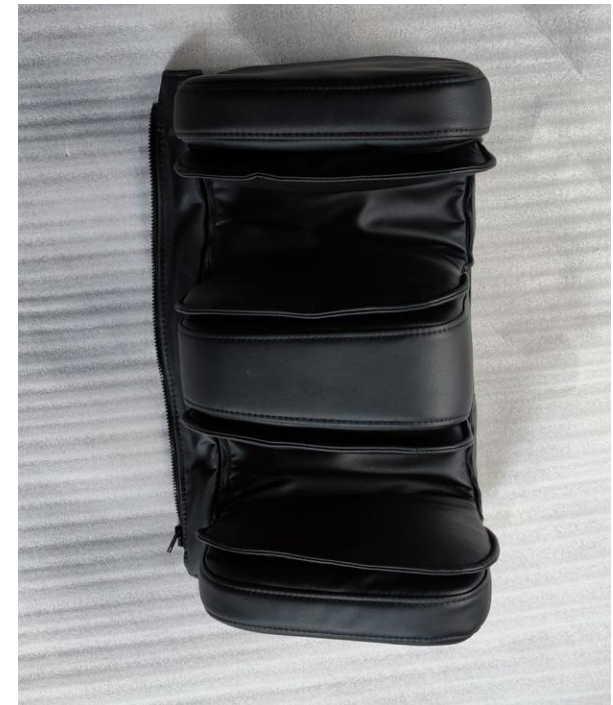
### 5.13. Schematic diagram of disassembly and assembly of upper and lower leg

**A. Remove the 4 screws**

**B. Remove the 1 ~ 5 screws, take out the plug-in and air hose in 6 ~ 7**

**C. Separate the upper leg kneading assembly.**

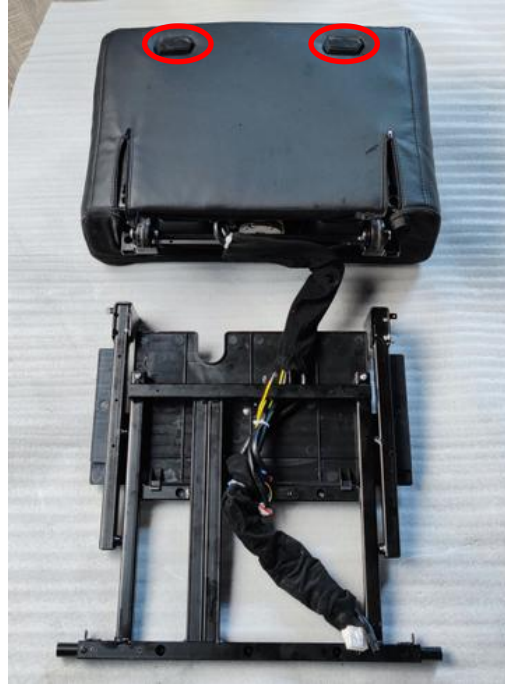
**B**

**B. Remove the 4 screws at bottom**

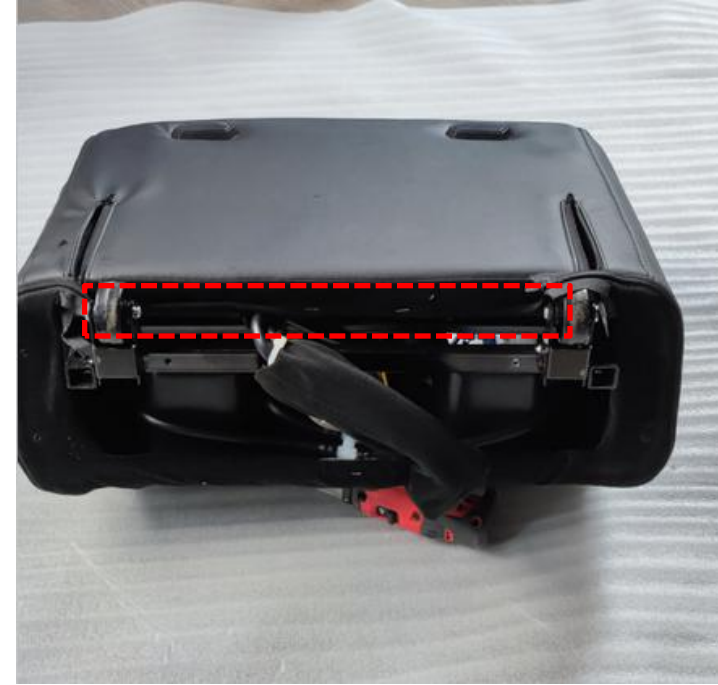
**C**

**C. Unzip the zip and remove the cover**
