The source of the sound in the footunit is the fabric sitting between the actual foot rolling mechanism on each foot and the outer leather padding. To eliminate the sound, you must remove the fabric by following these steps:

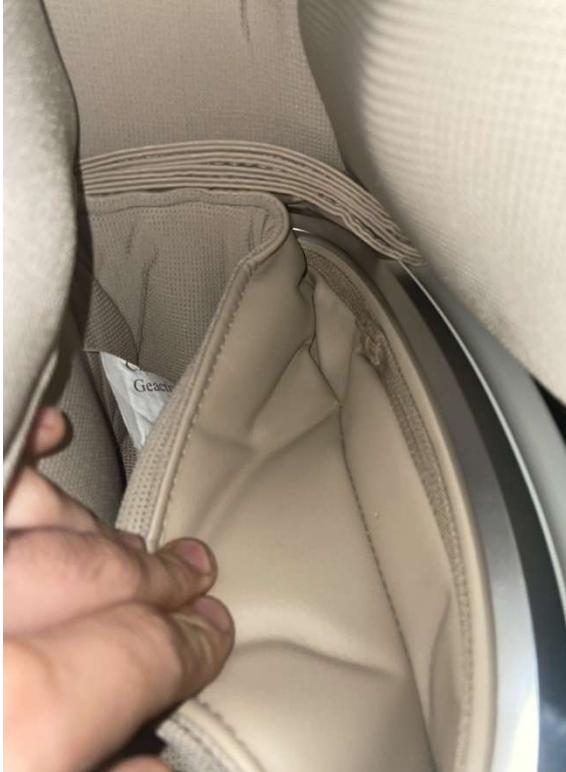
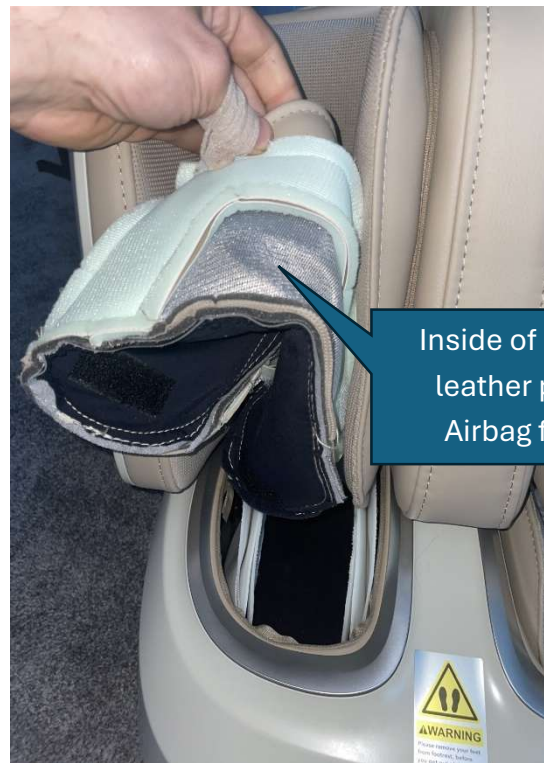
1. REMOVE THE OUTER LEATHER PAD BY UNZIPPING THE ZIPPER; ONCE UNZIPPED, BE MINDFUL OF THE AIRBAGS THAT ARE SEATED INSIDE A FLAP ON THE INSIDE OF THE PAD.

Inside of outer
leather pad;
Airbag flap

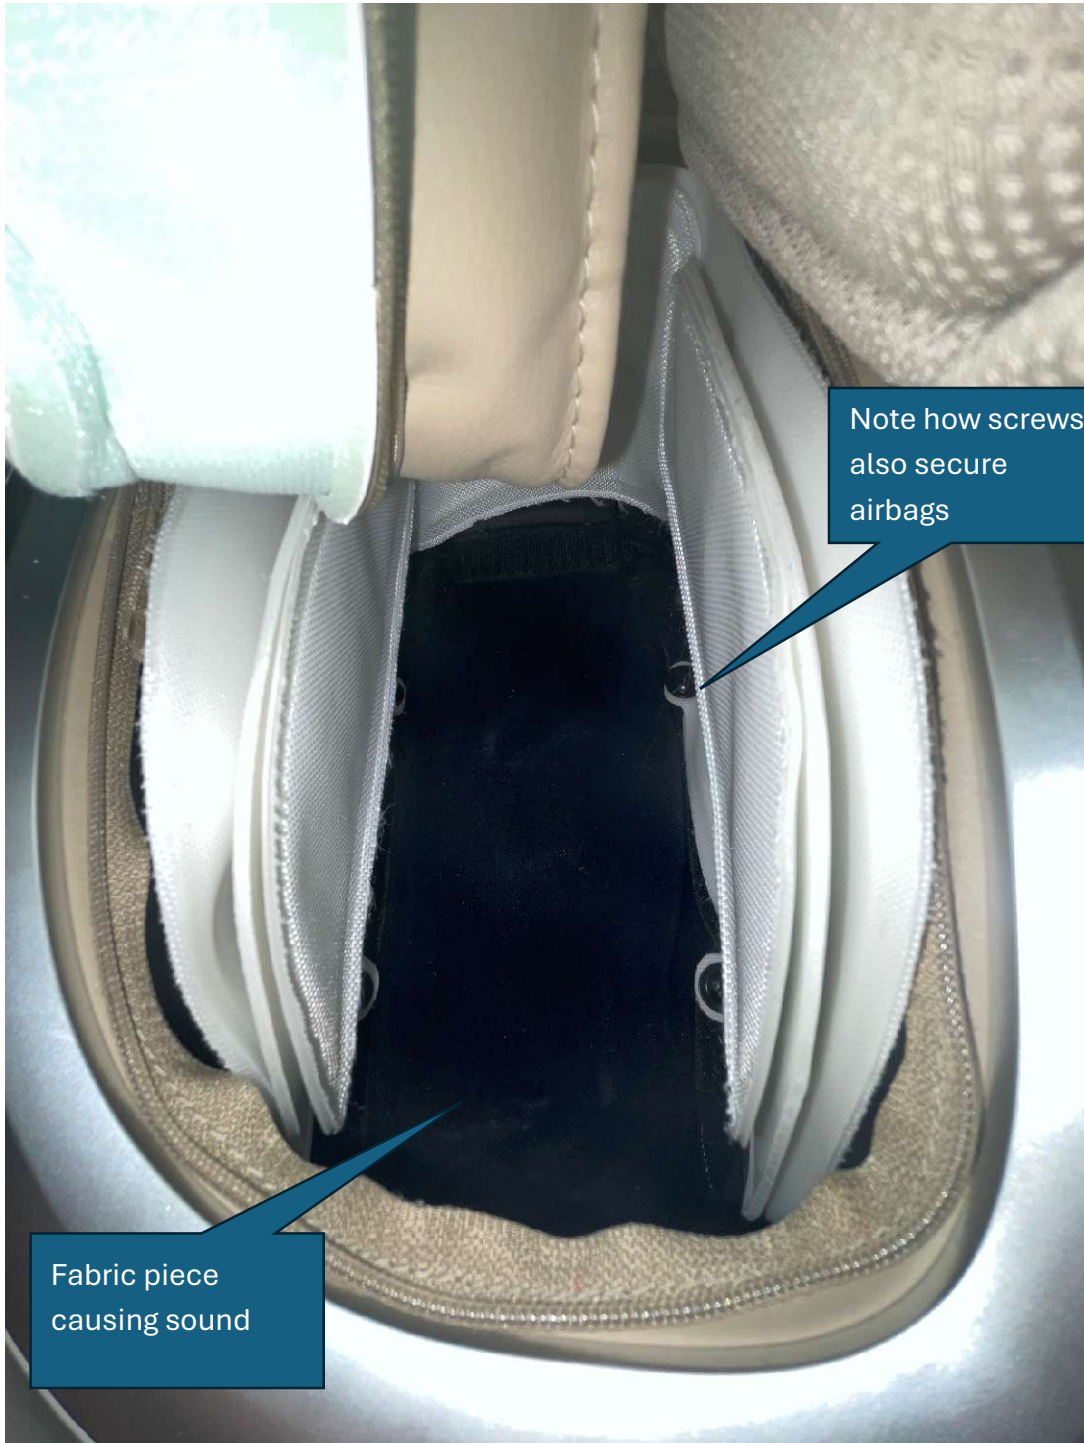
2. OBSERVE THE FABRIC IN QUESTION. TO REMOVE THE FABRIC, YOU MUST REMOVE 6-8 SCREWS THAT SECURE IT TO THE FOOT. NOTE: THE 4 SCREWS ON THE PERIMETER SECURE THE AIRBAGS IN PLACE. **YOU MUST BE SURE TO SECURE THE AIRBAGS WITH THESE SCREWS WHEN REASSEMBLING OR THEY WILL BECOME CAUGHT IN THE FOOT ROLLER AND BREAK THE UNIT.**
