# Apex duo 5D+4D

## Service Manual

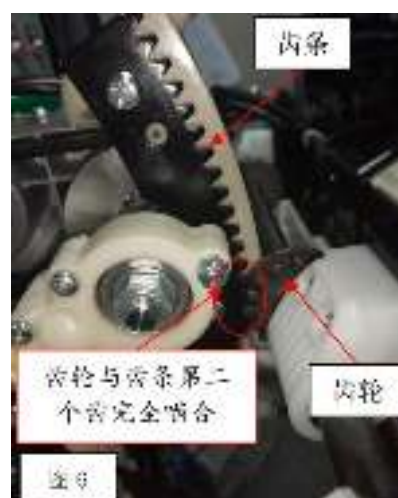
10.2 The massage mechanism fails to reach the correct tilting forward position or exceeds the limit, indicating a tilting forward counting fault. This situation has two scenarios: one is a fault of the tilting forward counting board, which will work normally after replacement (see 10.3); the other is a change in the position of the "magnet sensing plastic part" in Figure 4. The solutions are as follows: 1. As shown in Figure 6, ensure that the gear is fully meshed with the second tooth of the rack. If not fully meshed, adjust the rotating shaft of the tilting motor until meshed. Align the magnet of the plastic part with the lower Hall element and fix it.

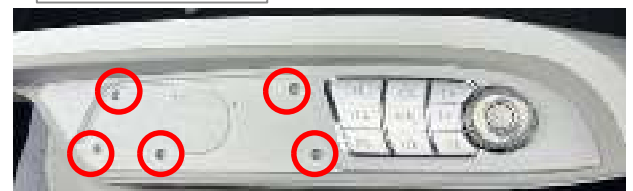
Left non-slip pad

2.1.3 Removing the upper armrest assembly 2.1.3.1 Disassembling the upper armrest assembly First, peel off the non-slip pad, then use a tool to remove the screws, firmly separate the clips, unplug the connector, then take off the upper armrest assembly and replace the internal components.

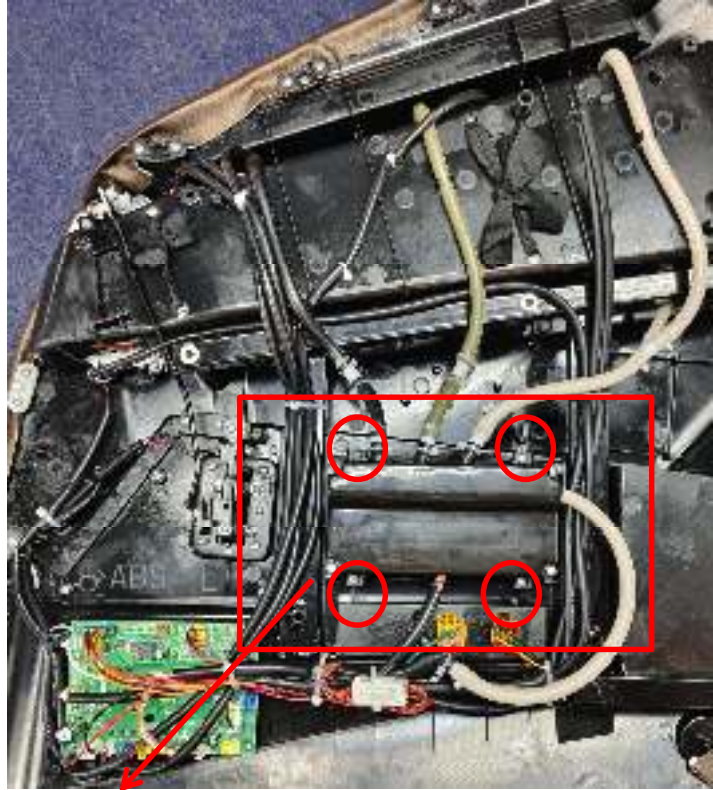
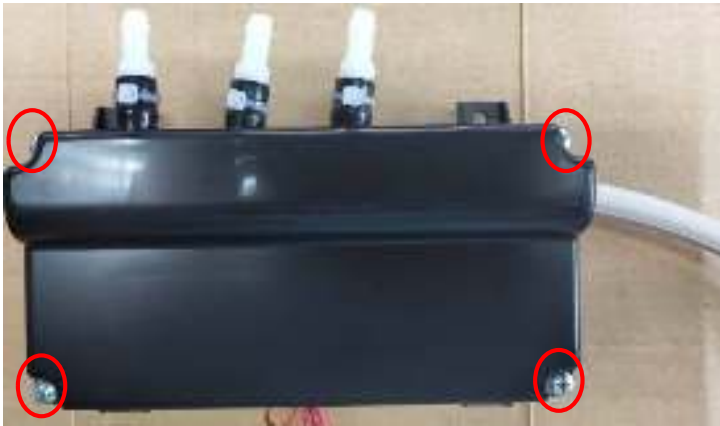
2.1.6 Replacing the armrest solenoid valve assembly 1. Remove the 4 screws fixing the solenoid valve assembly, then disconnect the connecting wire harness and air pipe. 2. Remove the 4 screws on the solenoid valve cover to expose the solenoid valve, then remove the 4 screws fixing the solenoid valve and replace the solenoid valve.

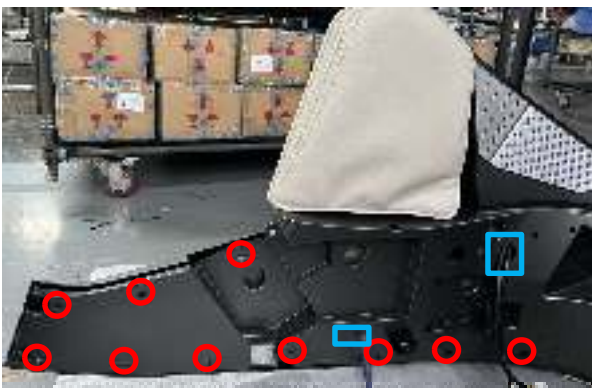
When assembling the inner and outer shoulder assemblies: There are 5 fixing points under the shoulder airbag, 1 fixing point under the anion/aroma cover, and 2 fixing points under the speaker cover (a total of 39 fixing points).

As shown in the above figure: Use a tool to remove the 39 screws, separate the inner and outer shells of the shoulder, then take off the shoulder outer shell and replace all internal component assemblies.

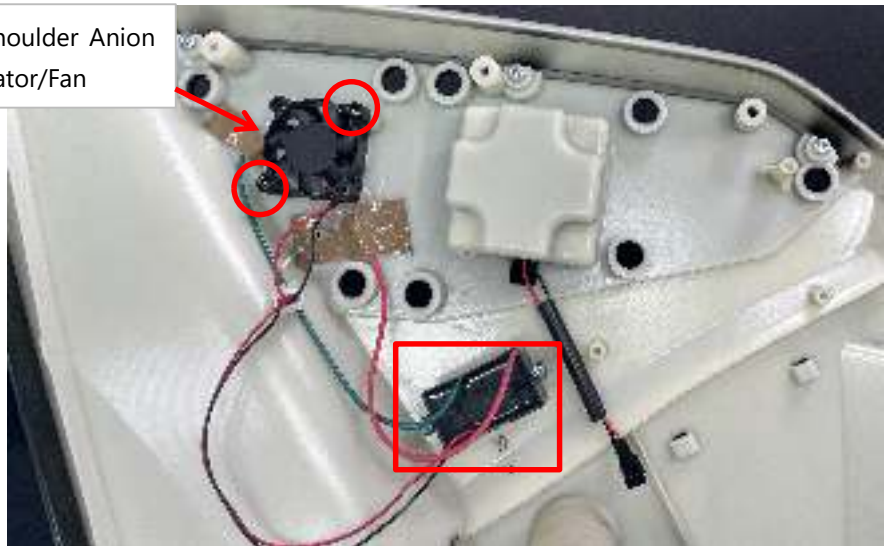
Left Shoulder Anion Generator/Fan

2.2.5 Removing the Shoulder Negative Ion Generator and Fan As shown in the figure, remove the

The air pipe must be placed here; otherwise, it may easily get crushed.

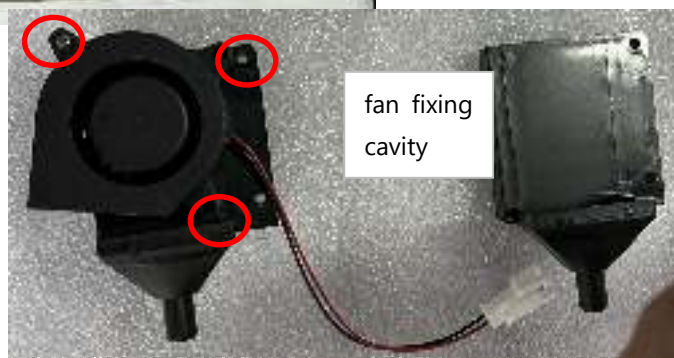
Each of the five fan groups corresponds to a respective aroma group.

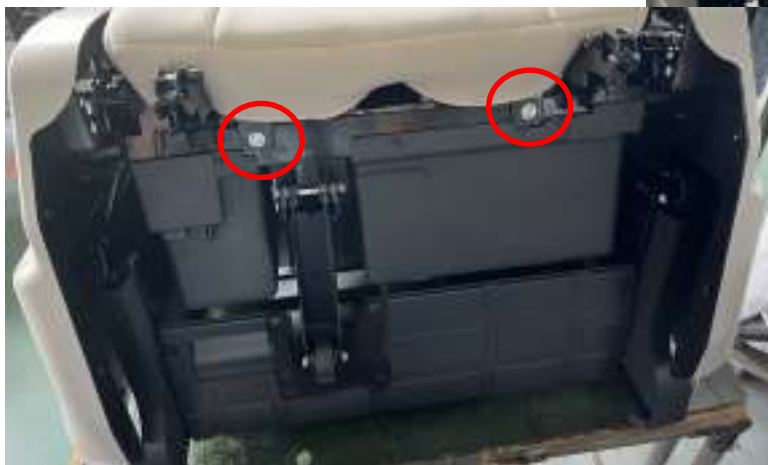
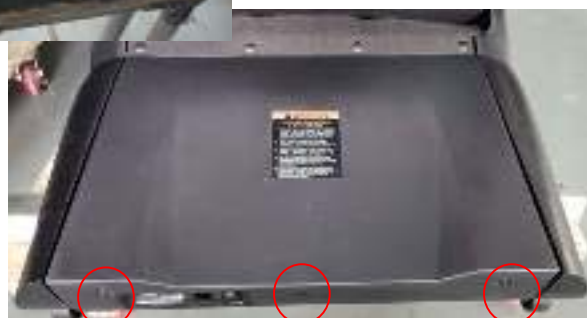
3. Removing the front backrest plastic body assembly As shown in the figure, after removing the rear shield, remove the 4 screws on the left and right sides and the 2 screws at the front end according to the indicated positions. Then unplug the air pipes of the front seat side of the backrest and the lumbar airbag, and replace the front backrest plastic body assembly.

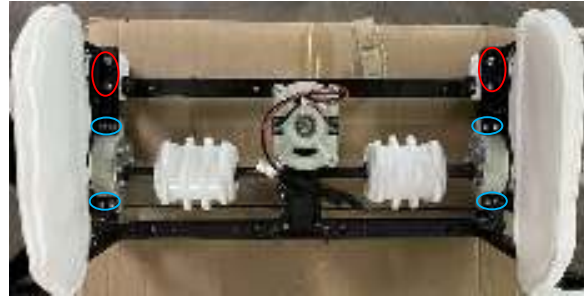
5.4.2 Removing the leg massage assembly  
Remove the screws and connectors at the indicated positions, then replace the leg massage assembly.

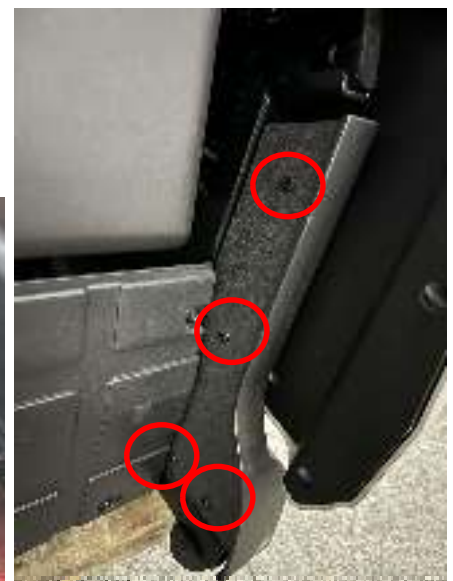
9.3.2 As shown in the figure below: Use a tool to remove the 9 screws fixing the side baffle, take off the left side baffle assembly to expose the air pump assembly on the bottom frame, disconnect the air pump connector and connecting wire harness, remove the 4 fixing screws and air pipe of the air pump, and replace the air pump assembly on the bottom frame.
