Nexus (EC-8607) massage chair service guide

- 一、 Product introduction
- 二、 Massage chair tools and use
- 三、 Circuit working principle
- 四、 Massage chair removal instructions
- 五、 Massage chair fault judgment

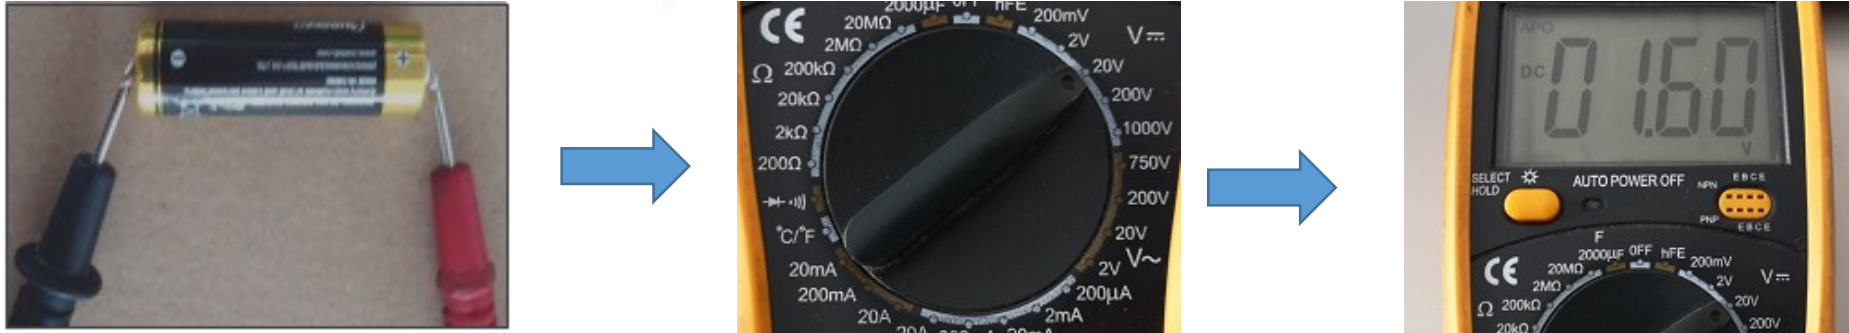
As shown in the figure above: the test result shows "1.58", indicating that the voltage at both ends of the battery has 1.58V, and the red watch pen is connected to the battery's "+" pole, while the black pen is connected to the electromagnetic "-" pole.

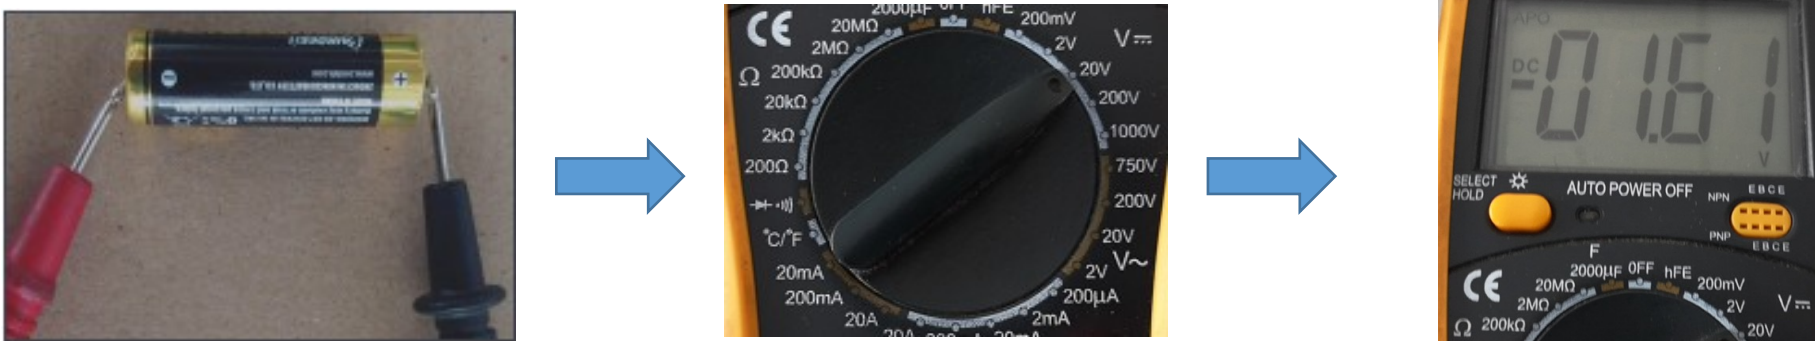
As shown in the figure above: the test result shows "-1.58", indicating that the voltage at both ends of the battery has 1.58V, and the red watch pen is connected to the battery "-" pole, and the black pen is connected to the electromagnetic "+" pole.

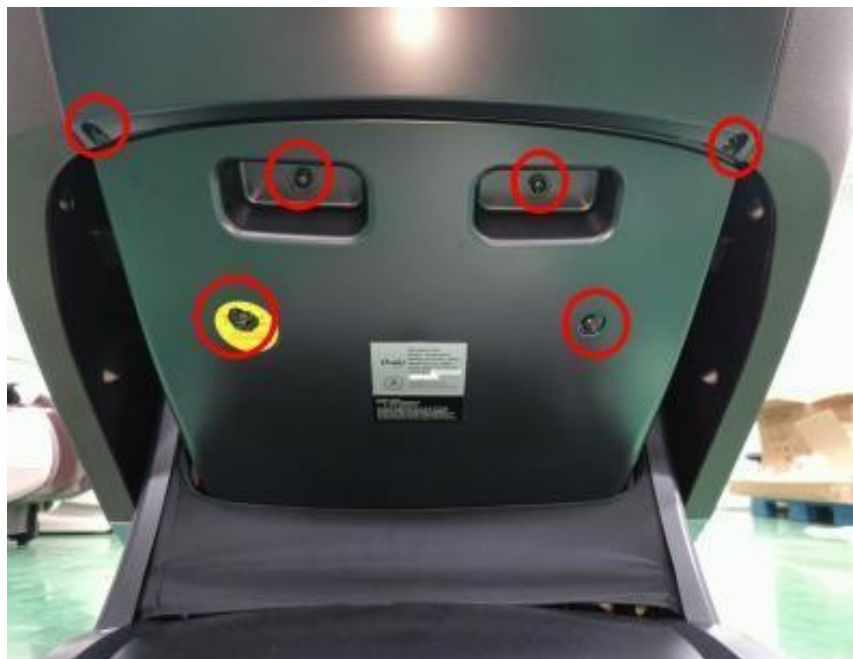
1. remove 6 screws

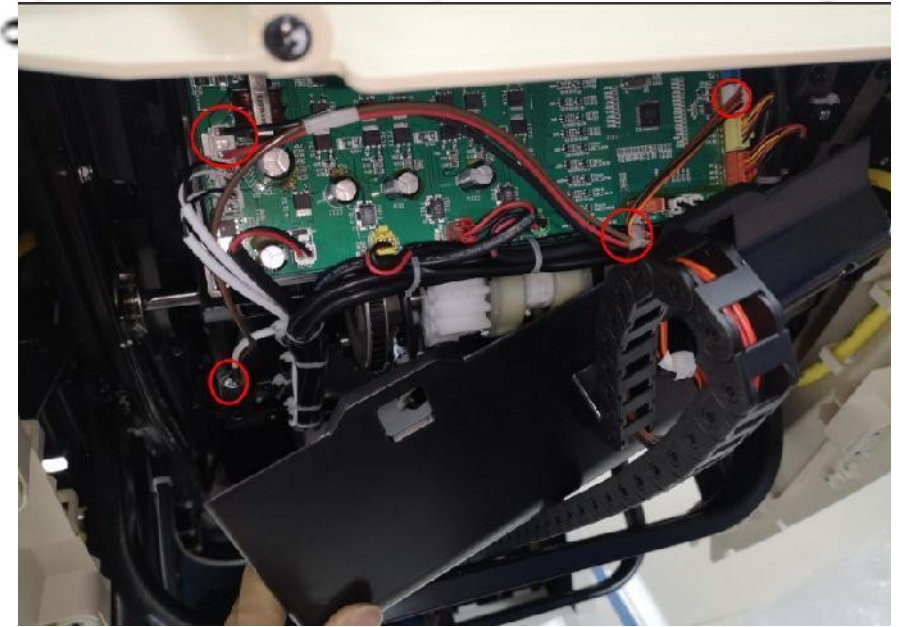
3 Unplug the terminal, remove the ground wire, and cut the cable tie

4 Connect the red terminal to an external 24V power supply to move the gear box up and down for removal
