# **A502S-2 Massage Chair After-sale Maintenance**

## **Acro massage chair after-sale service product internal structure**

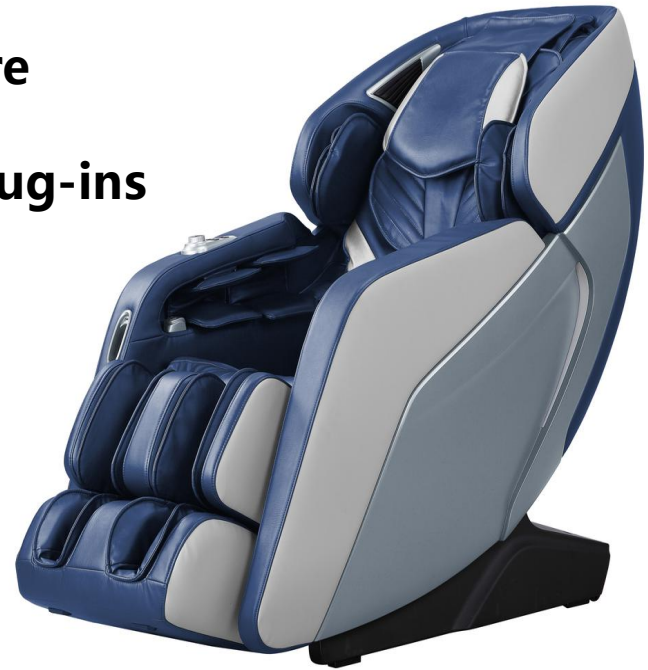
## Part Name

1. Head cushion
2. Sound
3. Upper arm airbag
4. Palm Arm Bag
5. Help shortcut keys
6. Bump Magnetic Therapy Massage
7. Health test seat
8. Controller placement slot and USB Charge Plug
9. Remote controller
10. Seat cushion
11. Leg rest
12. Foot
13. Backrest cushion
14. LED Artistic Conception Lamp
15. Help
16. Side cover

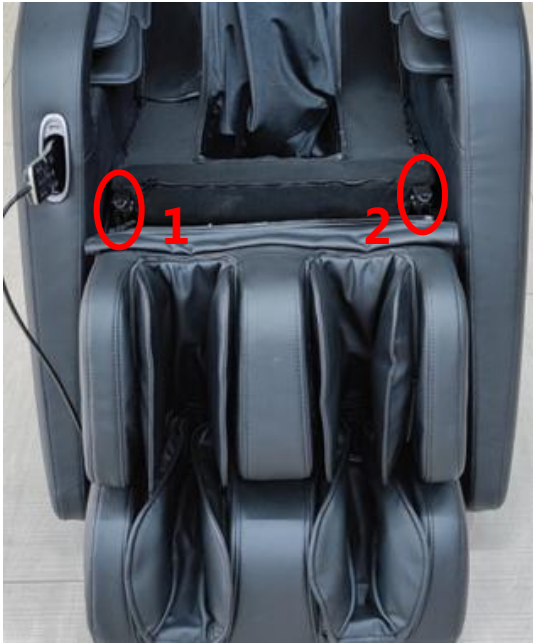
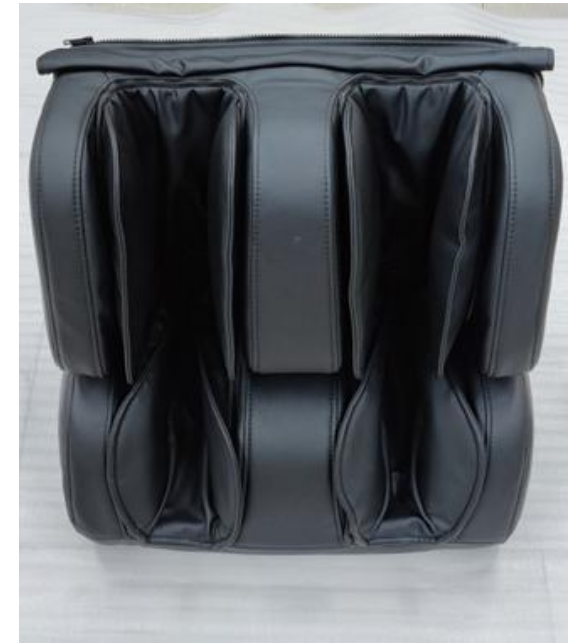
## 5.2. Schematic diagram of calf disassembly

**A. Remove the mounting seat screws 1 ~ 2 in Figure A**

**B. Separate the air hose from the plug-in 3 in Figure B**

**C. Remove the lower leg assembly**
