**EASEPAL**

# EC-8610E massage chair service

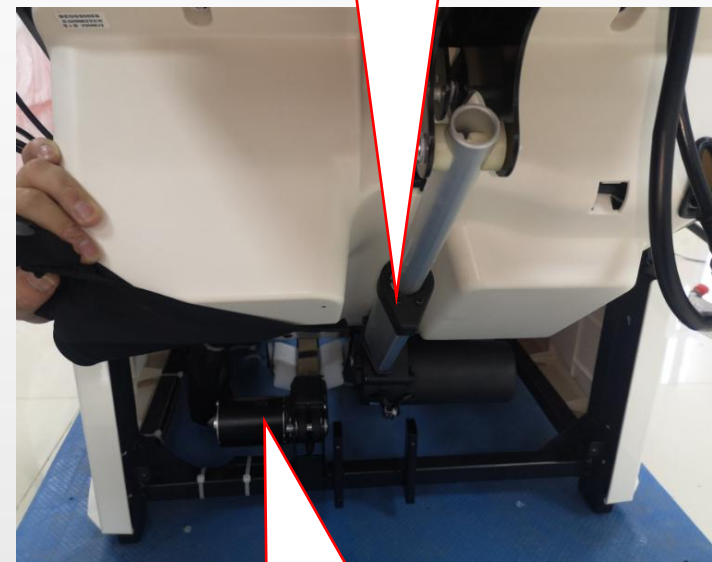
#### 1、Internal structure diagram (overall):

mechanism

under seat PCB

air pump

main PCB box

legrest actuator

backrest actuator

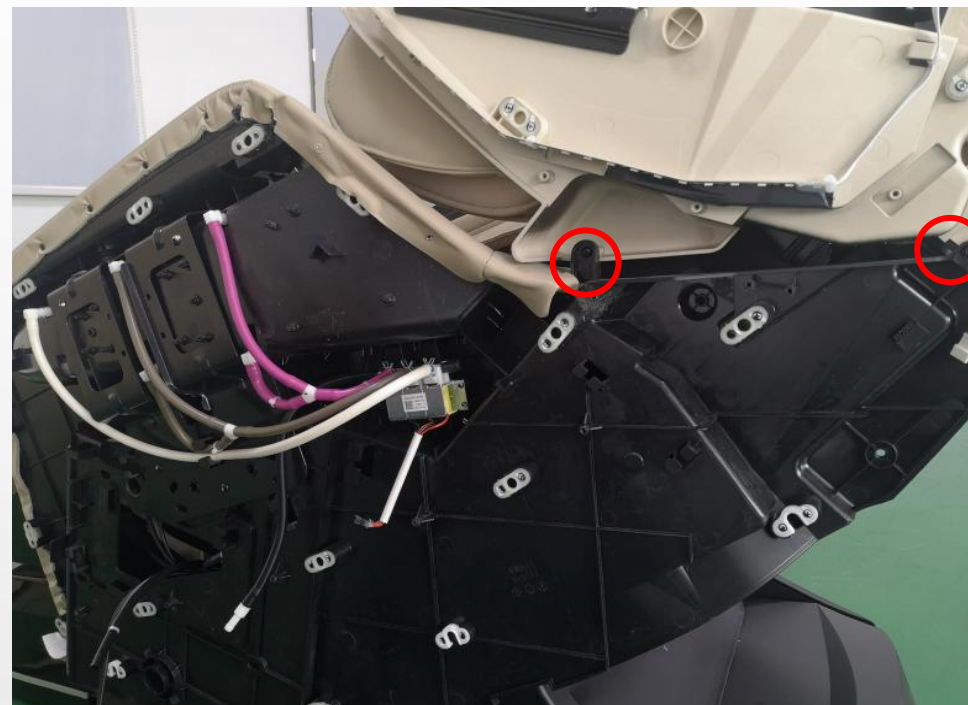
remove 2 screw, then remove  
left side panel

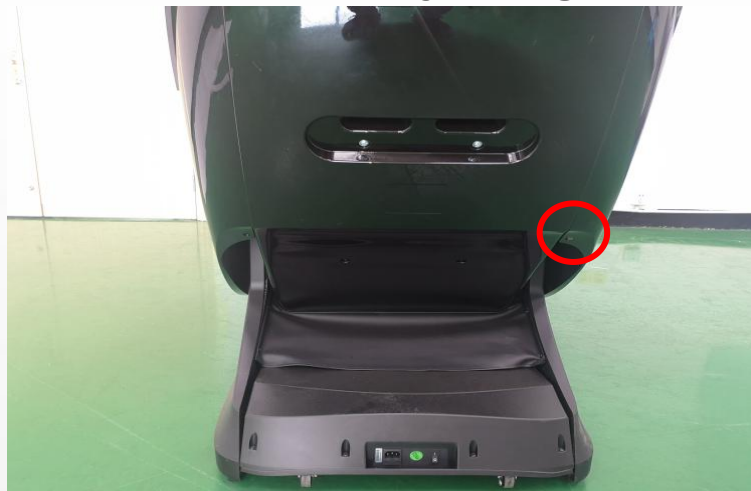
remove a screws

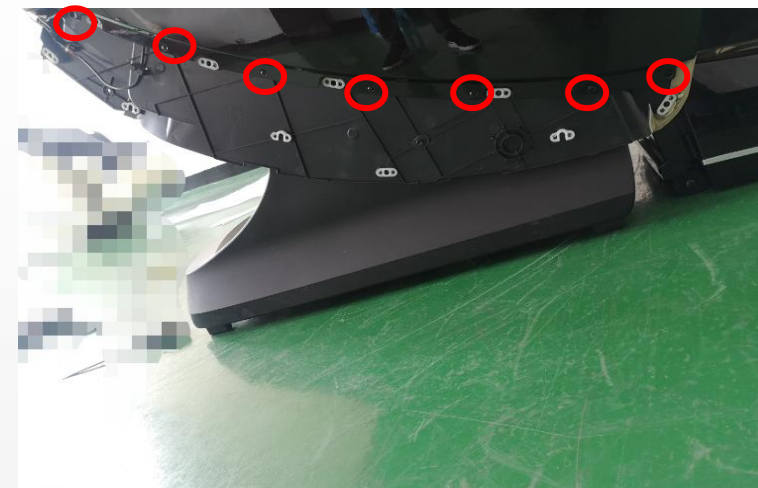
remove 7 screws and remove upper cover

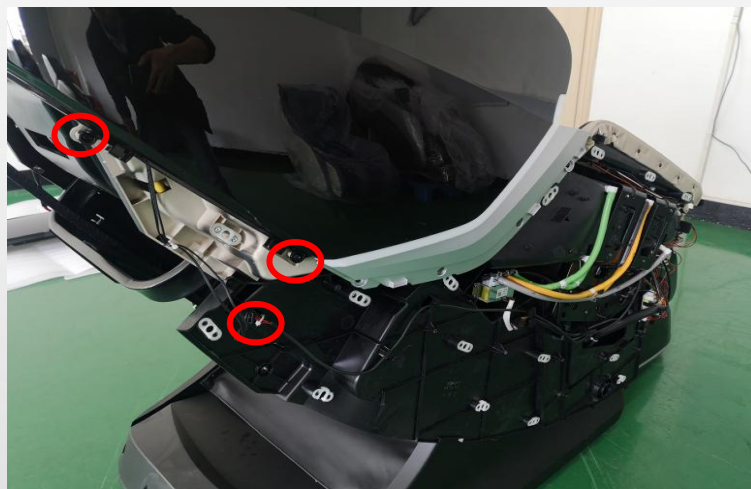
remove 2 screws and  
discontent the terminal

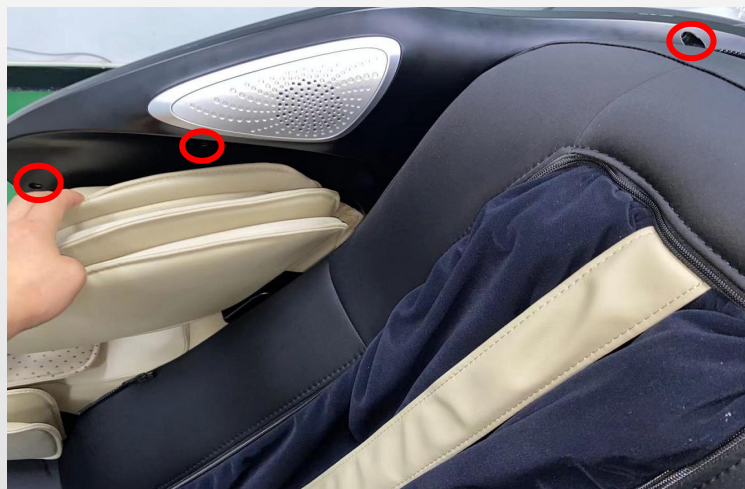
remove 3 screws and remove the  
hood cover

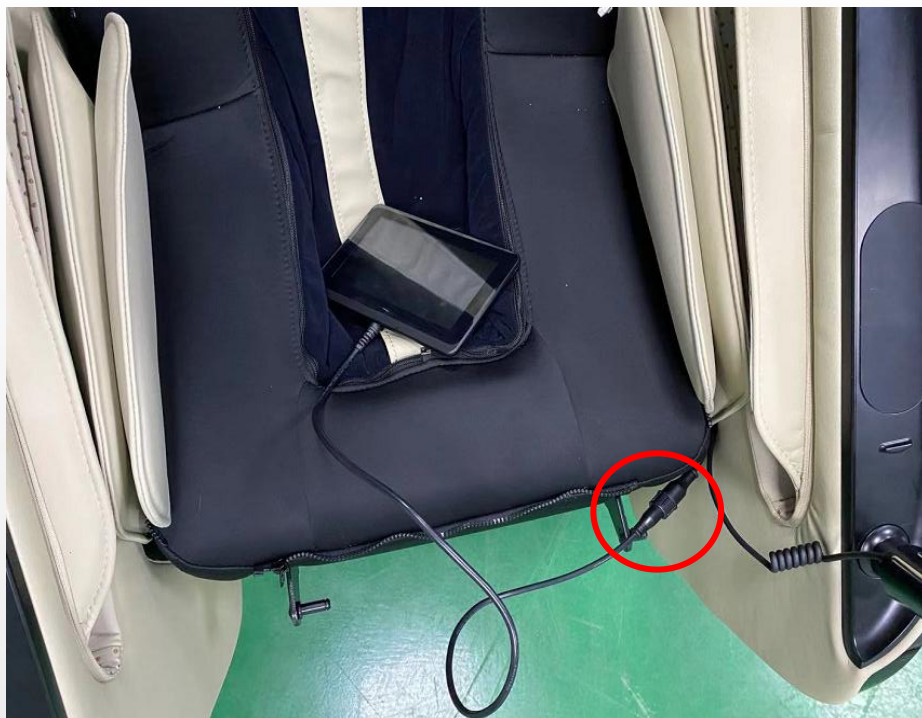
disconnect the terminal

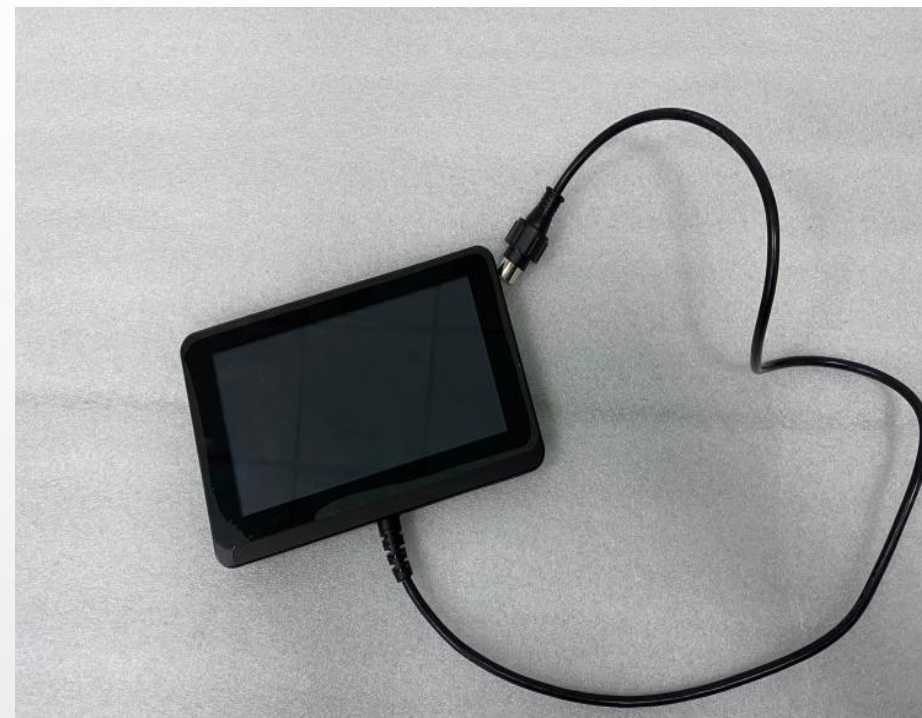
remove the remote control

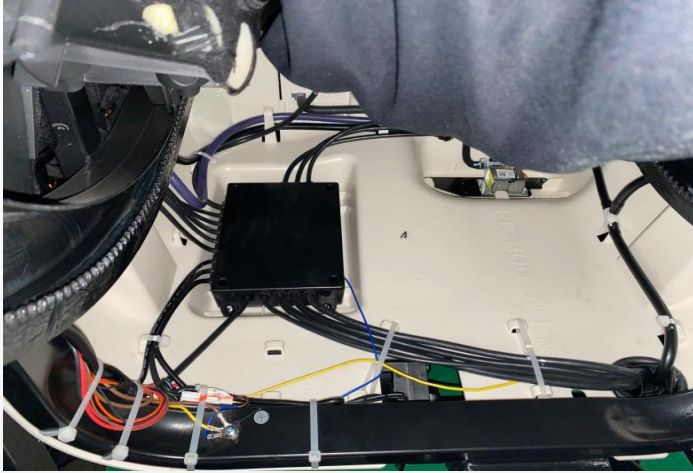
open rear cover

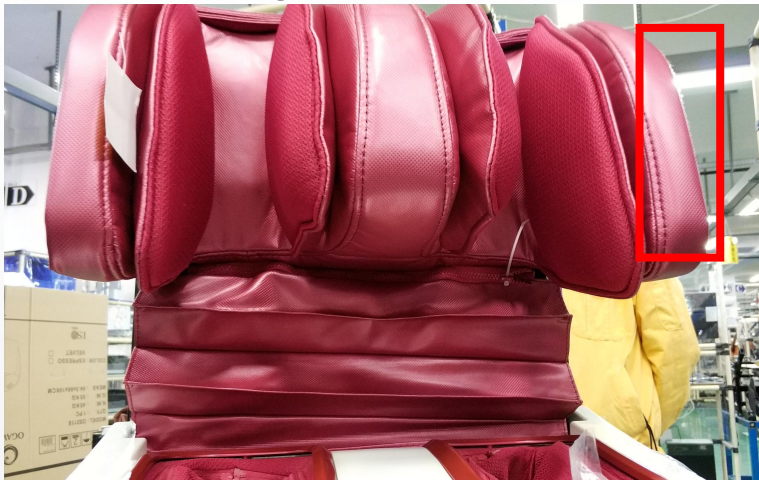
open left cover

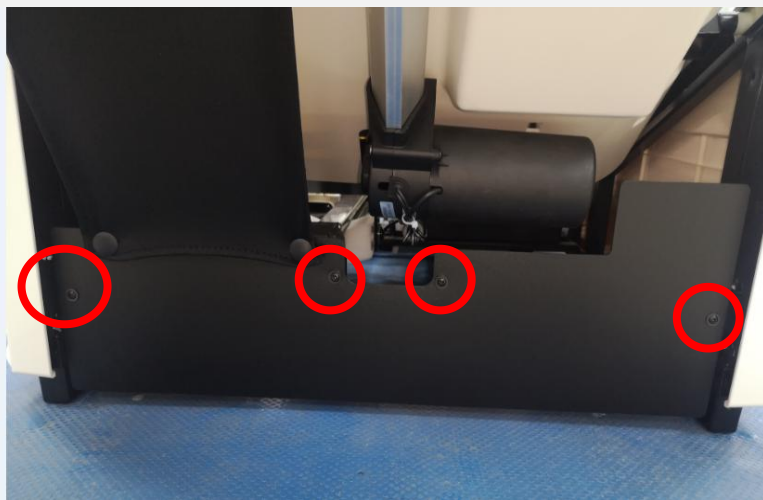
remove 4 screws

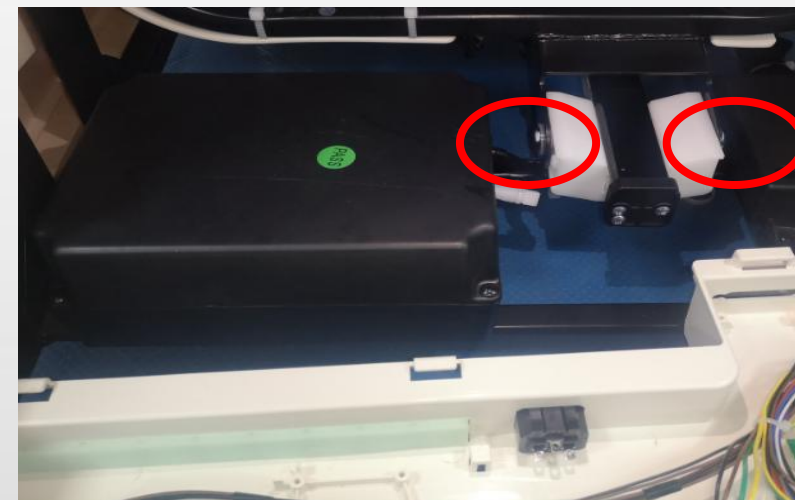
remove 2 screws
