EASEPAL. 厦门蒙发利电子有限公司客户服务部

EI-8701C-massage chair service guide

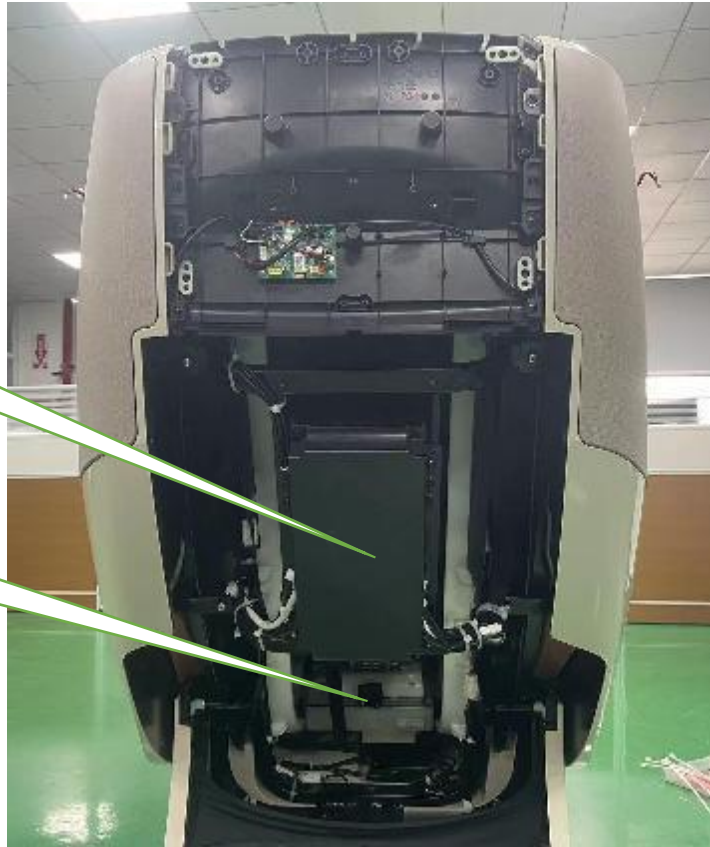
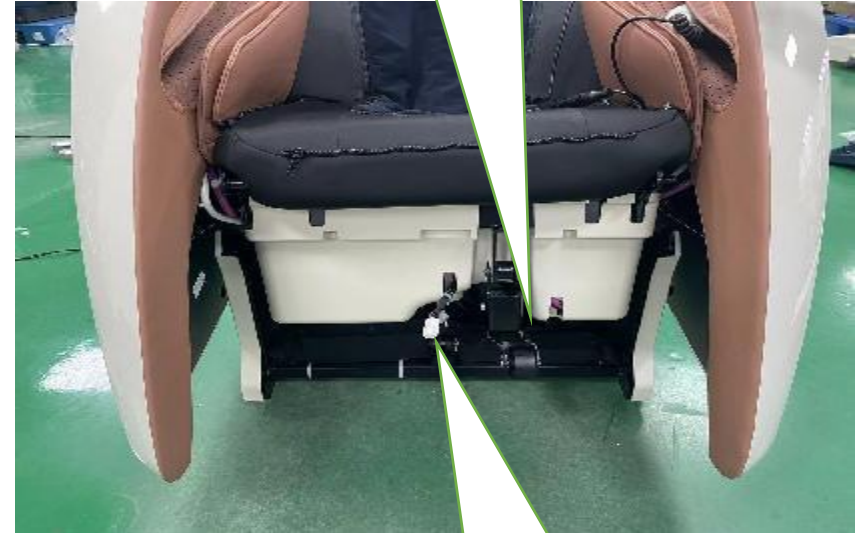
1.1、Internal structure diagram (overall):

control box

mechanism

legrest actuator

backrest actuator
