# A385 massage chair after-sales maintenance guide

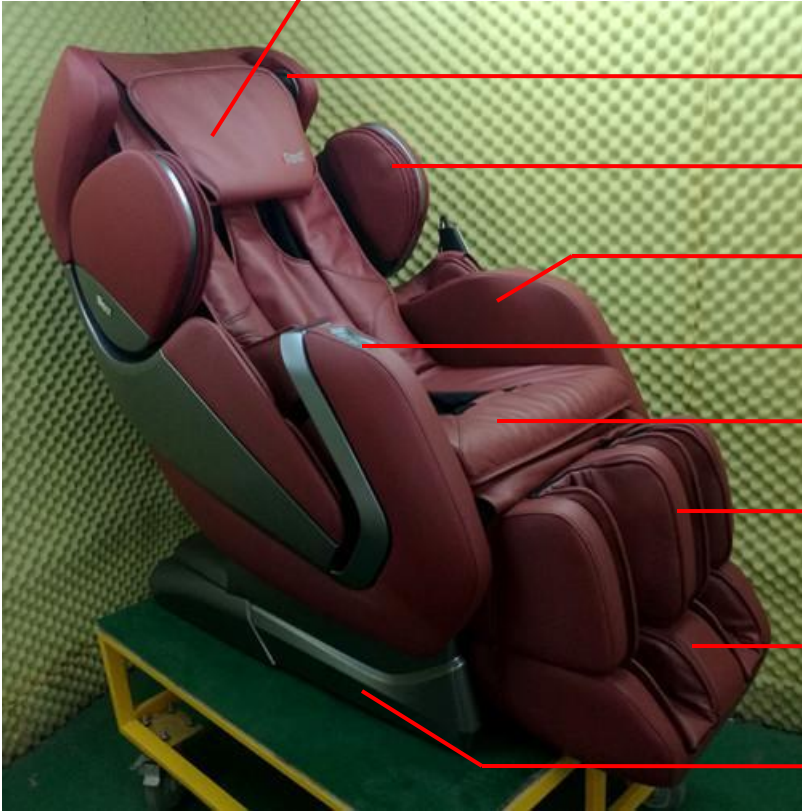
## 1. Front side view

- 1. pillow
- 2. 3D Sound
- 3. Upper arm device assembly
- 4. armrest assembly
- 5. Shortcut control keys
- 6. Cushion assembly
- 7. Leg rest
- 8. sole roller
- 9. Side cover assembly of seat frame

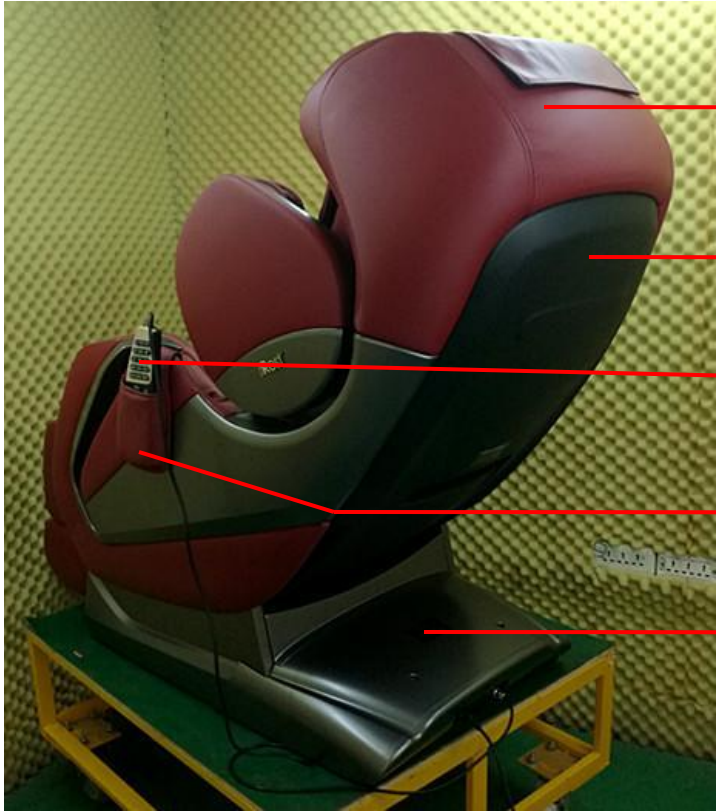
## 2. Back side view

- 1. Capsule components
- 2. Backrest cover (back cover)
- 3. Manual controller
- 4. Hand controller pocket
- 5. Back cover assembly of seat frame
- 6. remote wire aviation socket
- 7. Power switch
- 8. Fuse Block
- 9. Power outlet

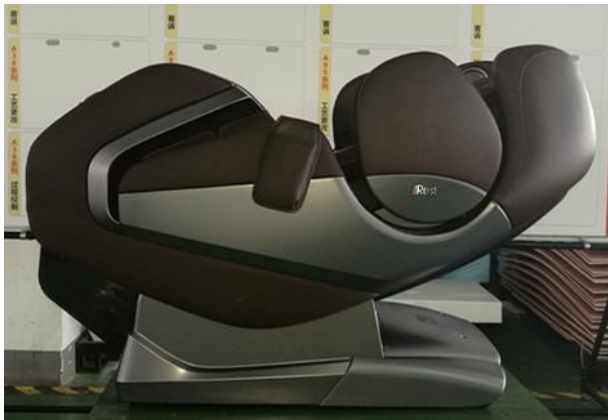
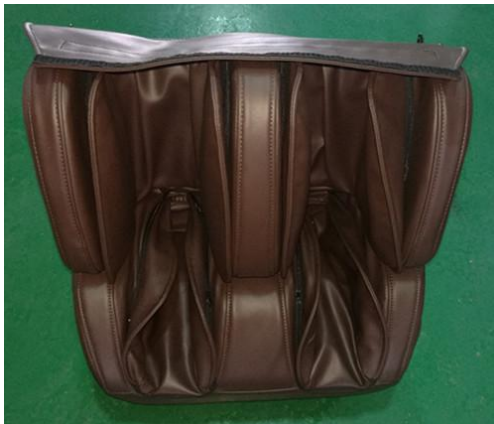
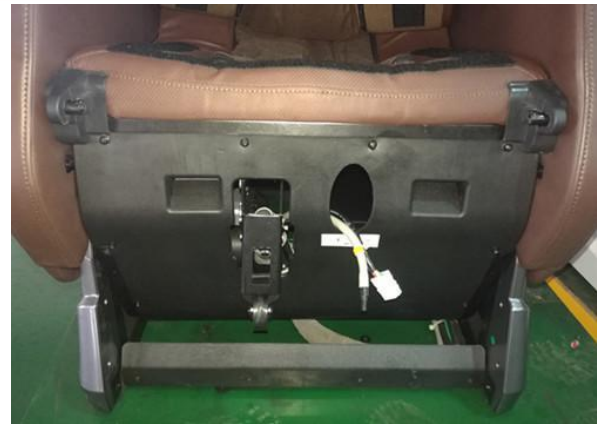
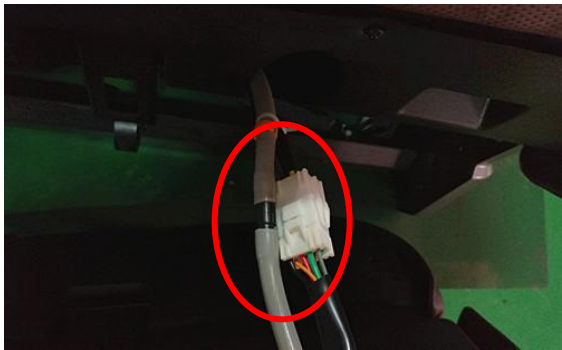
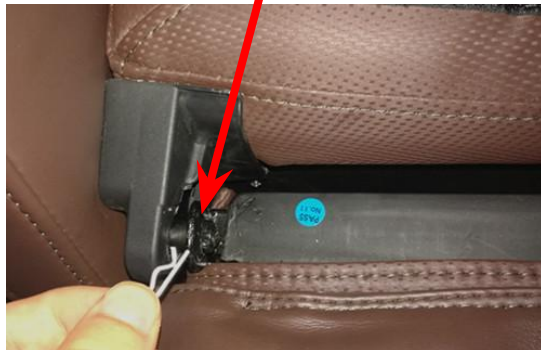
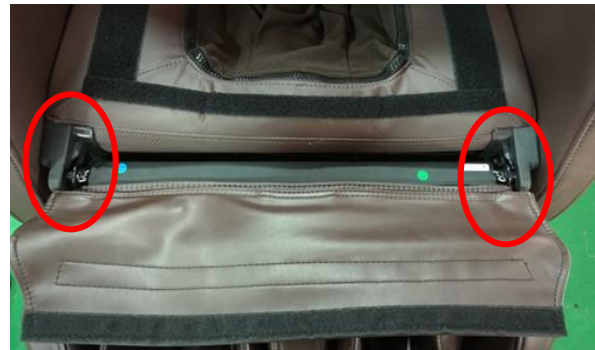
**1. This machine is packed in 2 pieces, and the calf and main body should be assembled for the installation of the new machine.**

**2. First insert the calf air hose and wiring harness firmly (pay attention to the plug-in direction), then hang the calf on the main body and insert the bolt on the calf installation shaft firmly.**

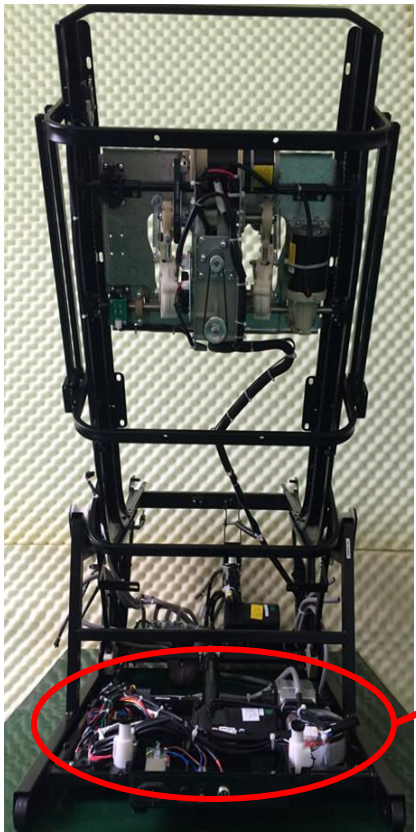
#### 3.2. Internal components on the back of the main body

Power supply board

Drive board

Backrest electric cylinder

Air pump

Round transformer

Safety switch

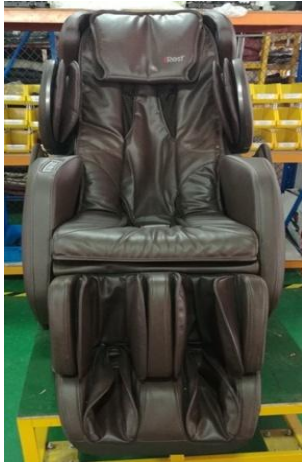
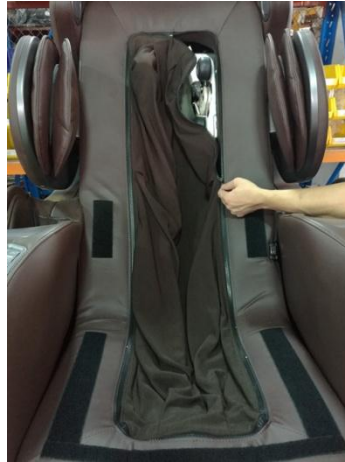
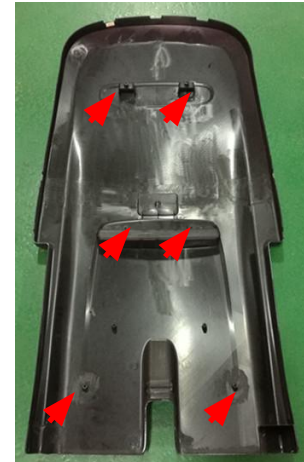
1. Remove the head cushion and cushion, unzip the kneading cloth on the rack, and finally remove the 6 screws on the back cover to remove the back cover.

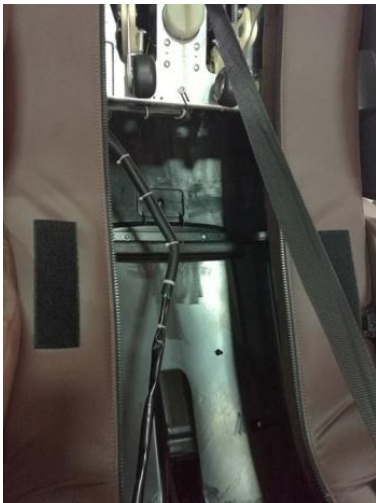
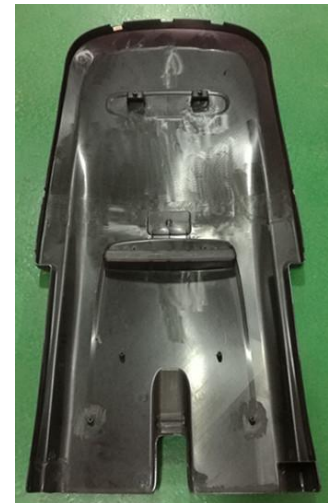
2. In case the screw is blocked by the manipulator, turn off the power supply of the machine first, then press down or pull up the manipulator to expose the screw, then remove the back cover.

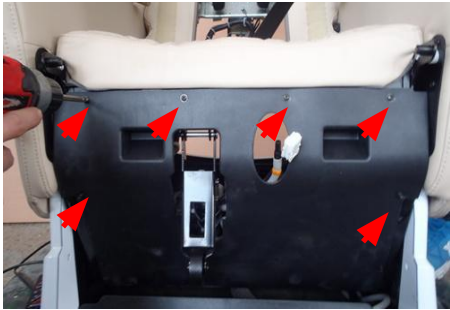
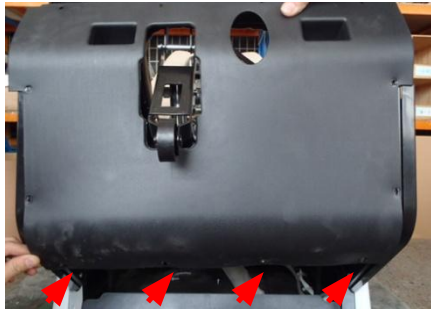
**3. First remove the 6 screws on the front sealing board, then lie down the chair to remove the lower 4 screws, and then remove the 2 screws at both ends of the front side of the armrest (up and down in the two red circles)**

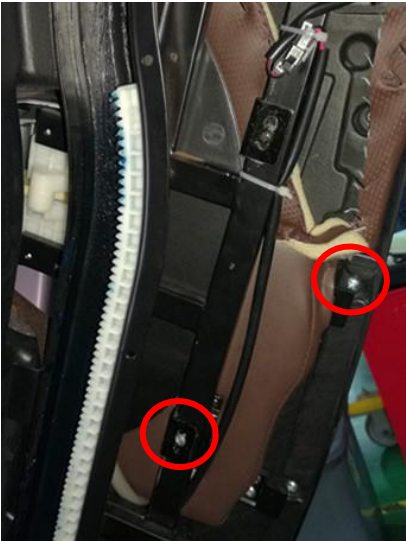
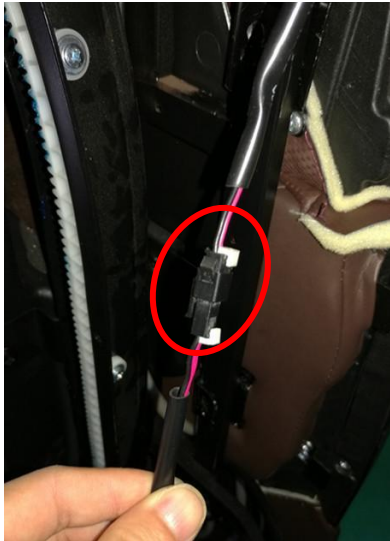
**4. Remove two armrest mounting screws on the left and right inner sides of the backrest steel frame (in the red circle), and then separate the DC12V power cord.**

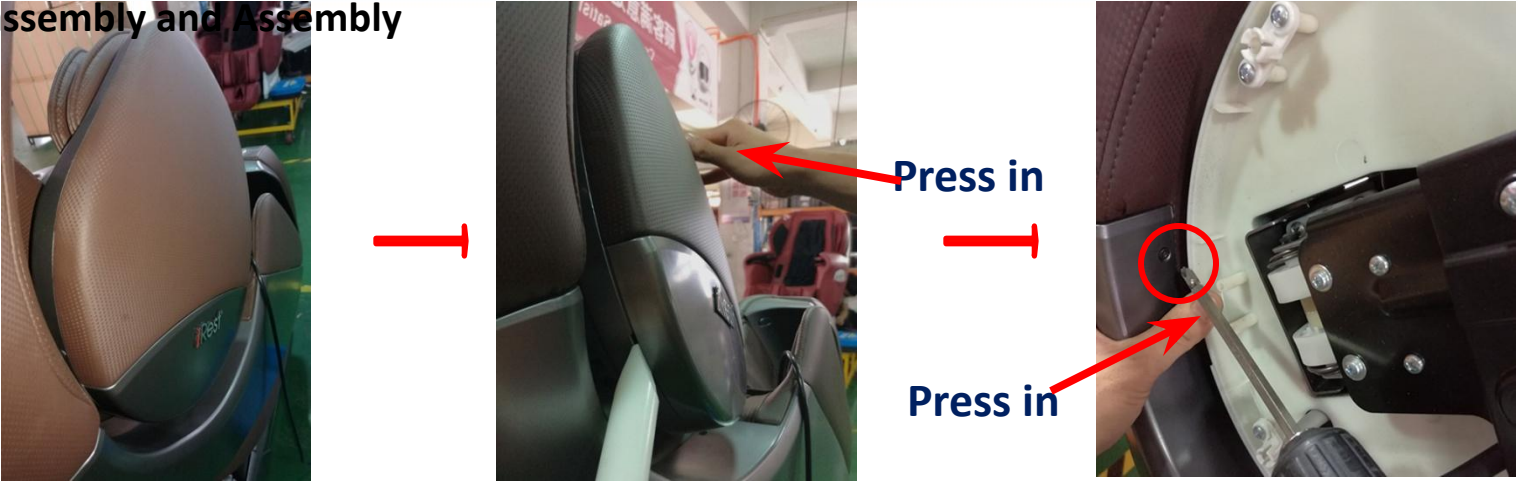
5. Press the upper arm device inward first, then pry open the outer cover, then press the inner cover of the upper arm device with your thumb (shown by the arrow under the red circle) and remove the screws in the red circle with a screwdriver.

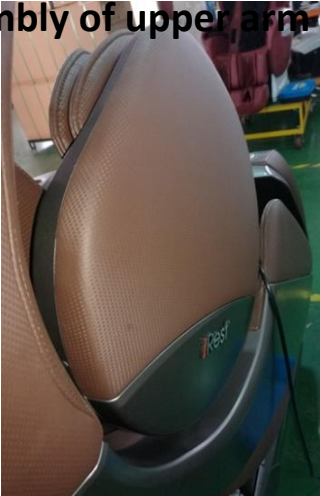
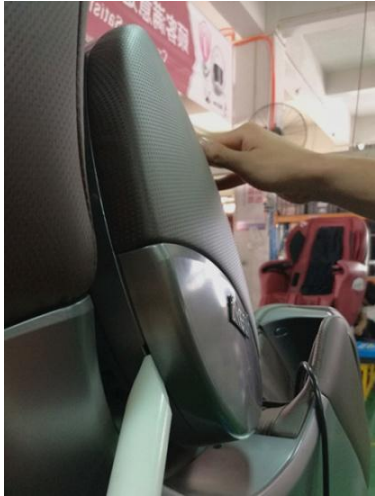
1. Press the upper arm device inward and expose the disassembly opening, and then remove the outer cover with a crowbar.

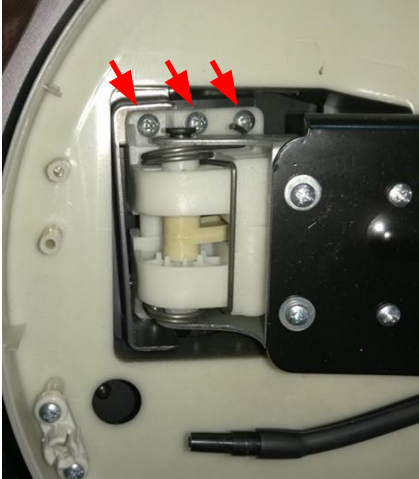
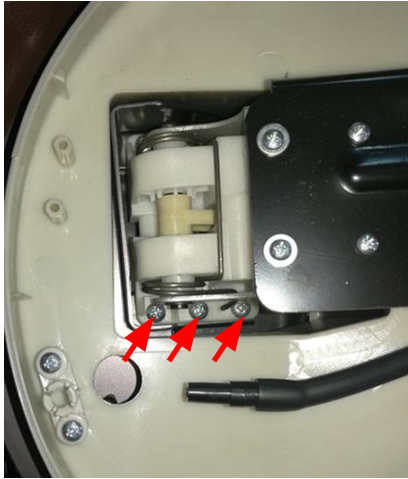
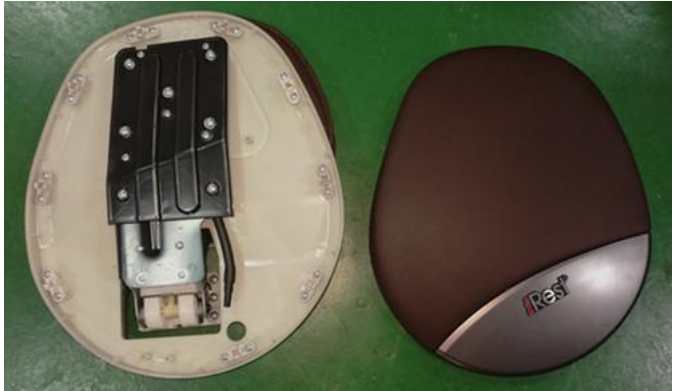
2. First remove the upper and lower screws of the arm mounting seat (indicated by the red arrow), and then remove the arm as a whole.

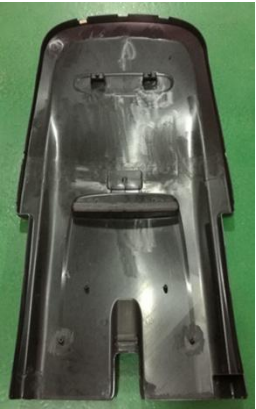
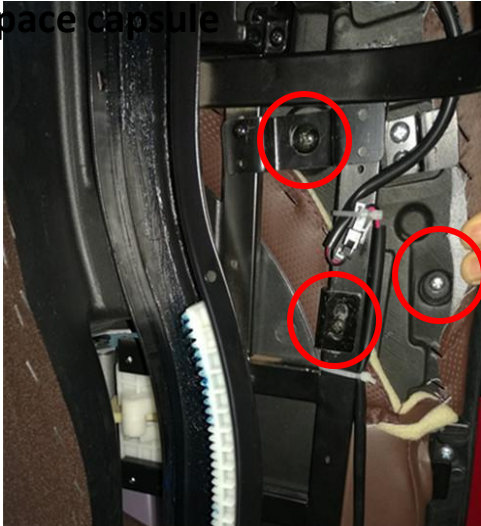
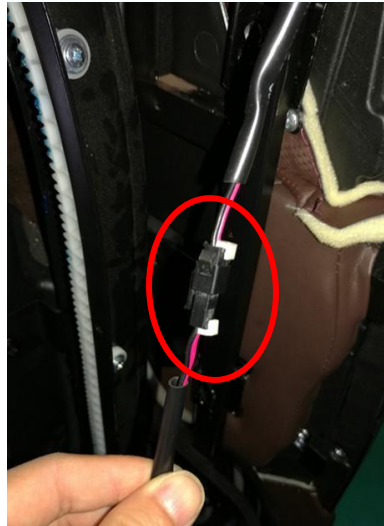
1. Remove the back cover first, then remove the three screws (in the red circle) that fix the space capsule on the left and right inner sides of the backrest steel frame, and finally separate the audio 12V power cord.

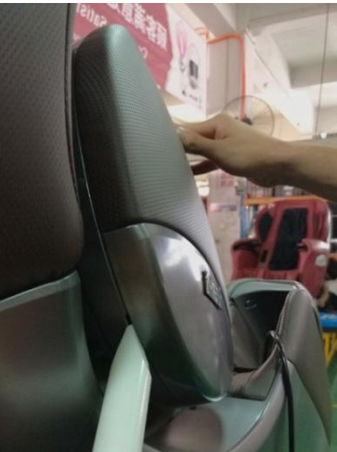
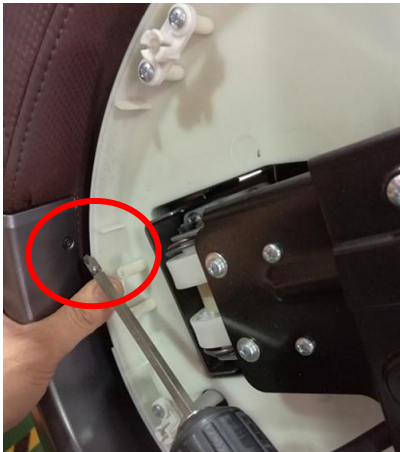
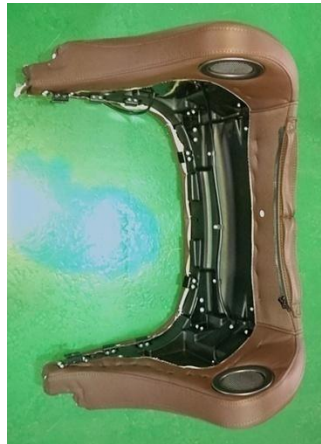
2. Remove the outer covers of upper arm devices on both sides, and remove the screws connecting the capsule with the outer covers of armrests, and finally remove the capsule as a whole.

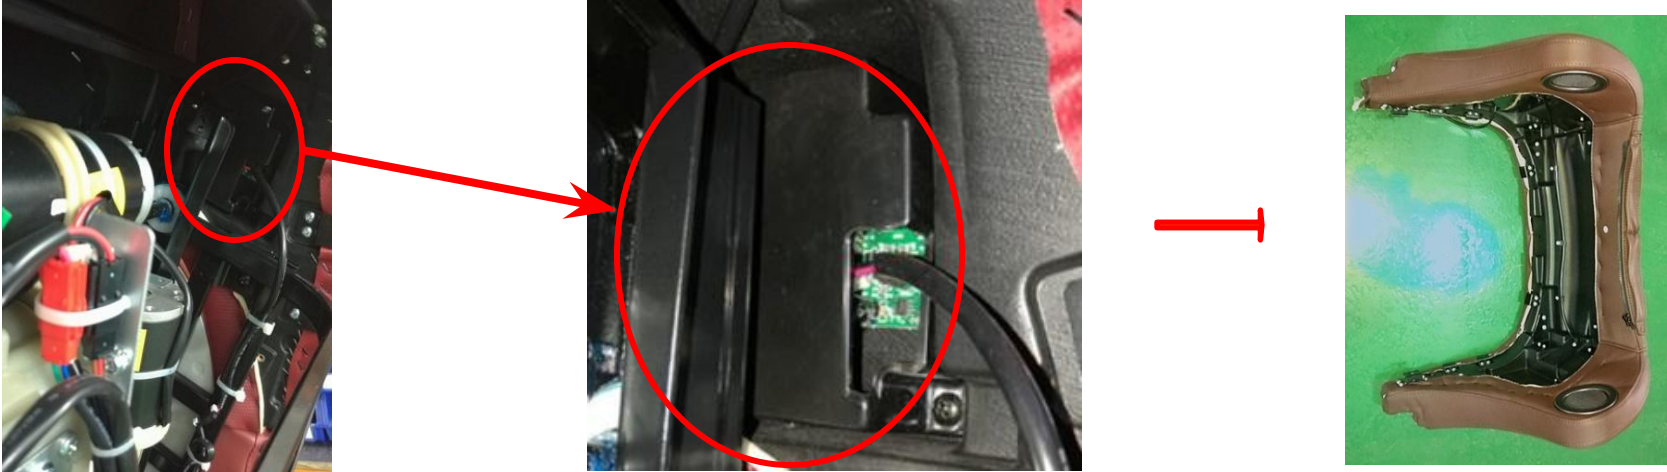
1. Because the audio board is installed on the right side of the capsule, it is necessary to remove the capsule before taking it out.

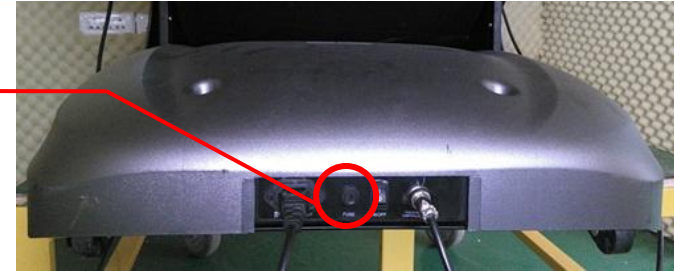
1 # 5A fuse

2 # 6.3 A fuse

(1) As shown in the right photo, if the 1 # fuse is burnt, then the rectifier circuit of the 5V switching power supply circuit or the "471K" varistor of the overvoltage protection device of the power supply board has breakdown, and the power supply board can be replaced;

(2) As shown in the right photo, if the 2 # fuse is burnt, it means that the output load circuit of the transformer has overcurrent. First of all, it is necessary to confirm whether the loads such as manipulator motor, leg and backrest lifting electric cylinder, air pump and heating pad are short-circuited. If there is short-circuited phenomenon, change the load such as motor before changing the drive board (if not replace the broken motor first, the new drive board will be burnt again). If there is no short-circuited phenomenon, the drive board can be replaced;

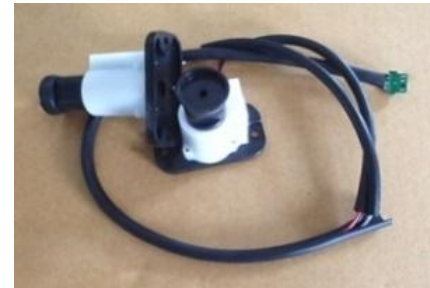
**Figure 2. Safety Switch**

When there is foreign matter on the outer cover of the seat frame, in order to protect the massage chair itself or prevent the articles from being crushed, the program sets that the backrest only rises but does not fall, so the foreign matter is eliminated first, and then

Figure 2 eliminates whether the safety switch is broken.

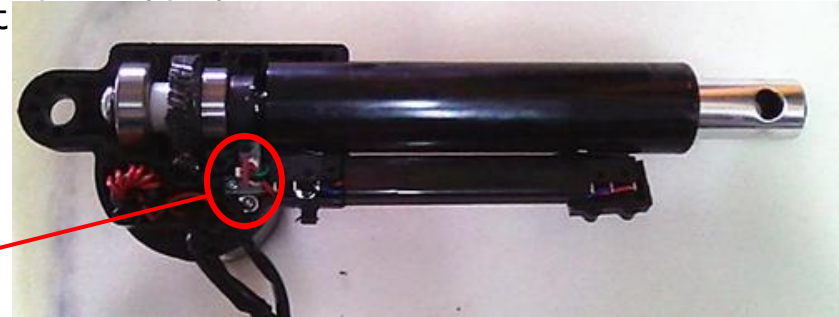
Telescopic circle number  
detection board

When this happens, the manually operated electric cylinder can rise and fall normally, but it can't be used normally when using the "Back Stretch/M2" key for traction and swing function, And the telescopic position (i.e., lying angle) of the electric cylinder cannot be remembered when the memory function is performed. As shown in the above figure, it is usually caused by the broken turn number detection board inside the electric cylinder (i.e., the telescopic turn number is detected to determine its telescopic position), so it can be judged by replacement method and replaced.

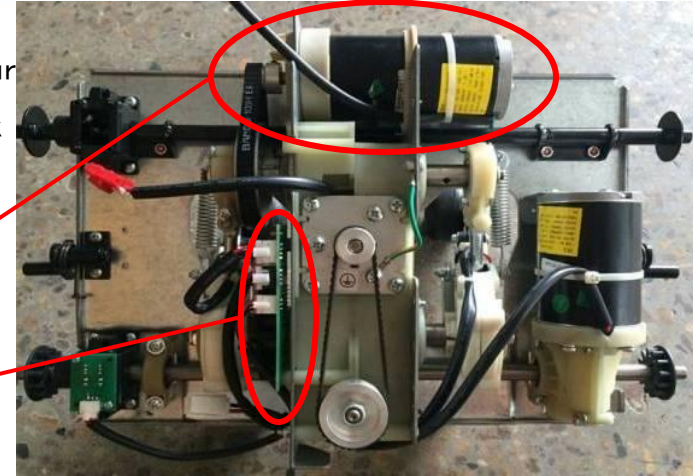
tapping motor

Width  
detection  
board

- (2) If the width detection board is defective as shown in the above figure, it can be eliminated and replaced.
- (3) The open circuit of tapping motor coil is broken, so it can be eliminated and replaced.
- (4) There is no driving power supply caused by the defect of the driving board, so it is enough to eliminate and replace the driving board.
- (5) broken wiring harness or inspection wire contact between drive board and motor causes motor can't run, and can be eliminated

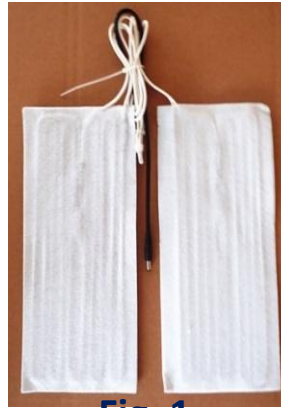
**Fig. 1.**  
**Heating pad**

- (1) If the heating pad in Fig. 1 is broken, it can be judged whether the resistance value is about 25  $\Omega$ ,
- (2) As shown in Fig. 2, the heating pad plug broken, in the red circle falls off.
- (3) If there is no heating power supply due to broken driving board, it is enough to eliminate and replace the driving board.
