# EC-3622A massage chair service

## Table of Contents

- 1、Product introduction**
- 2、Massage chair tools and use**
- 3、Circuit working principle**
- 4、Massage chair removal instructions**
- 5、Massage chair fault judgment**

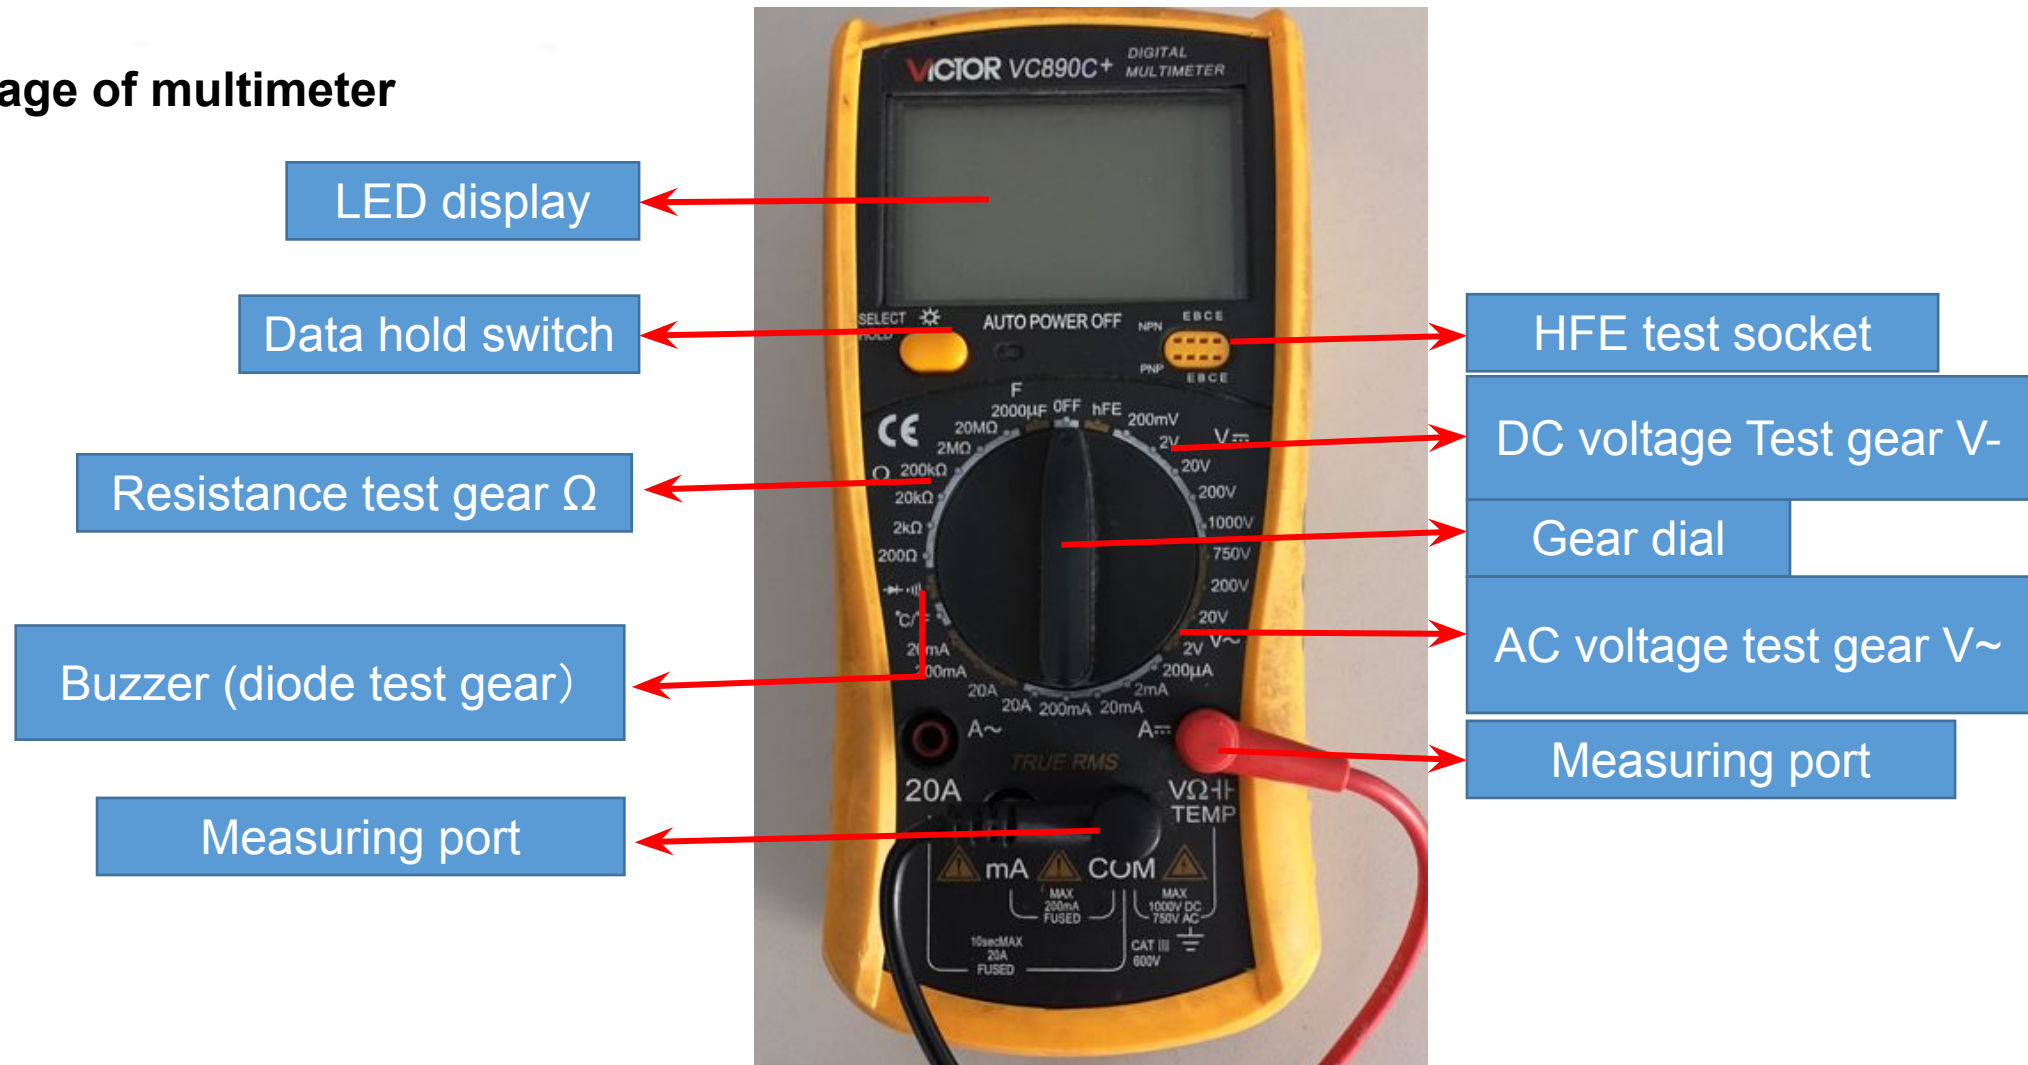
## 2、Usage of multimeter

**Data hold switch** : Memorize the measured data for comparison。

**Buzzer (diode test gear)** : Measure the quality of diode, the on-off and alarm function of circuit

**Resistance gear test gear** : Measure the quality and value of resistance

**DC voltage Test gear V-** : Measure DC voltage

**AC voltage test gear V~** : Measure AC voltage

**VΩ / COM** : VΩ Red pen port (+ pole) during test, black pen port (- pole) during com test

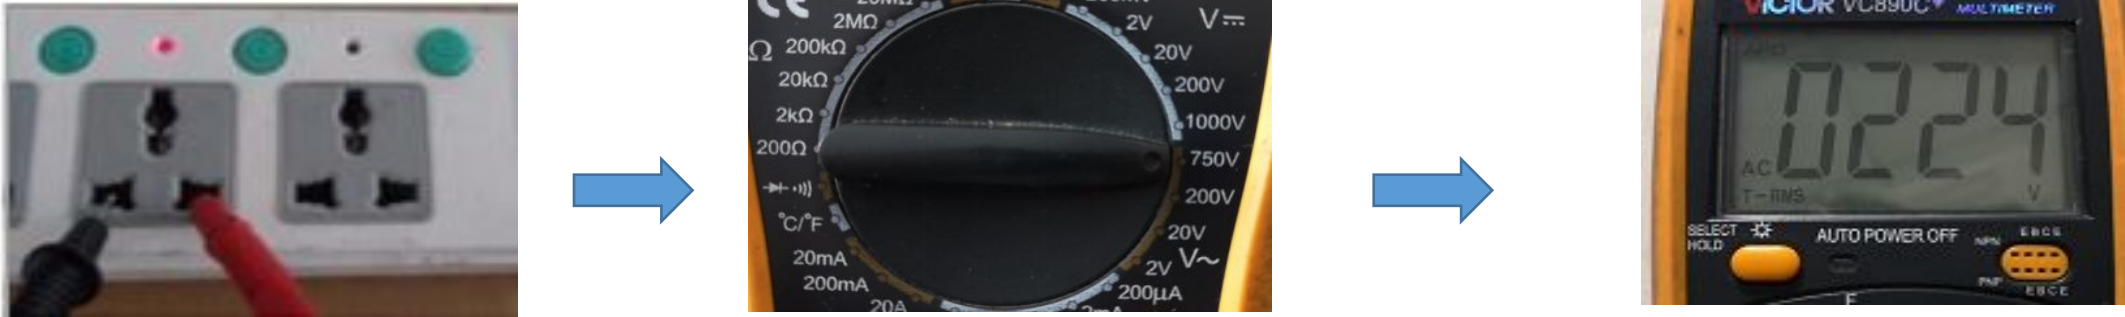
As shown in the picture above: measure the household plug-in board power supply (220V), select the range of 750, and the test result shows "224", indicating that the actual voltage of this group of sockets is 224v at the moment (the switch is pressed down, so there is power, and the light is on).

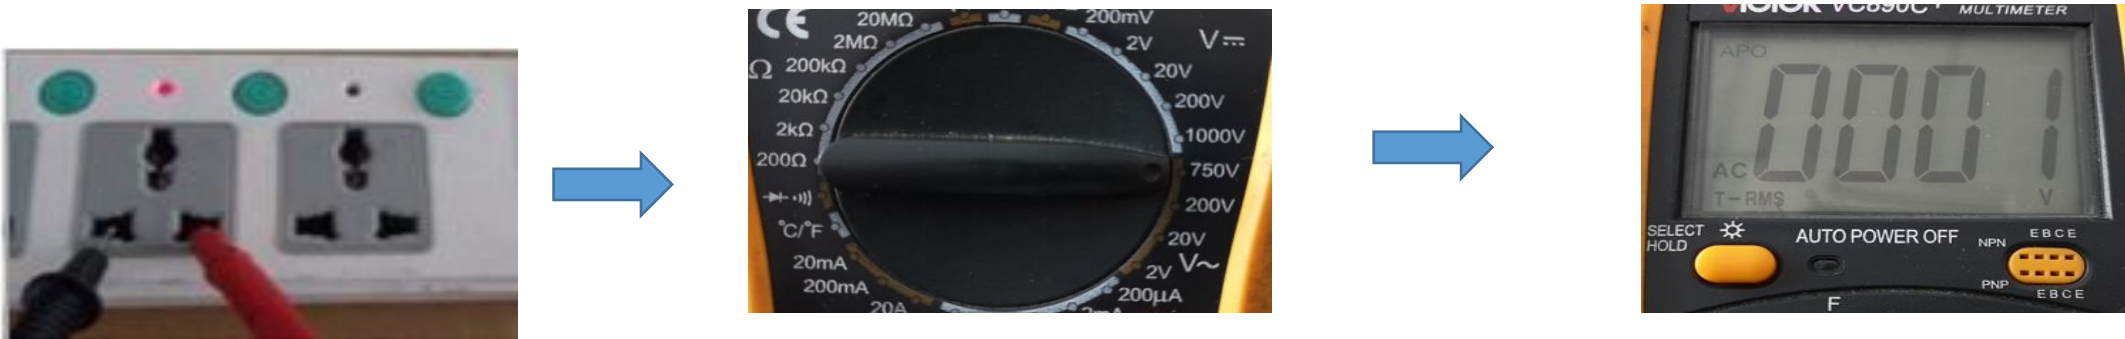
As shown in the above picture: measure the power supply (220V) of our household plug-in board, select the range of 750, and the test result is displayed as "001", indicating that the actual voltage of this group of sockets is 0V at the moment (the switch is not pressed down, so there is no power, and the light is not on).

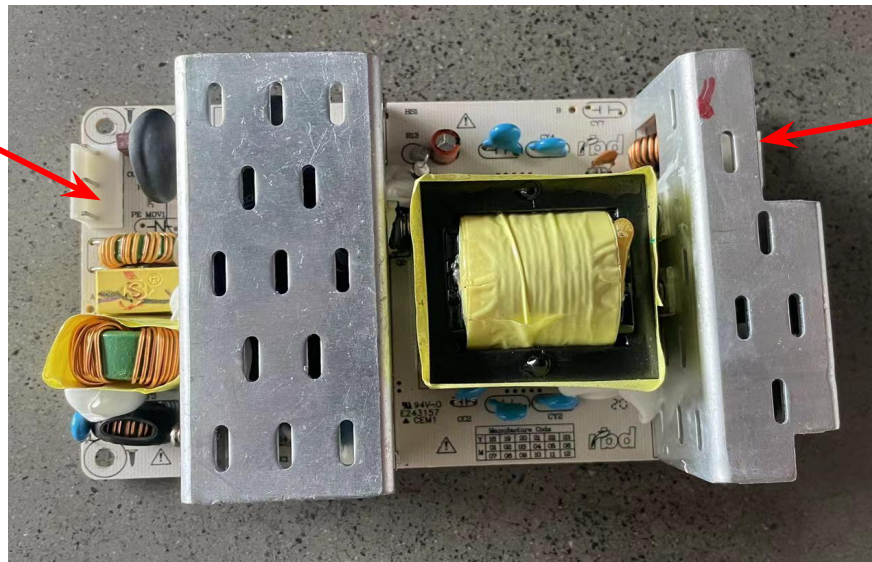
#### 2、power PCB:

power out (DC24V)

power in (AC110)

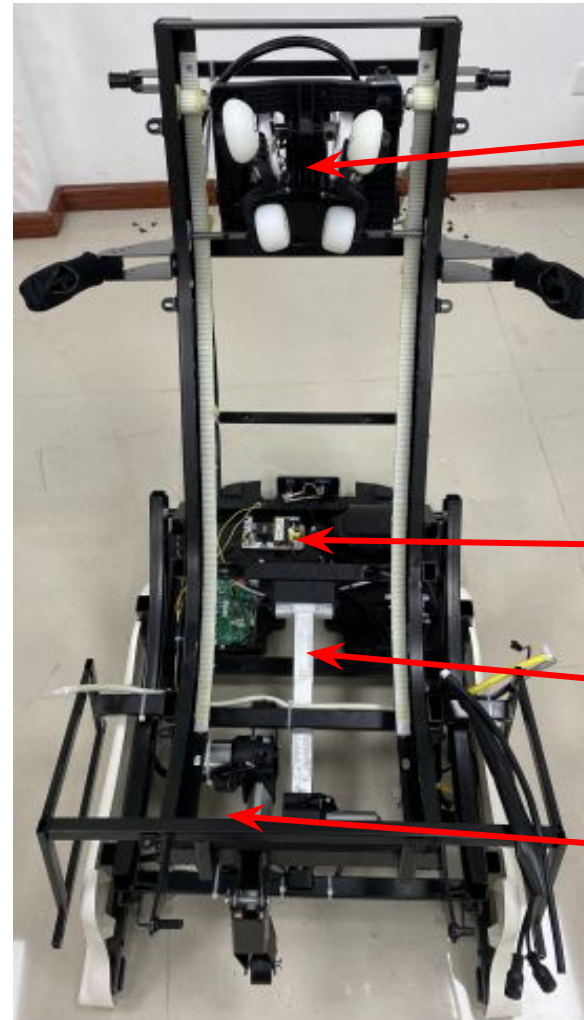
### 1.1、Internal structure diagram (overall)

gearbox

main PCB box

backrest actuator

legrest actuator

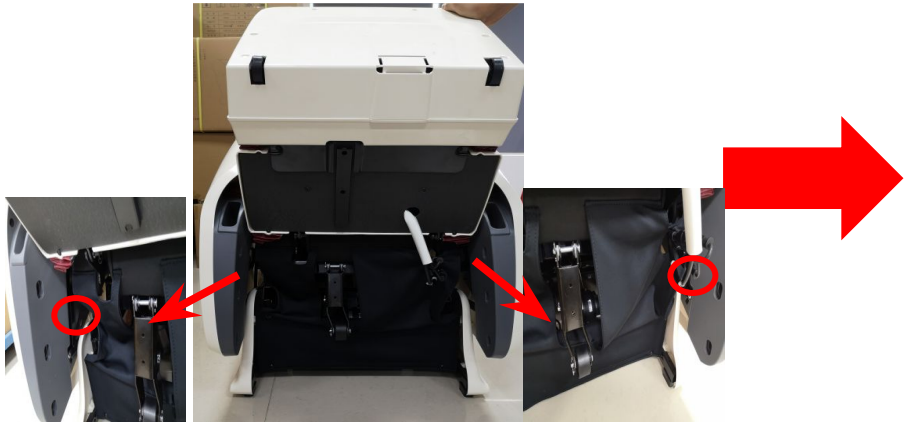
Lift up the footrest and remove 2 screws

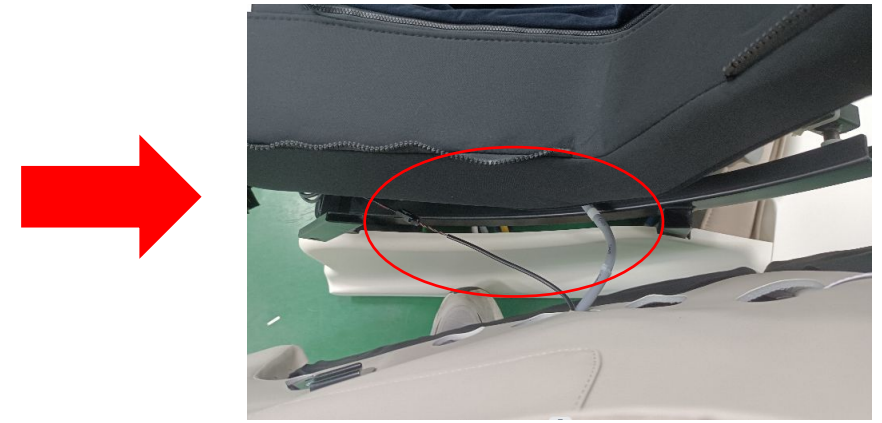
Disconnect the terminal and the gas hose connection.

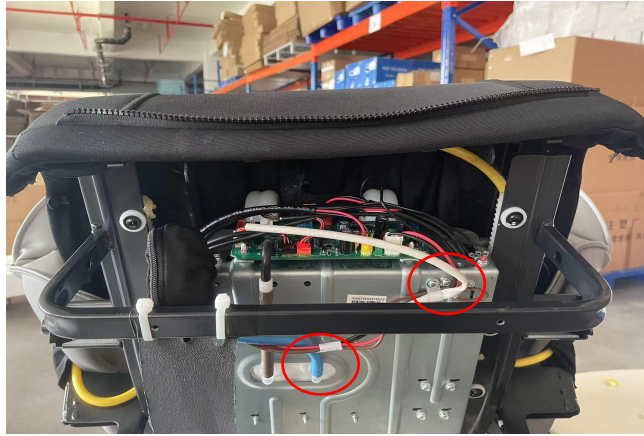
Remove 2 grounding screws and pull out 1 air hose.

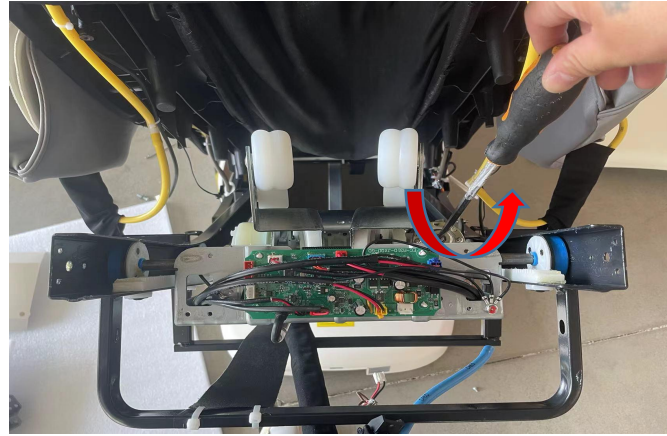
Use a flat-head screwdriver and turn counterclockwise to unscrew.

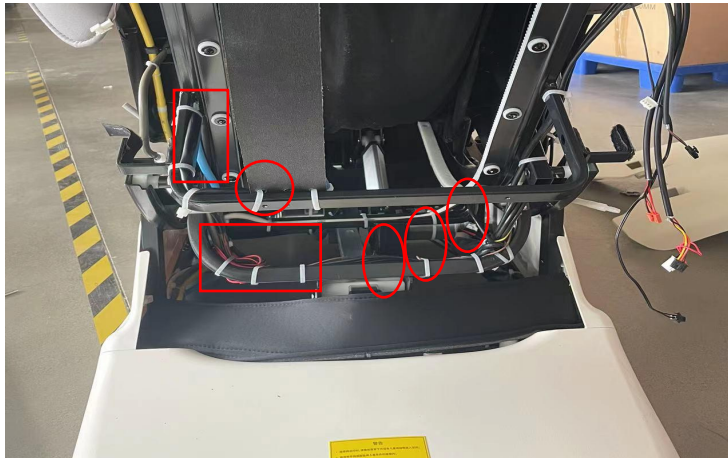
Remove the screw, pull out the terminal, and cut off the buckle.

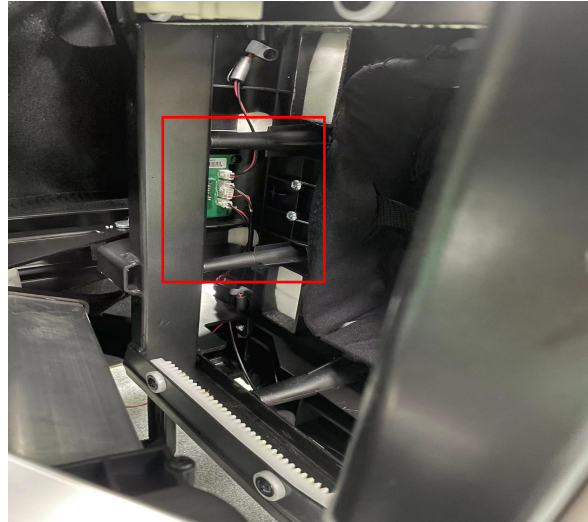
Remove 4 screws and pull out the terminal.

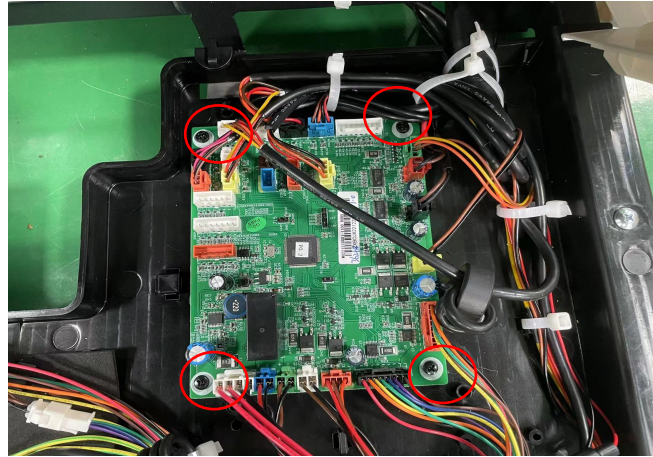
Pull out all terminals and remove 4 screws

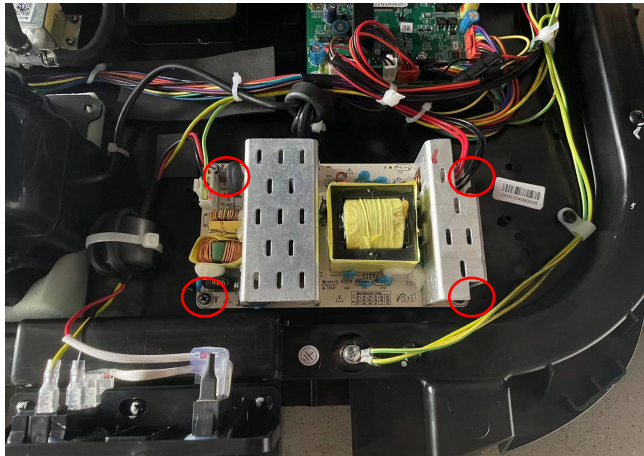
Pull out 2 terminals and remove 4 screws

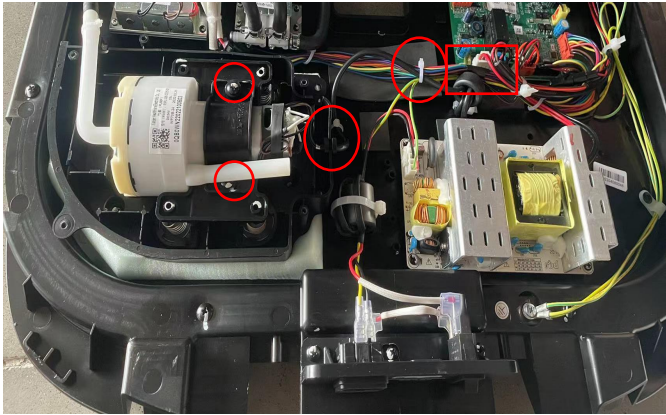
Remove 2 screws, cut off the buckle at the marked position, and pull out 1 terminal

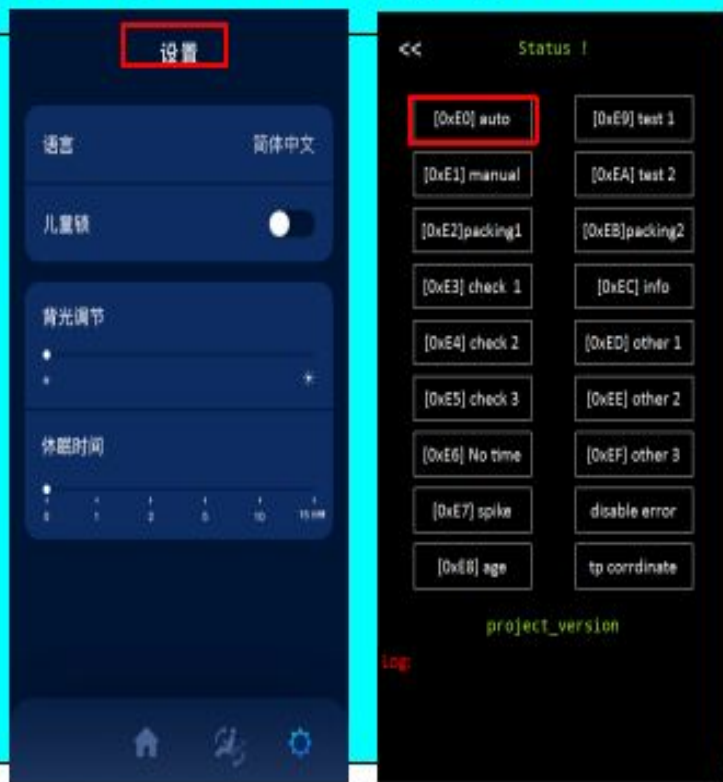
开启/关闭：长按设置4秒，进入密码界，输入0592，进入工程模式界面
