**ROTAI S80 Massage Chair
Maintenance Manual**

Shanghai Rongtai Health Technology Co., Ltd.

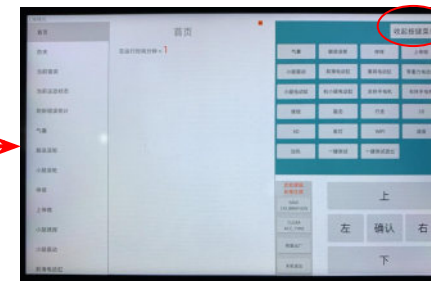
Click on Current Errors; machine faults will display, 0 indicates normal function, 1 indicates a fault

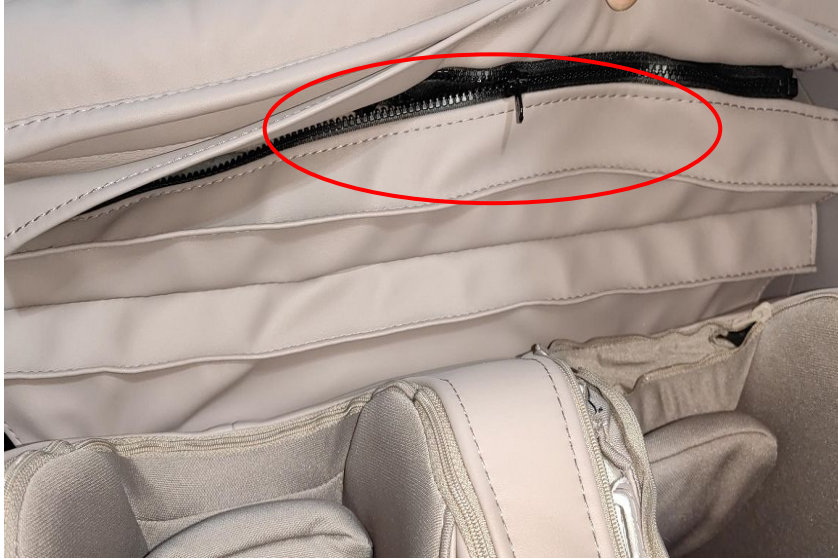
Pull open the marked red zipper as in Fig. 1

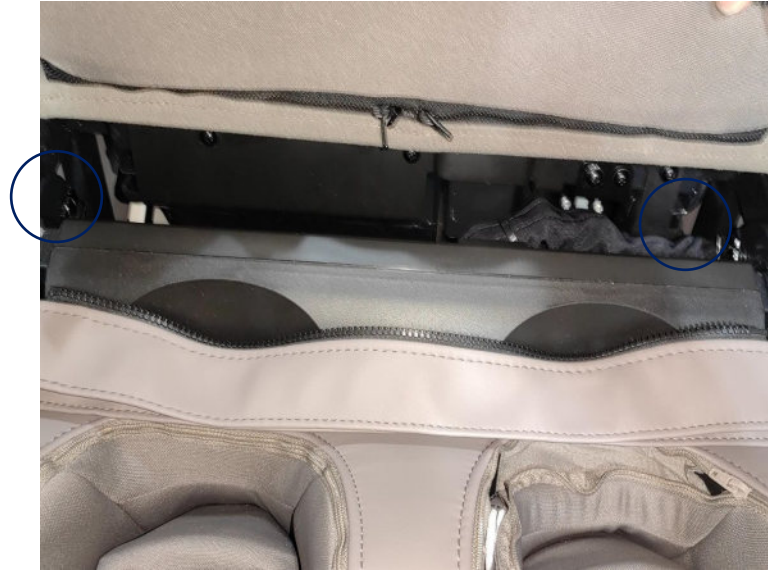
Remove the marked blue buckle as in Fig. 2

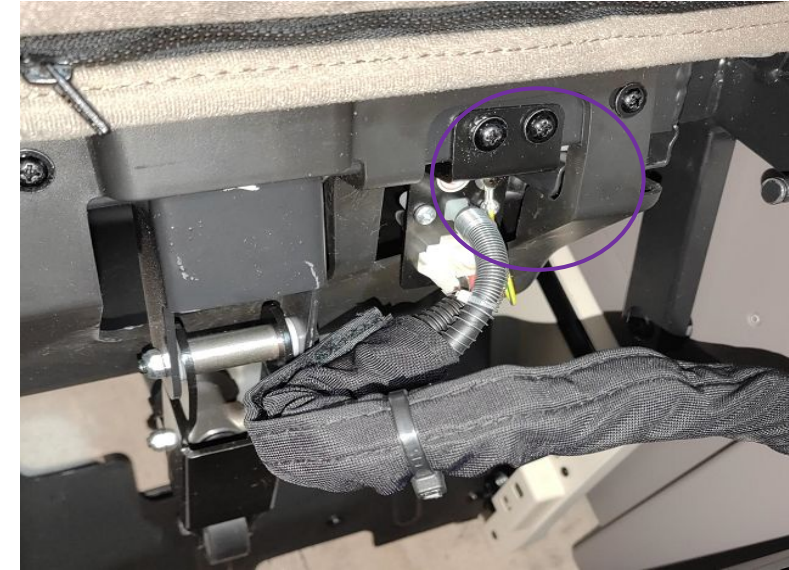
Unplug the marked purple component and air hose as in Fig. 3

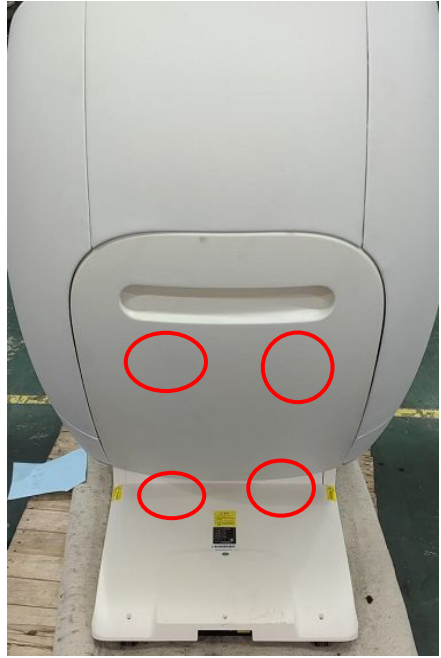
Remove the rear cover's marked red 4 screws, and take off the rear cover as in Fig. 1

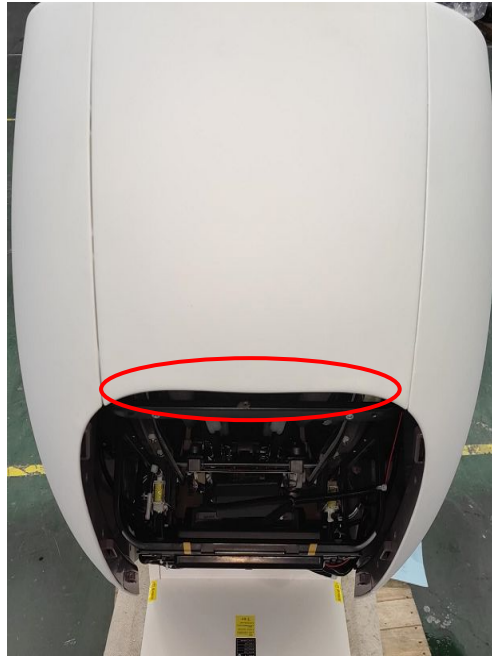
Pry open the upper cover from under the red marked buckle as in Fig. 2

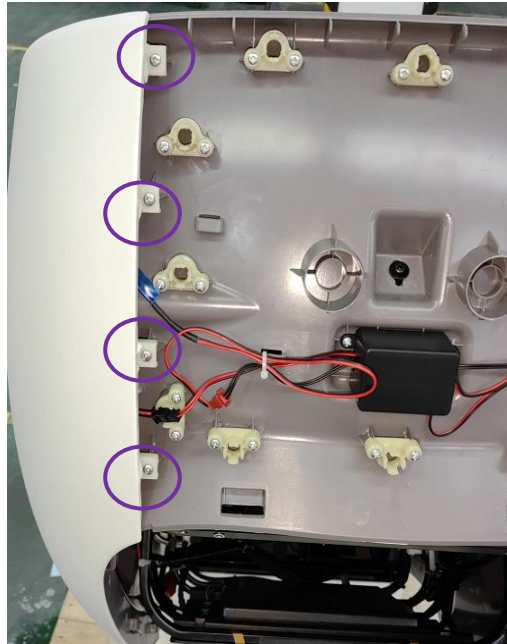
Remove the upper inner cover's marked purple 4 screws as in Fig. 3

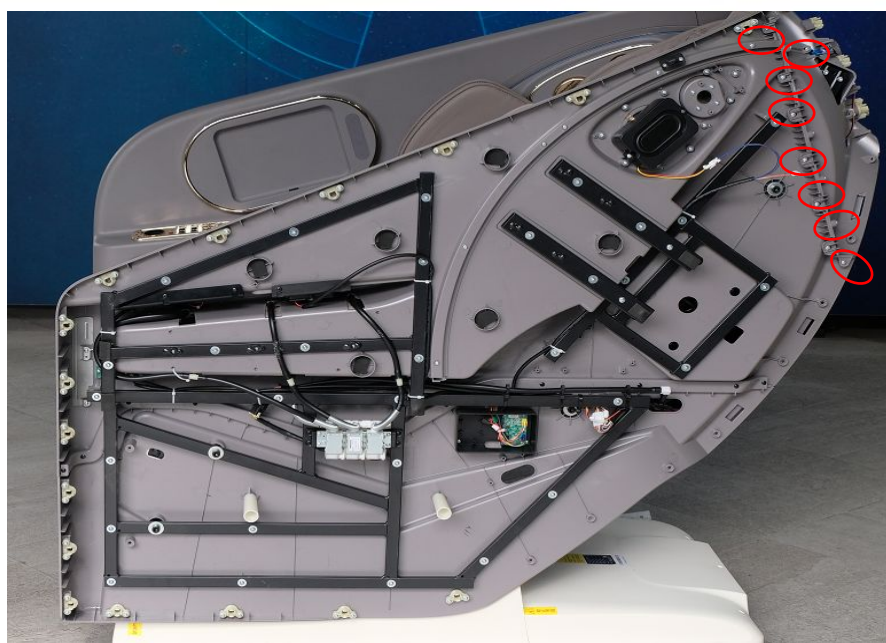
Fig. 1

Remove 14 screws each marked red on the left and right sides, and one in the middle; cut the blue tie, unplug the connector, remove the purple marked screw to remove the upper inner cover

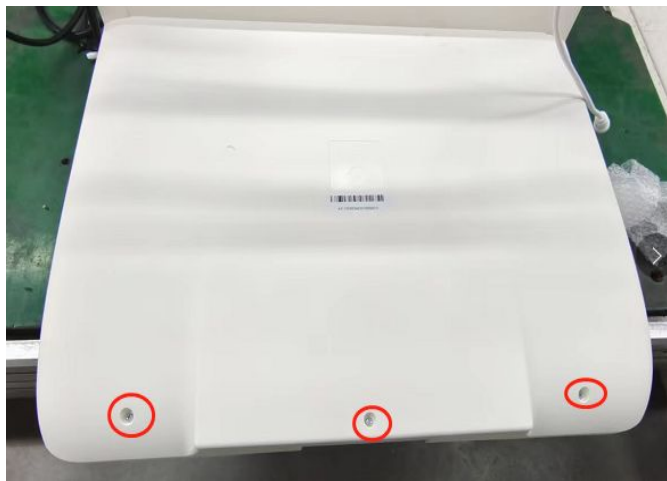
Remove the red marked three screws on top of the rear footrest cover as in Fig. 1

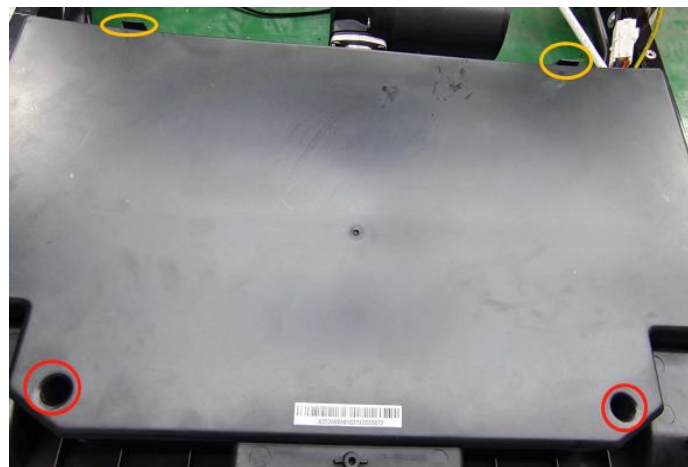
Remove the red marked two screws on top of the power box; slightly push forward the red marked buckle on the power box cover, then remove the cover as in Fig. 2

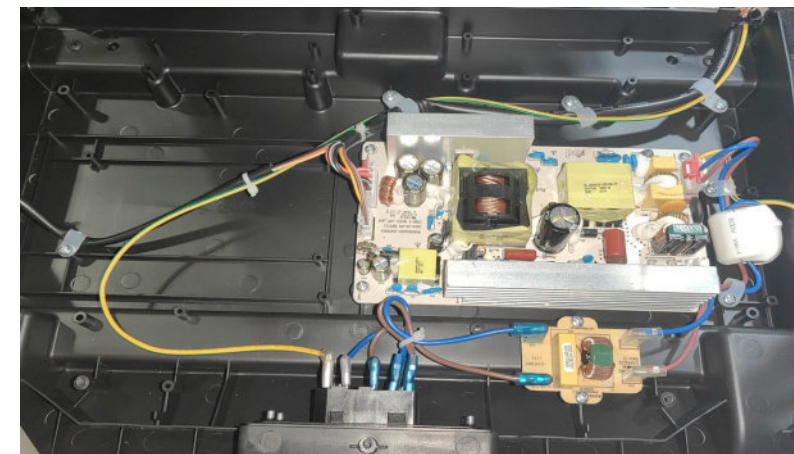
Inside the power box are switch components, power board, filter board as in Fig. 3

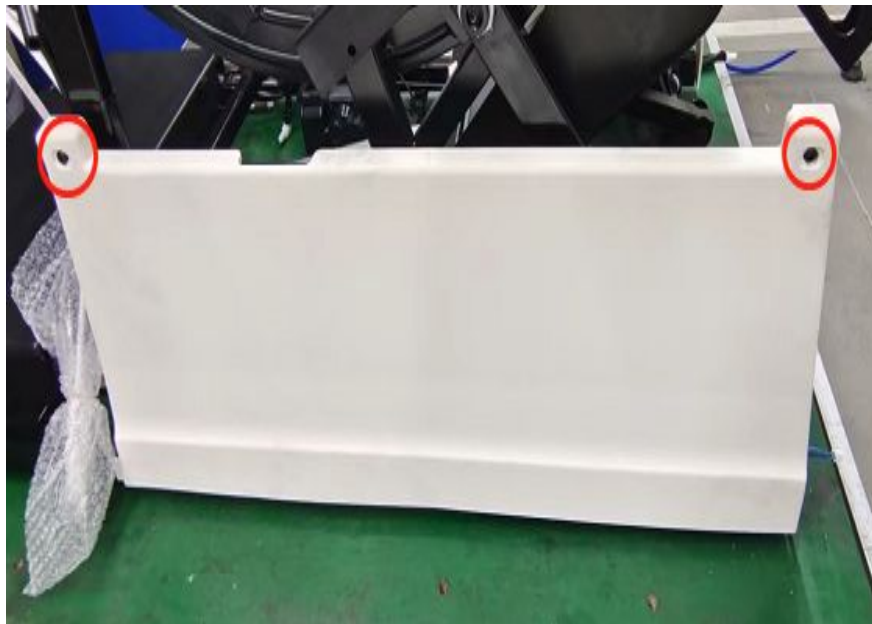
Remove the two screws outside of the footrest cover as in Fig. 1

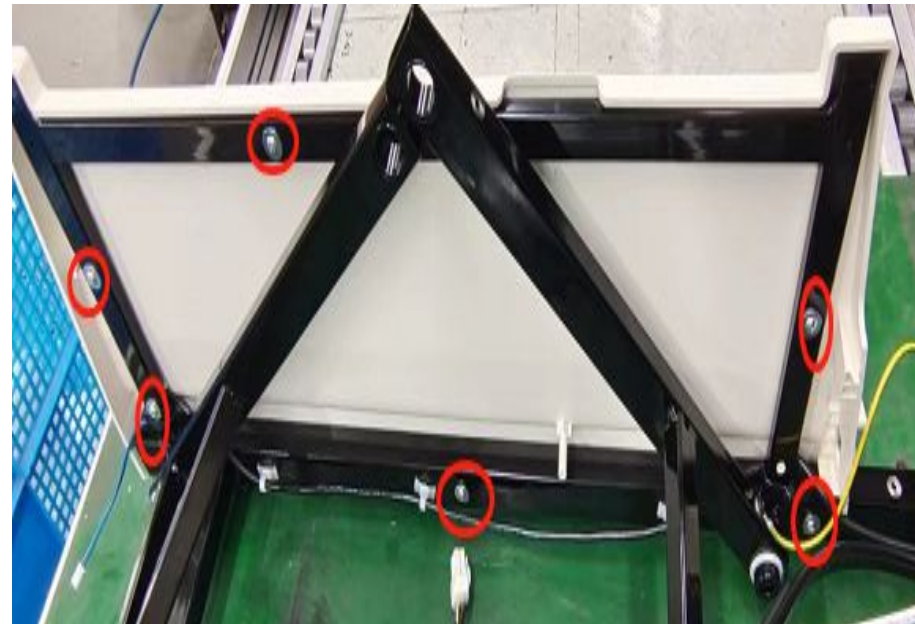
Remove the six inner screws of the footrest cover; then, remove the footrest cover as in Fig. 2

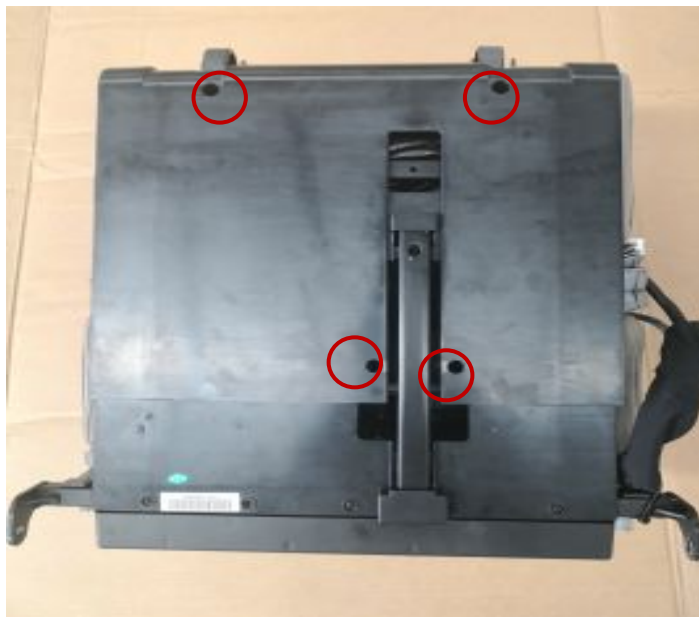
First, remove the upper cover's marked red 4 fixed screws as in Fig. 1

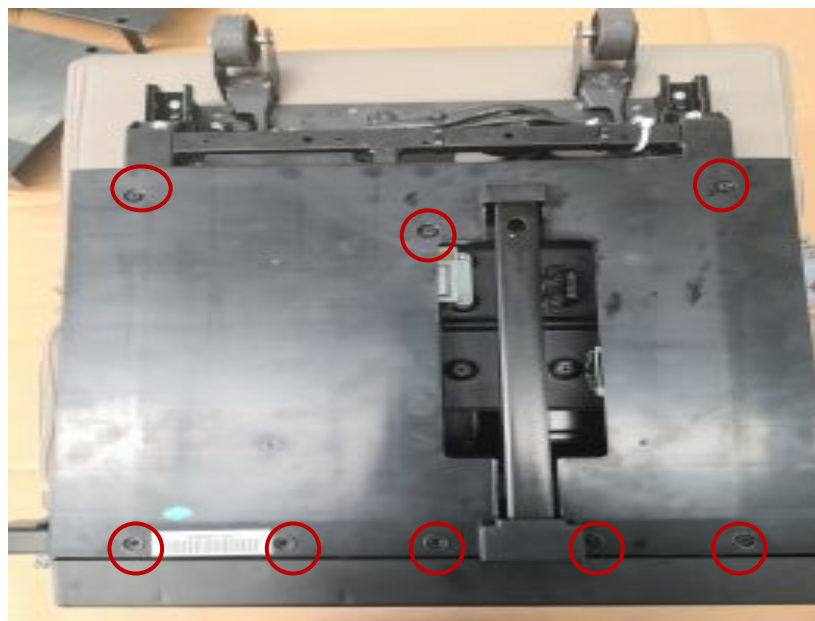
Remove the lower cover's marked red 8 fixed screws as in Fig. 2

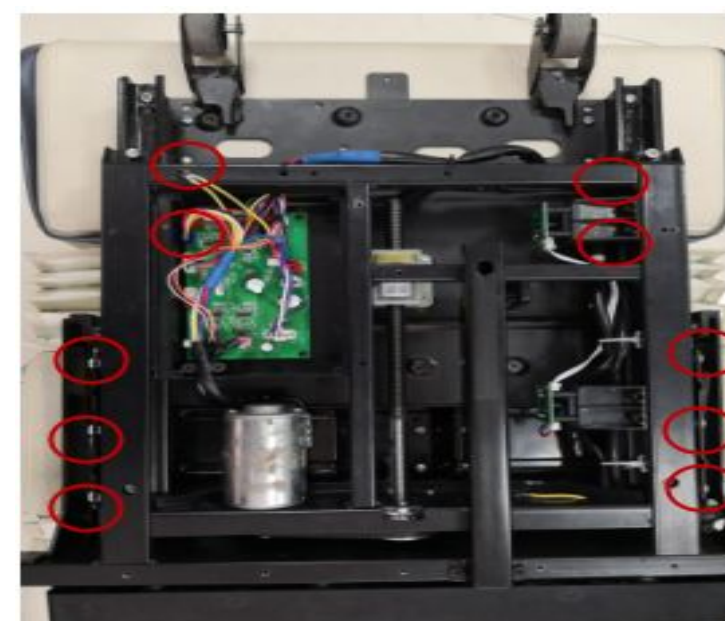
First, remove 6 screws fixing the legrest extension unit, turn the extension belt, and remove the 4 fixed screws of the lower legrest as in Fig. 3

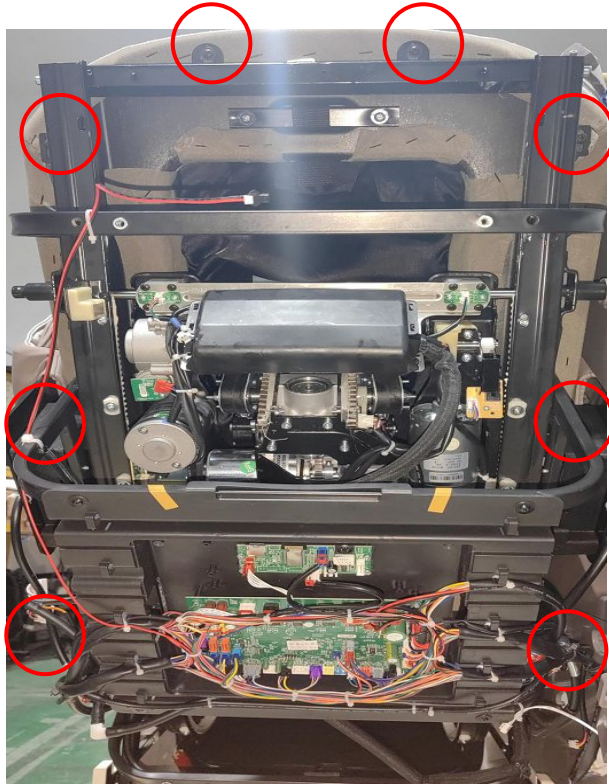
Fig. 1

Remove the 8 red-marked screws at the back of the backrest as shown in Fig. 1.

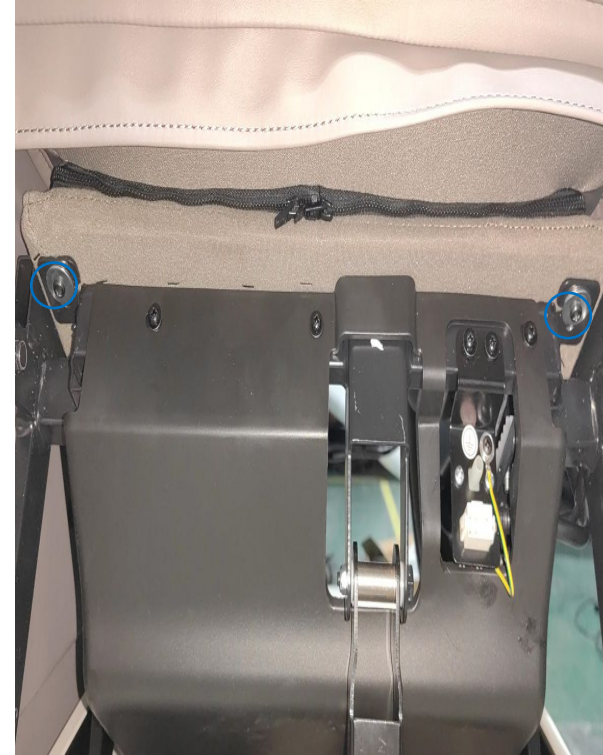
Fig. 2

Remove the 2 blue-marked screws at the front end of the backrest as shown in Fig. 2.

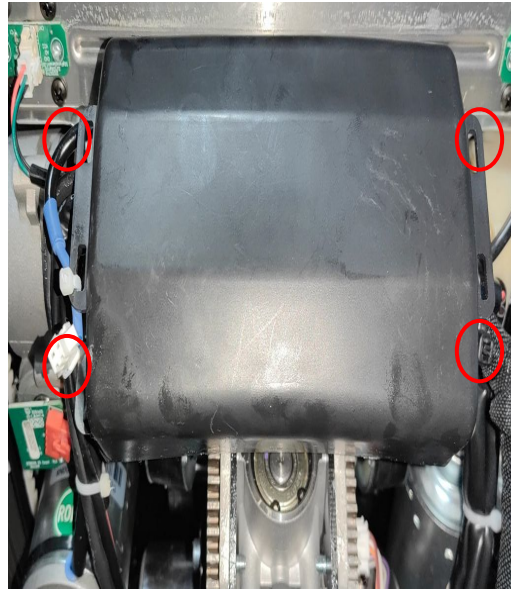
Fig. 3

Remove the 4 red-marked screws on the mechanism cover as shown in Fig. 3.

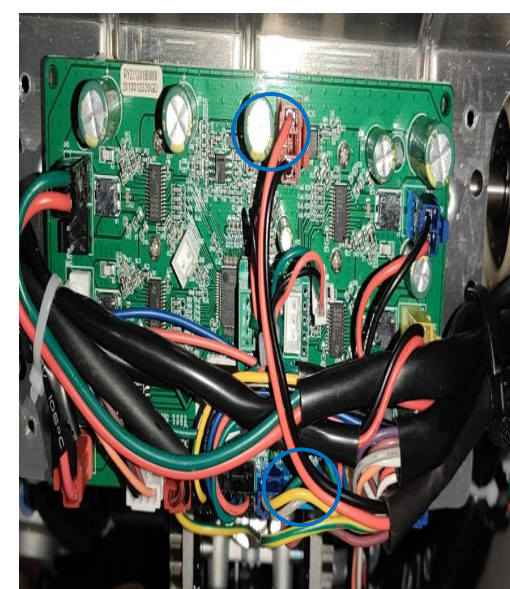
Fig. 5

Cut the zip ties, unplug the blue-marked connector, and remove the mechanism as shown in Fig. 5.

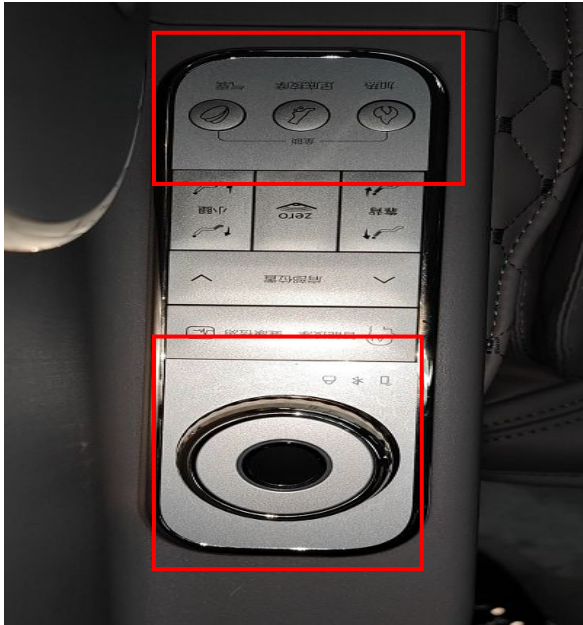
Fig. 1

Peel off the two red-marked stickers as shown in Fig. 1.

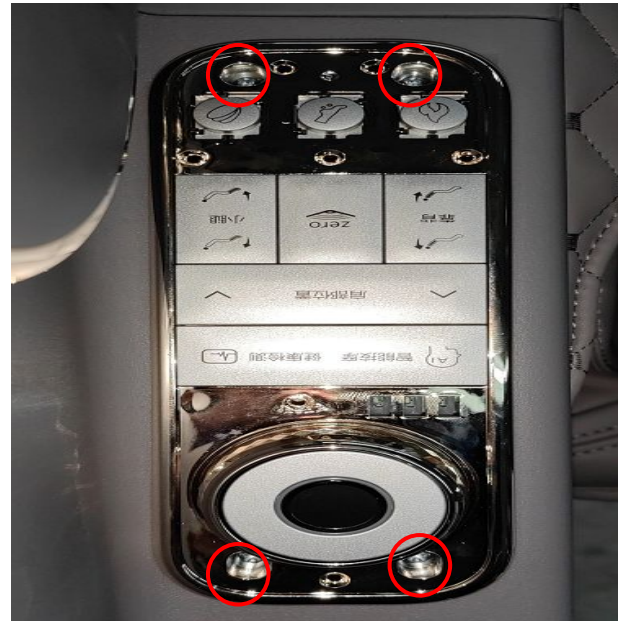
Fig. 2

Remove the 4 red-marked screws as shown in Fig. 2.

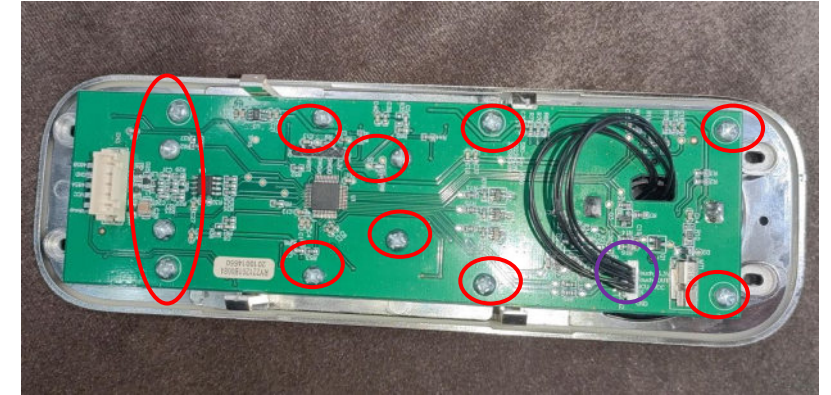
Fig. 3

Remove the 12 red-marked screws, unplug the purple-marked connector as shown in Fig. 3.

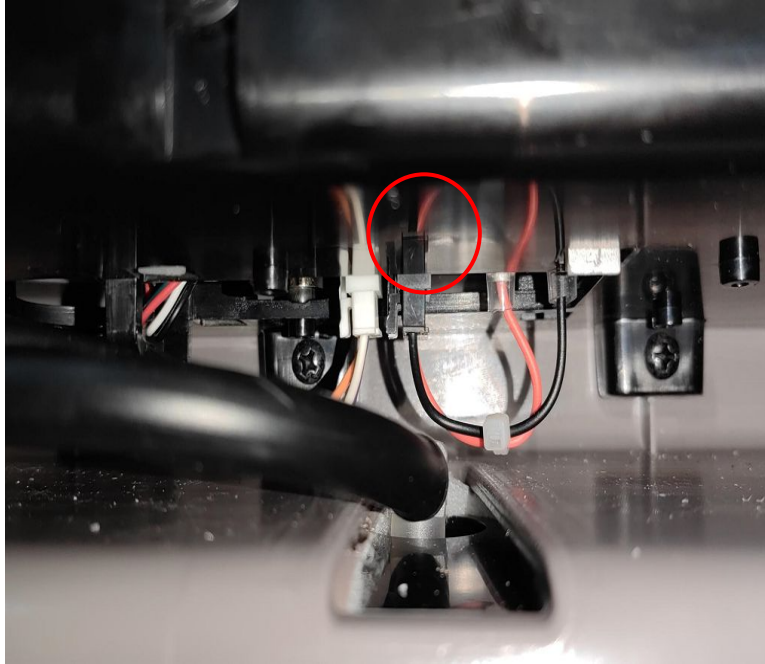
Fig. 1

In the state of the armrest outer cover removed, use a tool to push up the red-marked buckle as shown in Fig. 1.

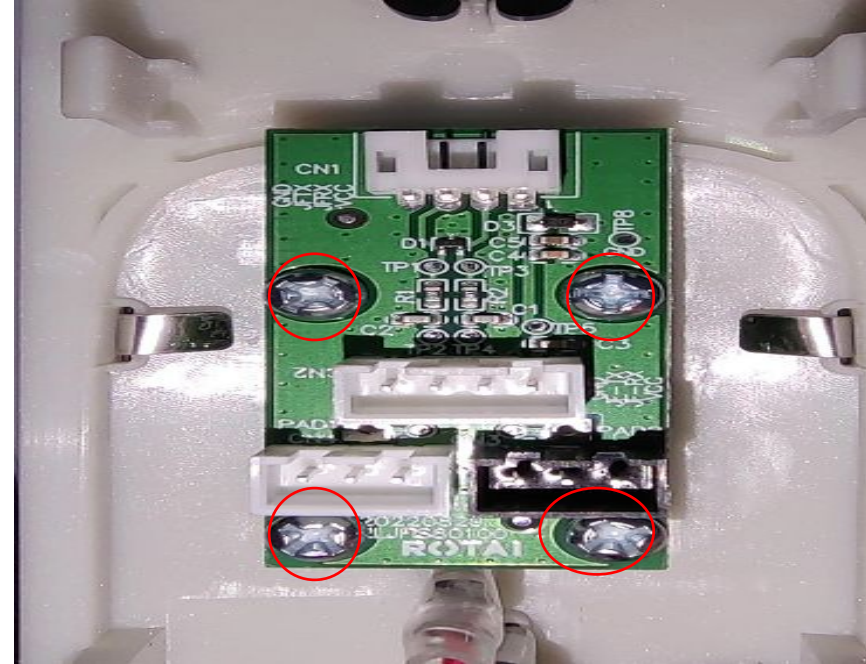
Fig. 2

Remove the 4 red-marked screws and unplug the connector as shown in Fig. 2.

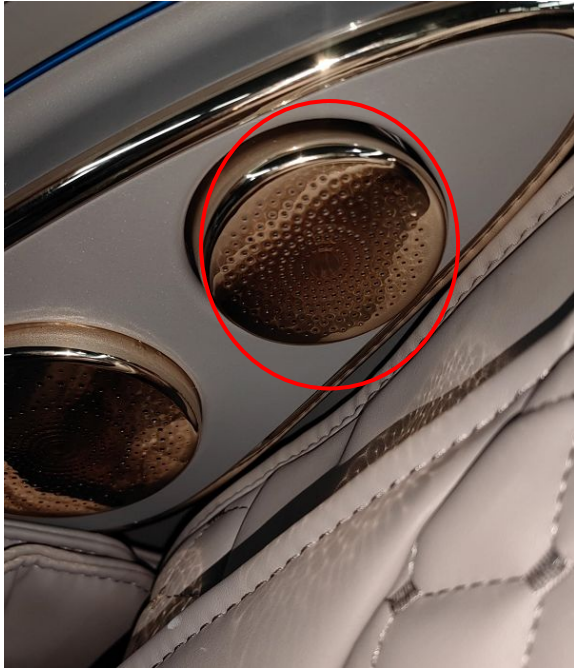
Fig. 1

Remove the aroma container from the red-marked right speaker position as shown in Fig. 1.

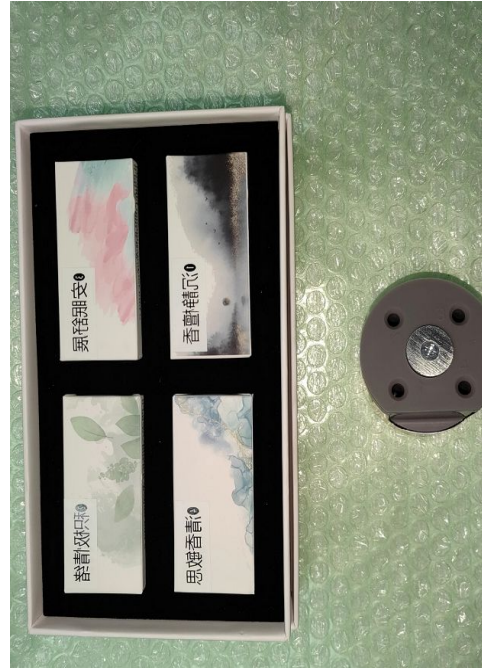
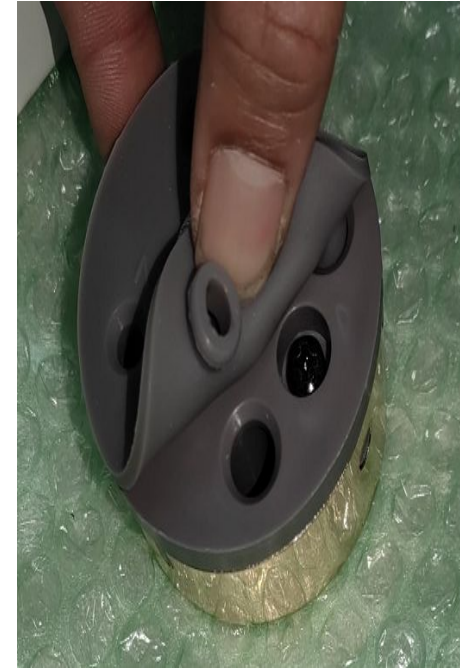
Take out the aroma, find the corresponding number, and open the rubber pad to place it inside as shown in Fig. 2 and Fig. 3.

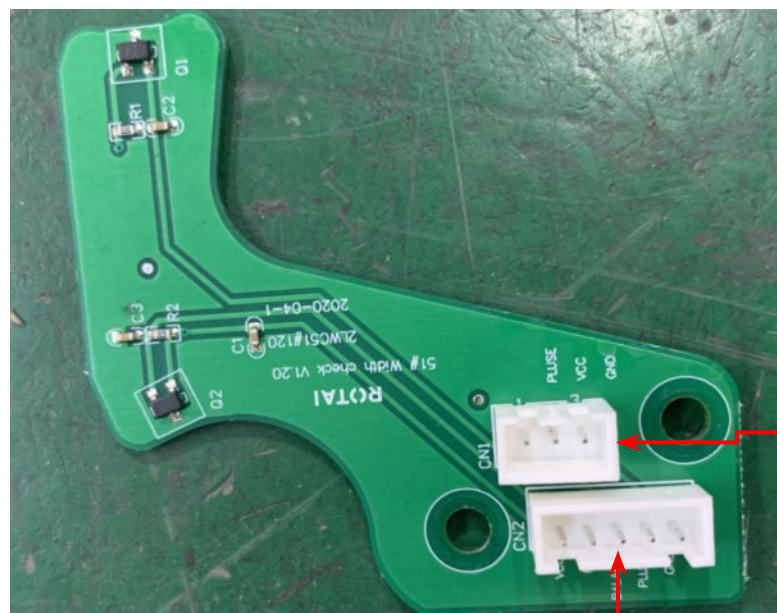
Width sensor board

walking motor counter signal connector

mechanism width sensor board

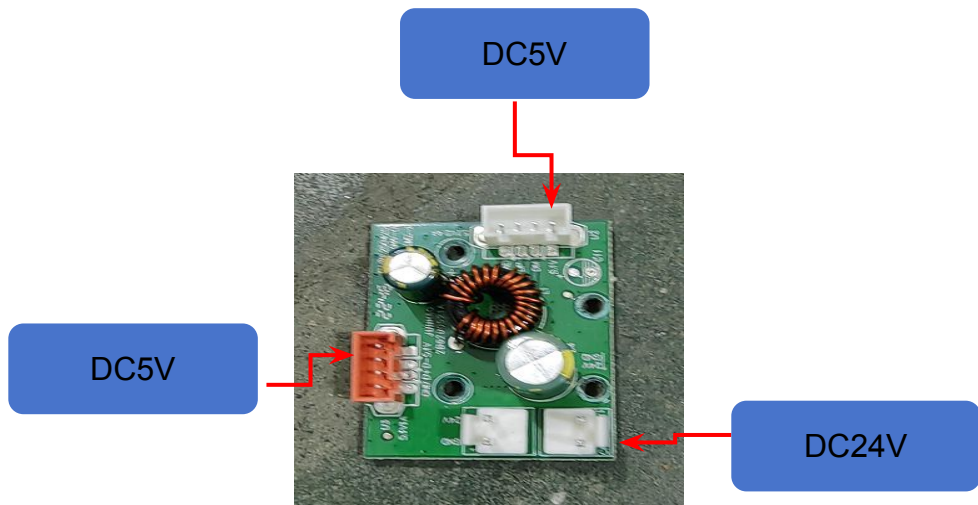
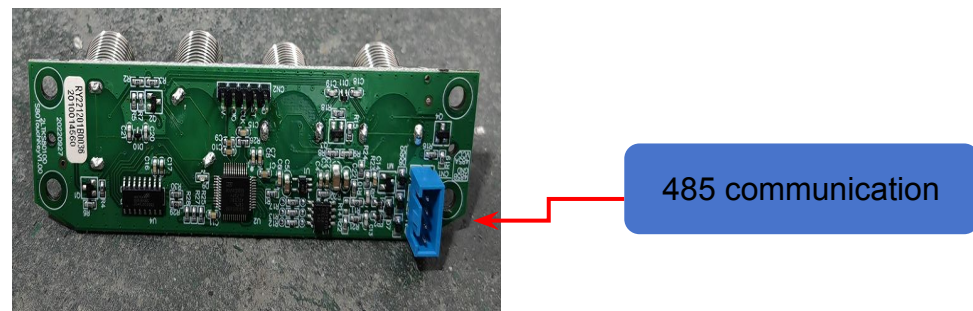
S80 3D counter board, push rod sensor board, button pad, charging board

DC5V

DC24V

charging board

485 communication

button pad

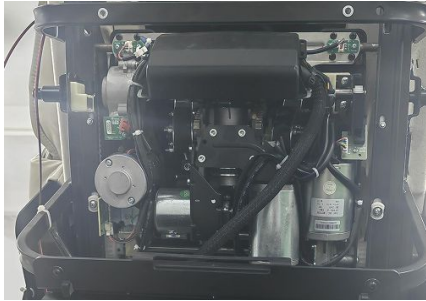
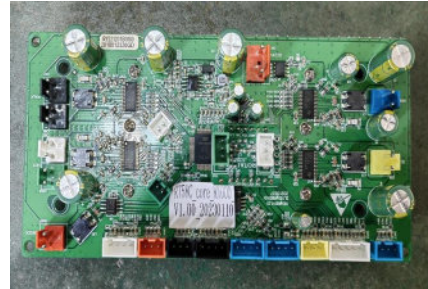
3. Kneading motor not working

Kneading motor malfunctions

Mainboard malfunctions

Loose/broken connection cable

1. Use controller to power on the chair, select MANUAL mode -SYNC Massage. Connect kneading motor to tapping motor connector port on the mechanism mainboard, and check if the kneading motor works. If not, replace the kneading motor.

2. If it works, the mainboard is faulty. Replace the mechanism mainboard.

3. Use a multimeter to check if the cable harness has poor contact or is broken. Replace the cable harness.

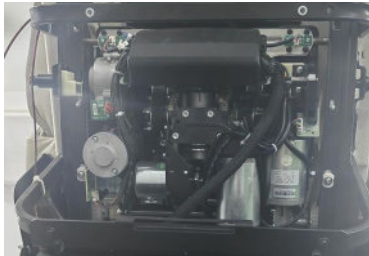
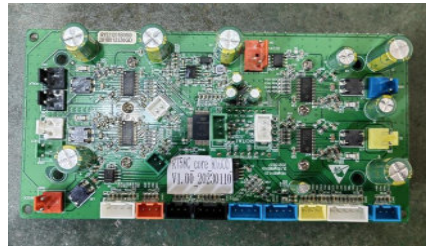
4.S80 Tapping motor not working

Knocking motor malfunctions

Mainboard malfunctions

Loose/broken connection cable

1. Use controller to power on the chair, select MANUAL mode -SYNC Massage. Connect tapping motor to kneading motor connector port on the mechanism mainboard, and check if the knocking motor works. If not, replace the knocking motor.

2. If it works, the mechanism mainboard is faulty. Replace the mechanism mainboard.

3. Use a multimeter to check if the cable harness has poor contact or is broken. Replace the cable harness.

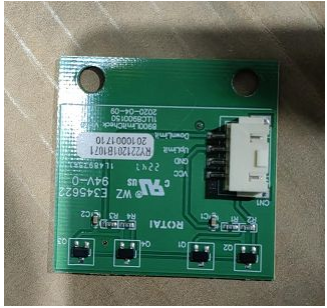
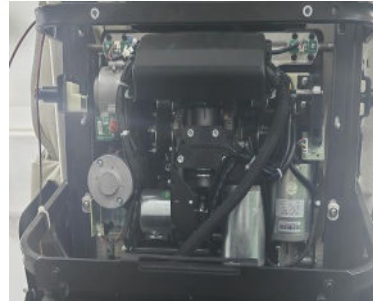
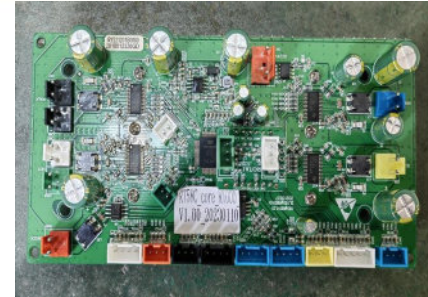
5. S80 Walking motor not working

Distance limit sensor board is damaged

Walking motor malfunctions

Mainboard malfunctions

Loose/broken connection cable

1. Switch on the controller and power on the chair, select MANUAL mode-SYNC message, then choose POINT message, press the "UP" or "DOWN" button to check if it double beeps. If there are fast beeping sounds, distance limit detection board is damaged and replace with a new one if needed.

2. If both have slow single beeping sound, the limit sensor signal is good, then unplug mechanism walking motor connector (black color) and plug it into tapping motor connector socket (red color) to check if walking motor works. If no, the motor is damaged and needs to be replaced.

3. Plug the motor back to its original position, exchange walking motor connector and kneading motor connector to check if the walking motor functions. If motor moves then replace the mainboard, if motor fails to move, the motor cable is loose or broken, replace with a new cable.

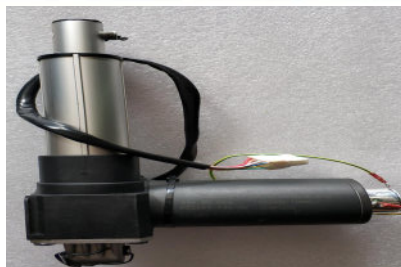
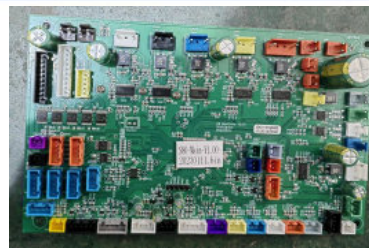
8.S80 Legrest actuator not working

Actuator
malfunctions

Loose/broken
connection
cable

Mainboard
malfunctions

Power on, press the leg rest up/down button, and use a multimeter to check if the actuator has resistance. If there is no resistance, actuator is faulty and needs to be replaced.

Use a multimeter to check if the cable harness has poor contact or is broken. Replace the cable harness.

If the cable is good, replace the mainboard

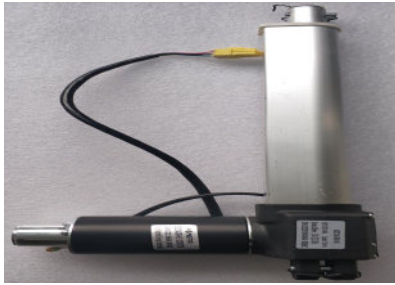
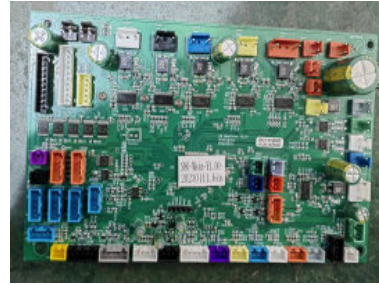
9.S80 Backrest actuator not working

Actuator malfunctions

Loose/broken connection cable

Mainboard malfunctions

Power on, press the backrest up/down button, and use a multimeter to check if the actuator has resistance. If there is no resistance, actuator is faulty and needs to be replaced.

Use a multimeter to check if the cable harness has poor contact or is broken. Replace the cable harness.

If the cable is good, replace the mainboard

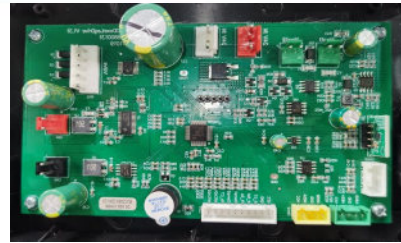
10.S80 lower legrest extension motor not working

Legrest extension
limit sensor board
malfunctions

Lower legrest
mainboard
malfunctions

Extension motor
malfunctions

Loose/broken
connection
cable

1. Adjust the lower legrest extension using the hand controller, listen to the sound. If the legrest stops in the reset position and there is a fast sound, it indicates an issue with limit sensor, and needs to replace the limit sensor board or checking if the limit detection board connection wire is open. If there is a slow sound, it suggests a motor or legrest mainboard issue with no motor working voltage output.

2. Switch on the leg extension function, use the multimeter to test legrest mainboard for DC24V voltage output, if there is no voltage output, replace the mainboard.

3. If there is, then replace the extension motor.

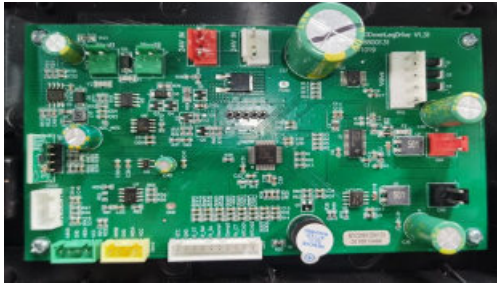
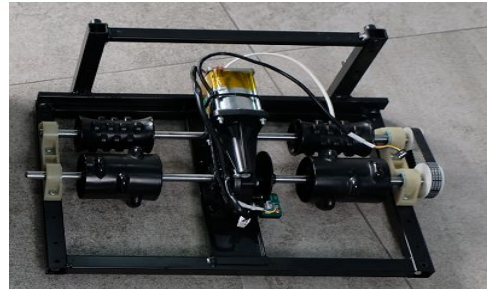
12.S80 Foot roller motor does not work

Legrest mainboard malfunctions

Roller motor malfunctions

Loose/broken connection cable

1. Switch on the foot roller function, use the multimeter to test the connector plug of legrest mainboard for DC24V voltage output, if no, replace the legrest mainboard.

2. If yes, replace the roller motor.

3. Use a multimeter to check if the cable harness has poor contact or is broken. Replace the cable harness.

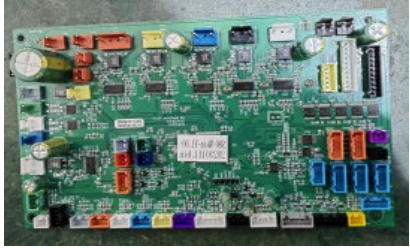
16.S80 Health detection no results

Mainboard

transfer board

Armrest Health Detection Module

Loose/broken connection cable

1. Check if there is a DC5V voltage output on the mainboard. If there is no voltage output, replace the mainboard.

2. Check if the 5V voltage on the transfer board is normal.

3. Check if there is a DC5V voltage output on the health detection board. If there is no voltage output, replace the health detection board.

4. Inspect the middle connecting cable for breaks or poor contact and replace the cable.

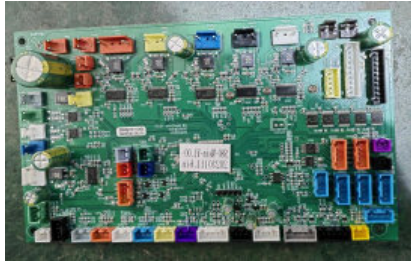
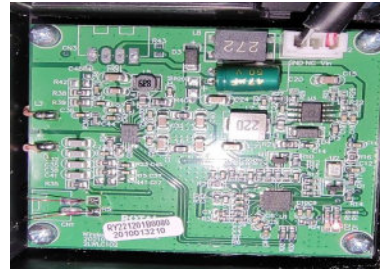
17.S80 Wireless charger not working

Mainboard

charging board

Loose/broken connection cable

Check if there is a DC24V voltage output on the mainboard. If there is no voltage output, replace the mainboard.

Check if there is a DC24V input on the charging board. If there is voltage input, replace the charging board.

Inspect the middle connecting cable for breaks or poor contact and replace the cable.

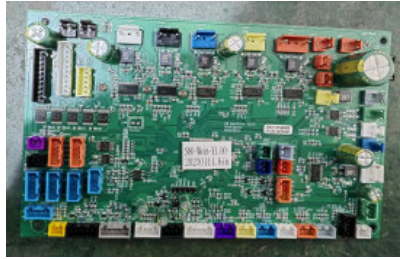
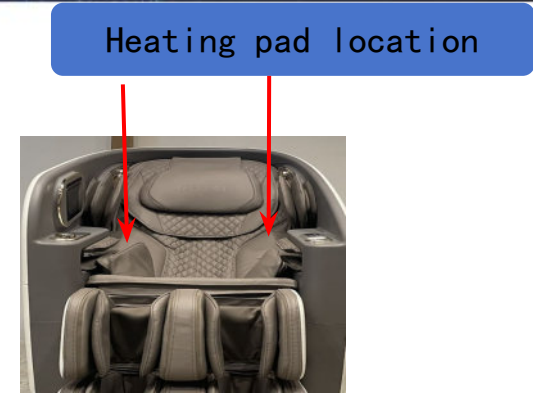
20. S80 Main chair heating not working

Mainboard

Loose/broken connection cable

Heating pad

Use a multimeter to measure if there is a DC24V output at the heating connector on the mainboard. If there is no output, replace the mainboard

Measure the cable. If the cable is faulty, replace the cable.

If the cable is good, replace the heating pad.

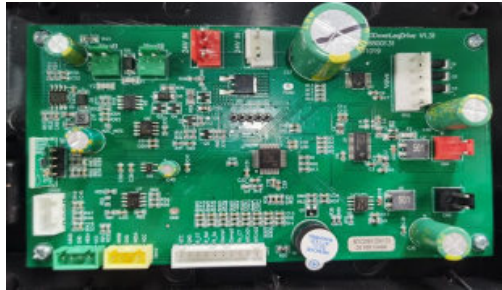
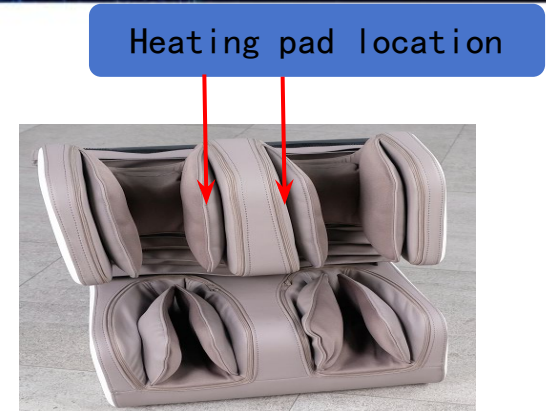
21.S80 Leg heating not working

Mainboard

Loose/broken
connection cable

Heating pad

Use a multimeter to measure if there is a DC24V output at the heating connector on the legrest board. If there is no output, replace the board

Measure the cable.
If the cable is faulty,
replace the cable.

If the cable is good,
replace the heating
pad.
