A503-2按摩椅售后维修指南

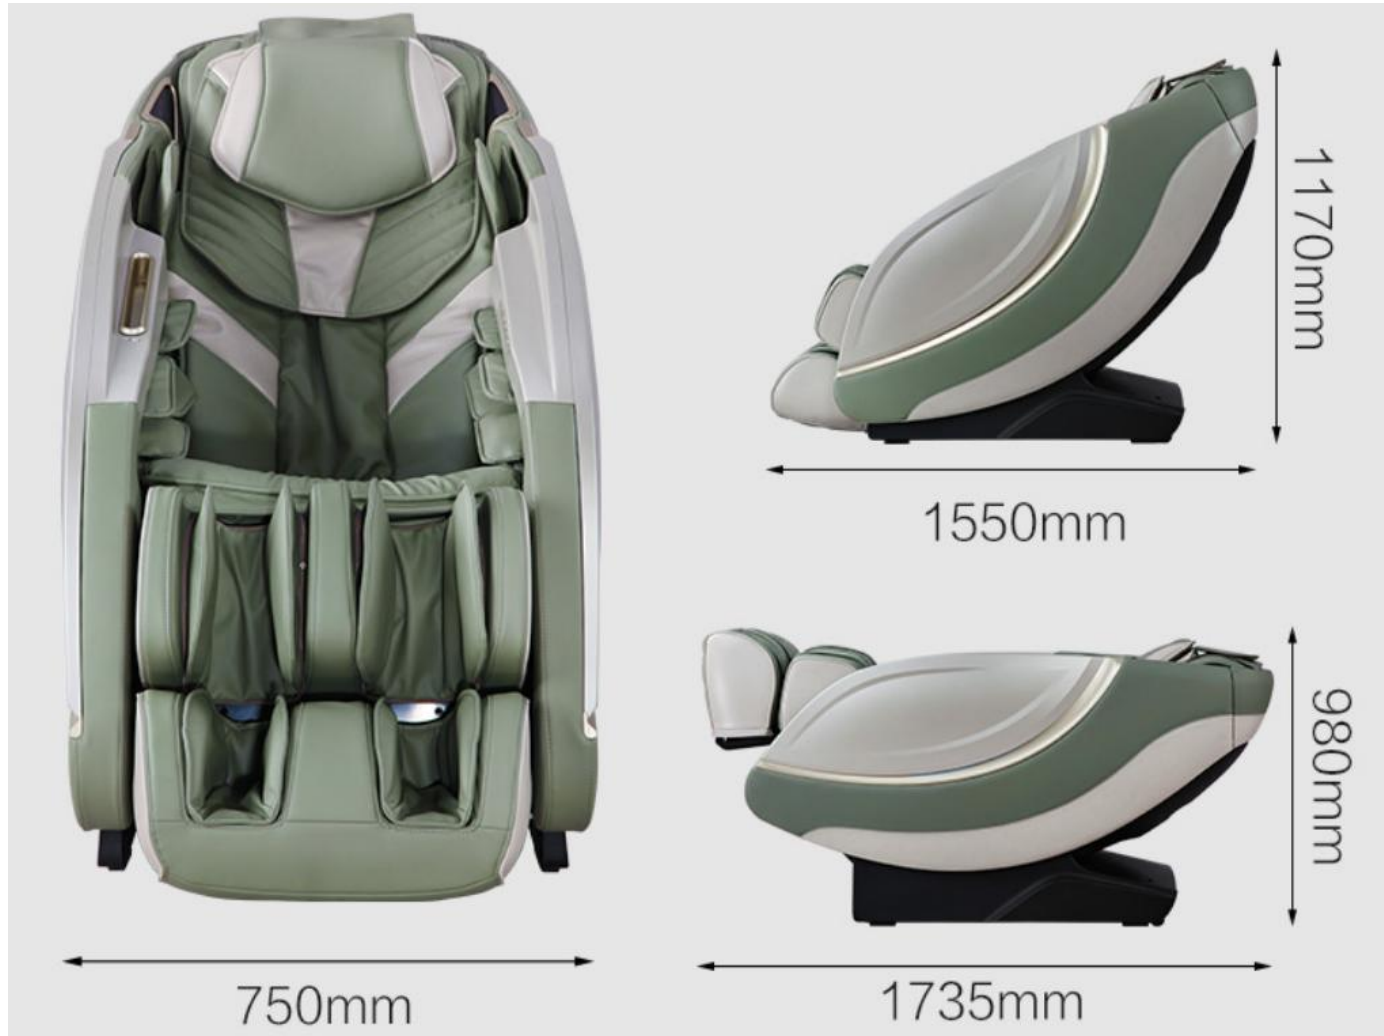
1、Chair size

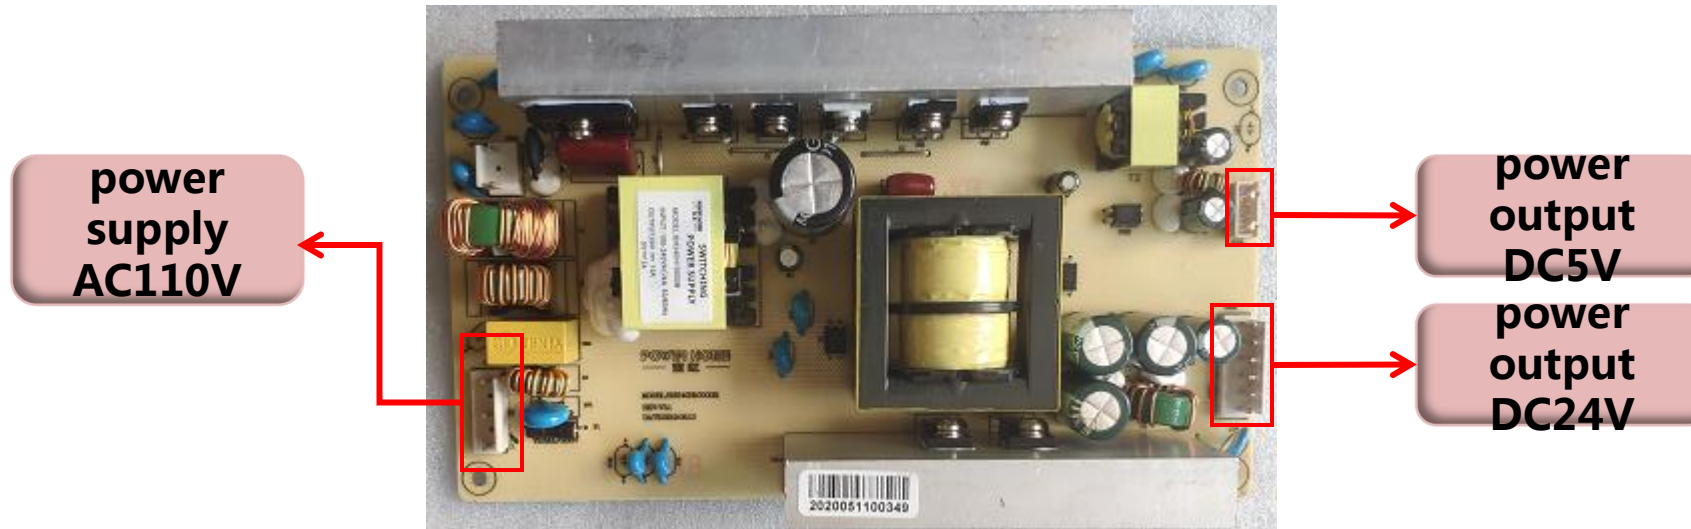
3.5 Switching Power Supply Distribution Diagram

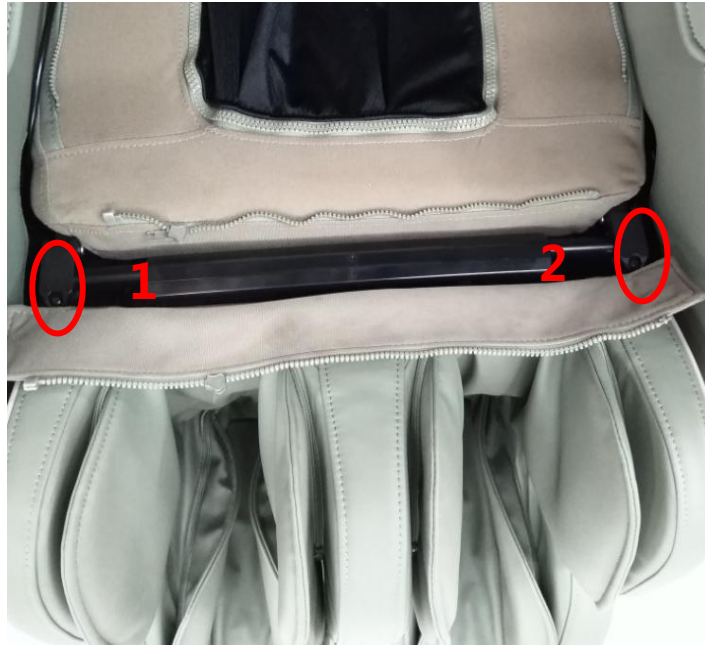
A、 Remove the screws 1 to 2 at the installation seat in Figure A

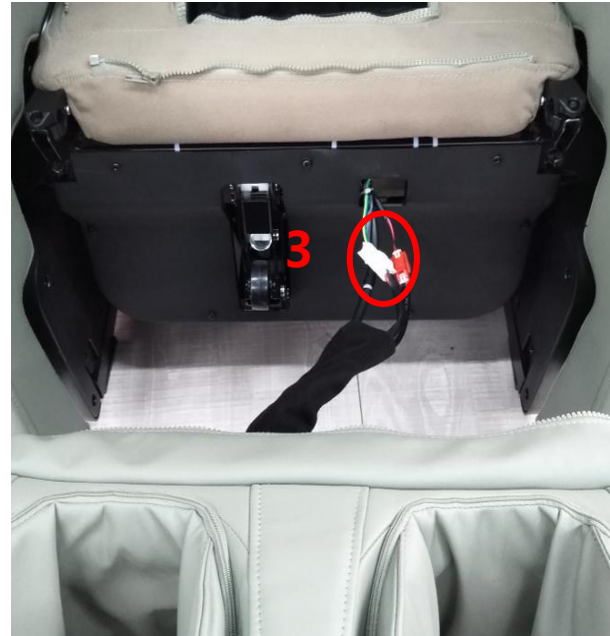
B、 Separate the air hose and plug at position 3 in Figure B

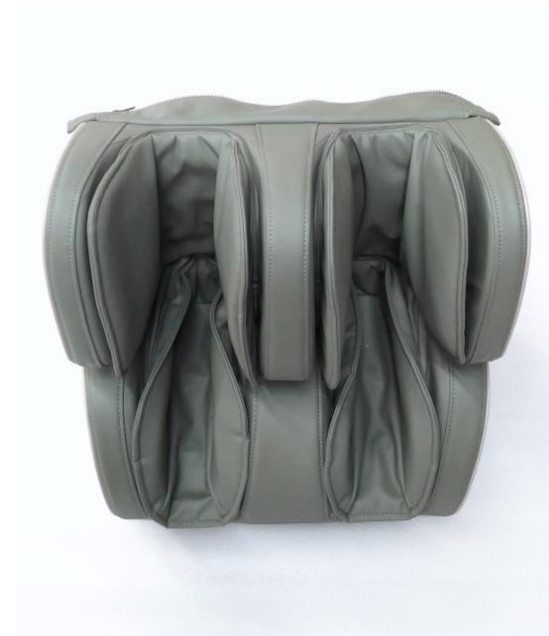
C

C、 Remove the footrest component.

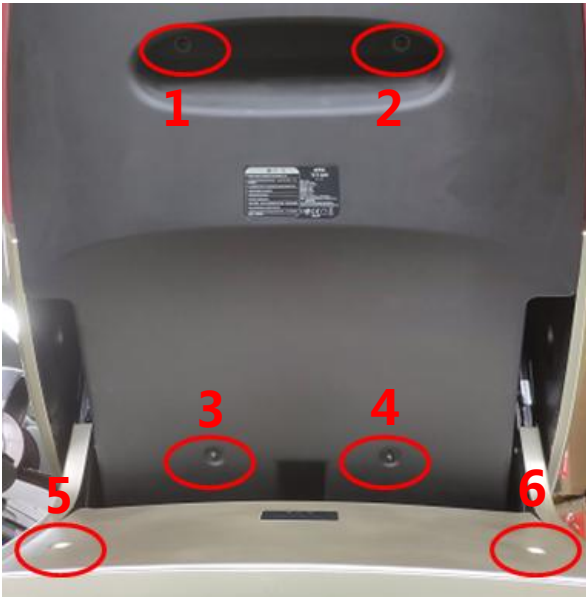
A

A、 Remove the screws in Figures A1 to 4 to take off the back cover

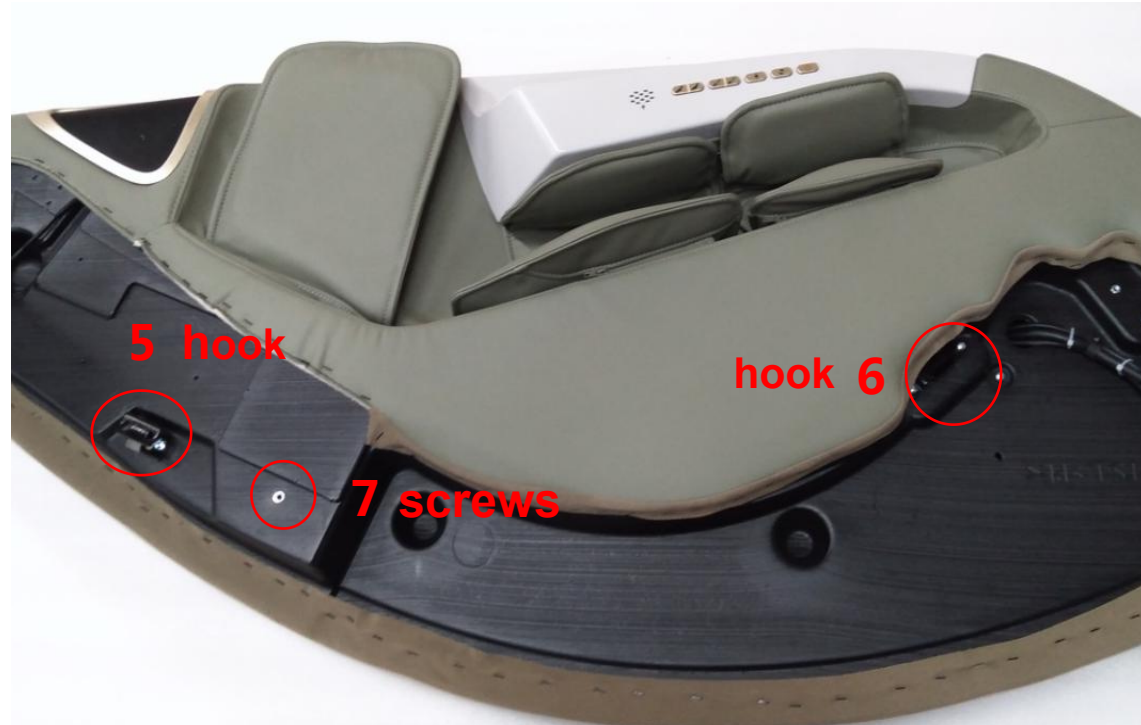
**B**

B、 As shown in Figure B, slightly lift the armrest upwards to remove the space capsule (it is recommended two people operate , one in front and the other behind).第13页 / 共48页

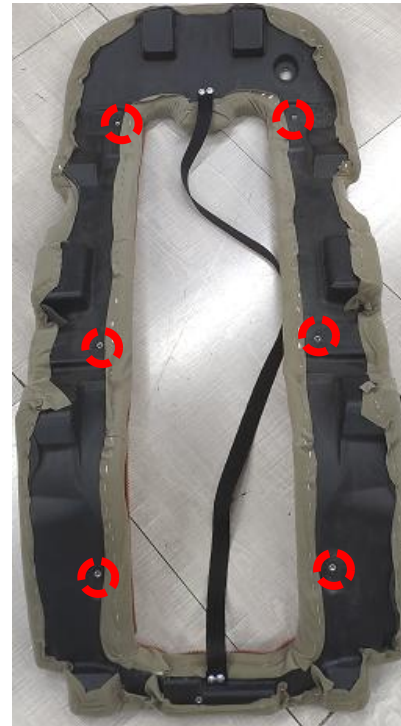
B、 Remove the yellow screw in Figure B

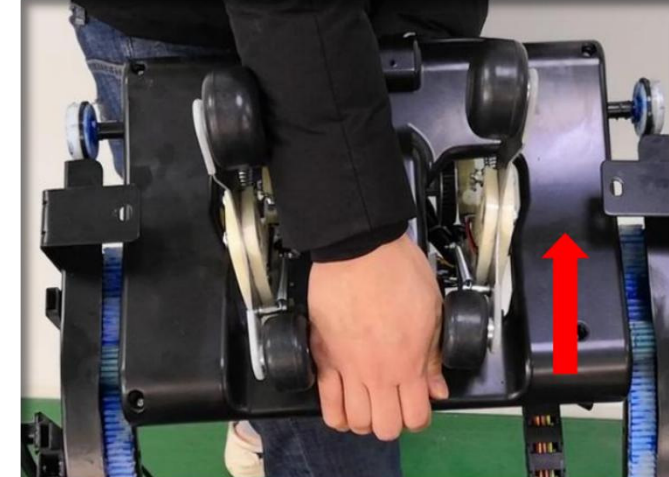
C、 Remove the massage hand and separate it from the machine (make sure the power off before you take out the massage hand).

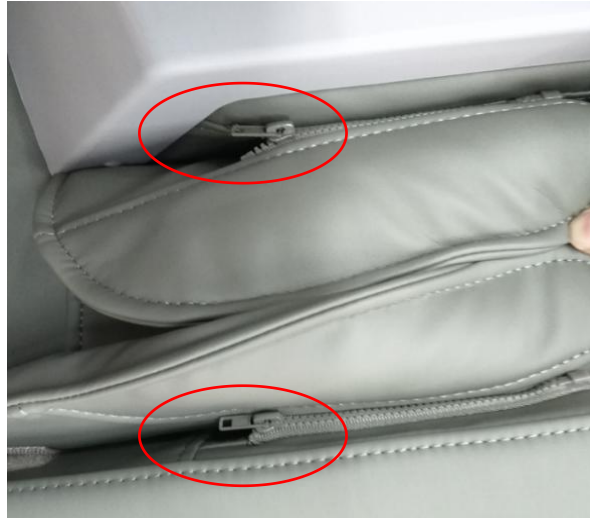
A Remove the zipper in Figure

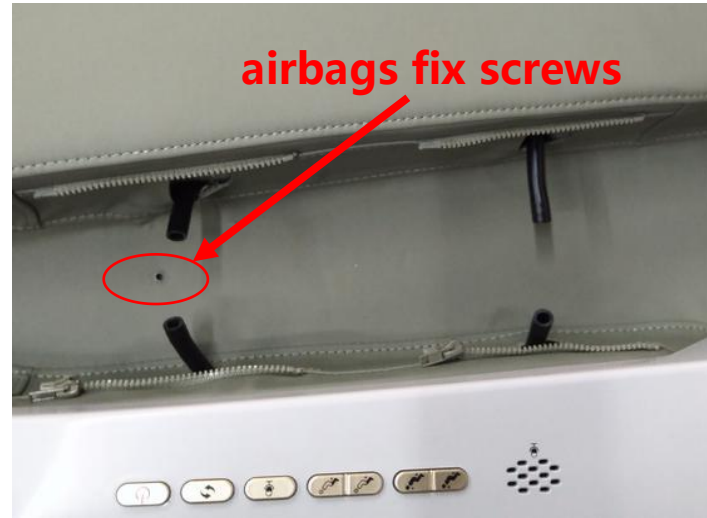
B Separate the four air pipes in Figure B

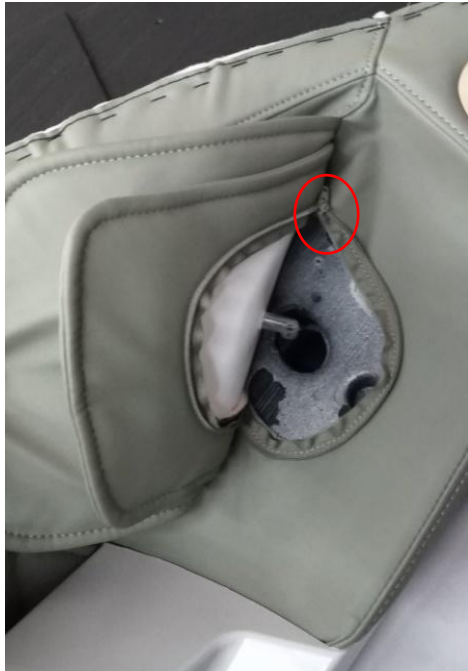
A Zip out

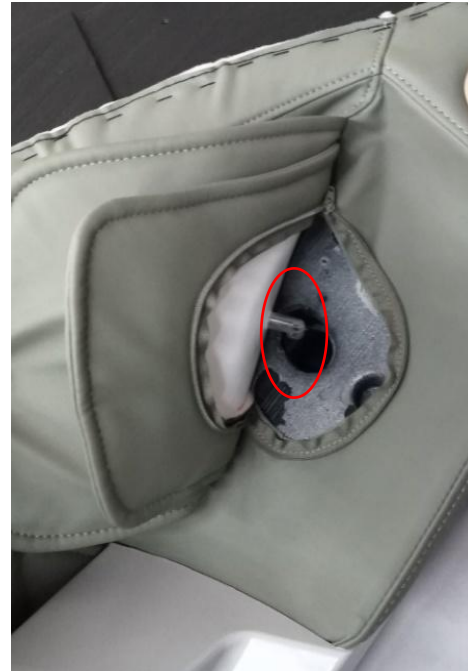
B Take out the air hose

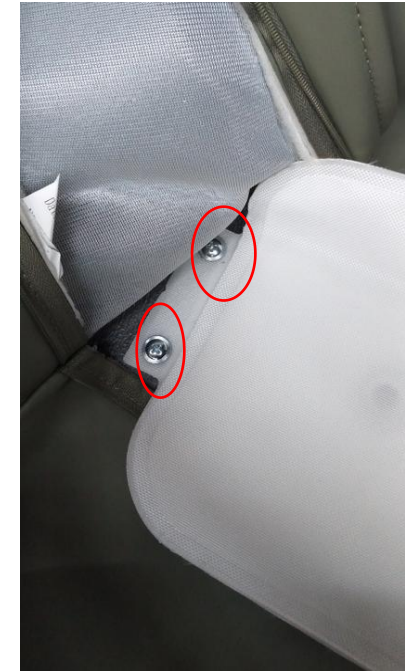
C Tke out the screws and remove the airbags

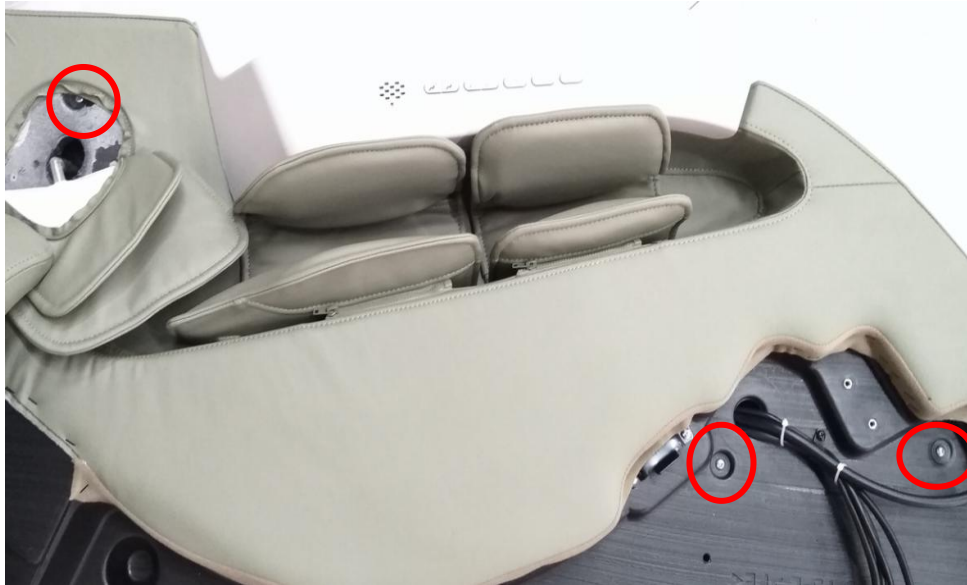
A Take out the 3 screws

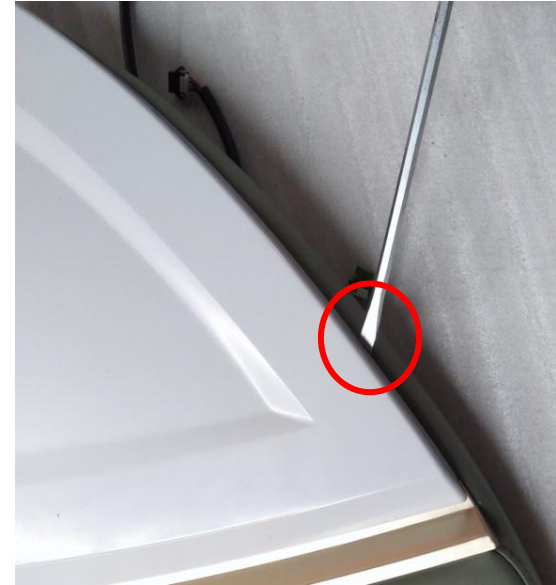
B Insert the flat-head screwdriver into the inner side of the outer cover edge, slightly lift it up, and then remove the outer cover

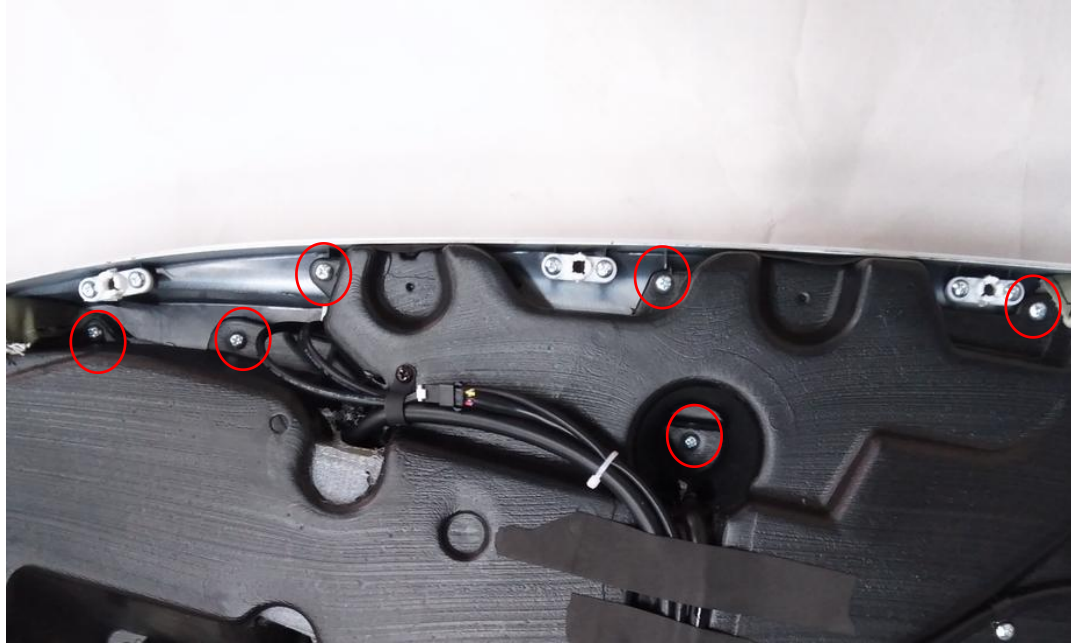
A

A、 Take out the 6 screws

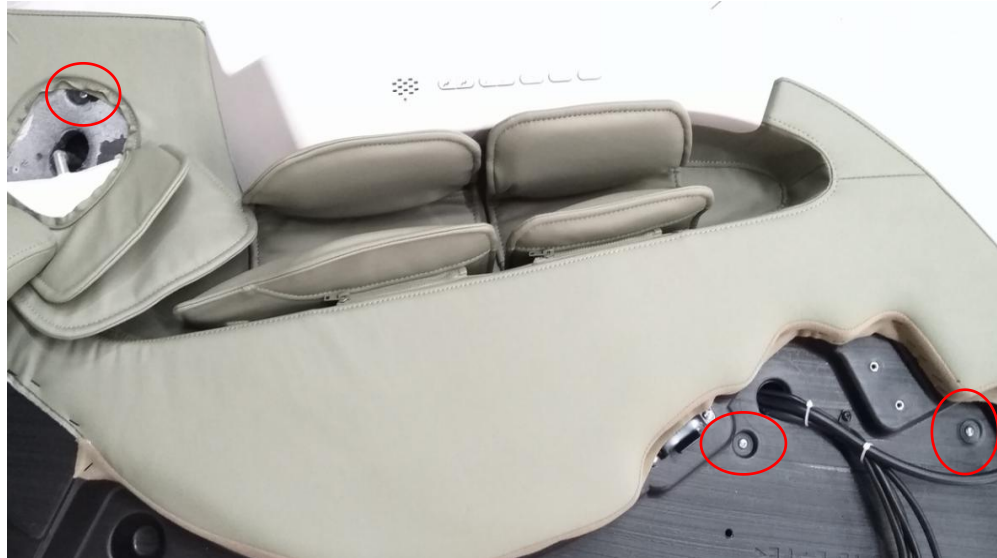
A Take out the 3 screws

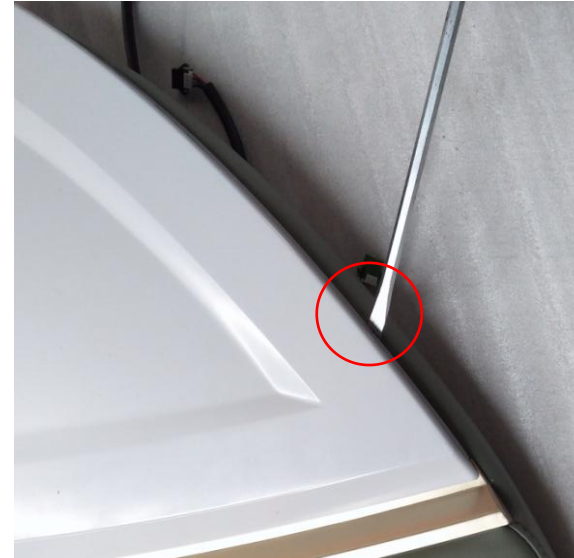
B Insert the flat-head screwdriver into the inner side of the outer cover edge, slightly lift it up, and then remove the outer cover

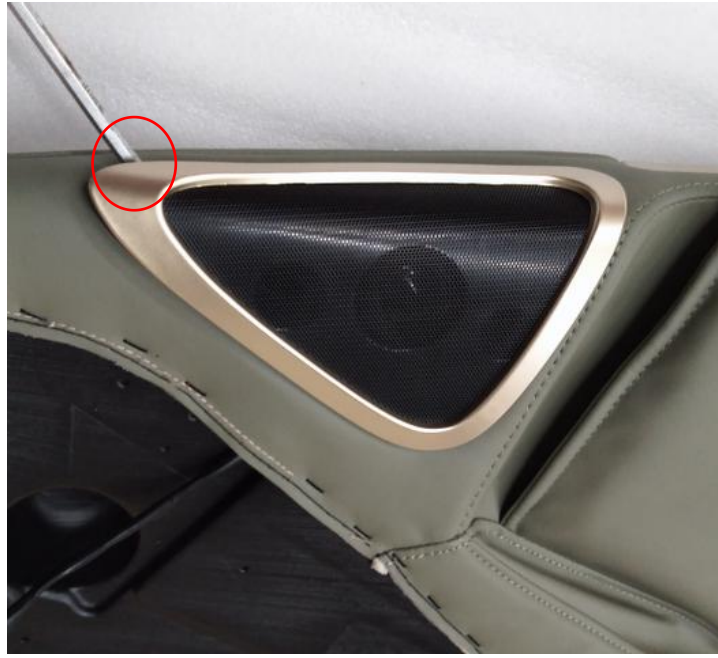
B

B. Insert the flat-head screwdriver into the inner side of the outer cover edge, slightly lift it up, and then remove the outer cover.

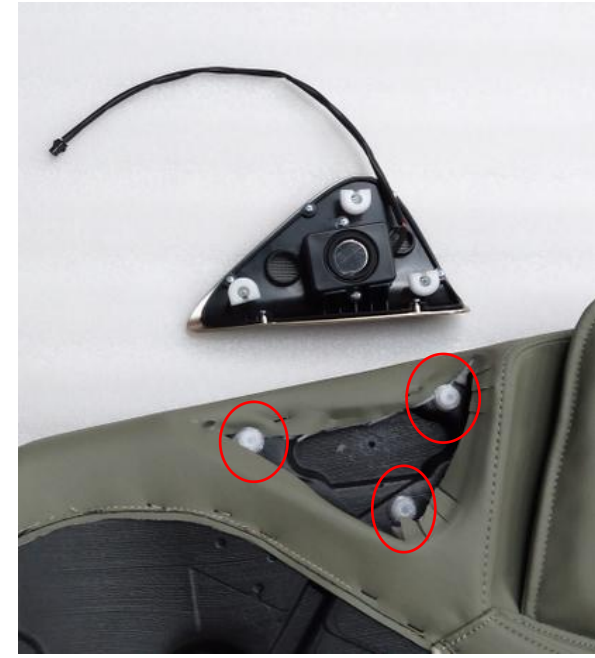
C

C. Remove the horn assembly (Note: If the car buckle is damaged, then replace a new one).

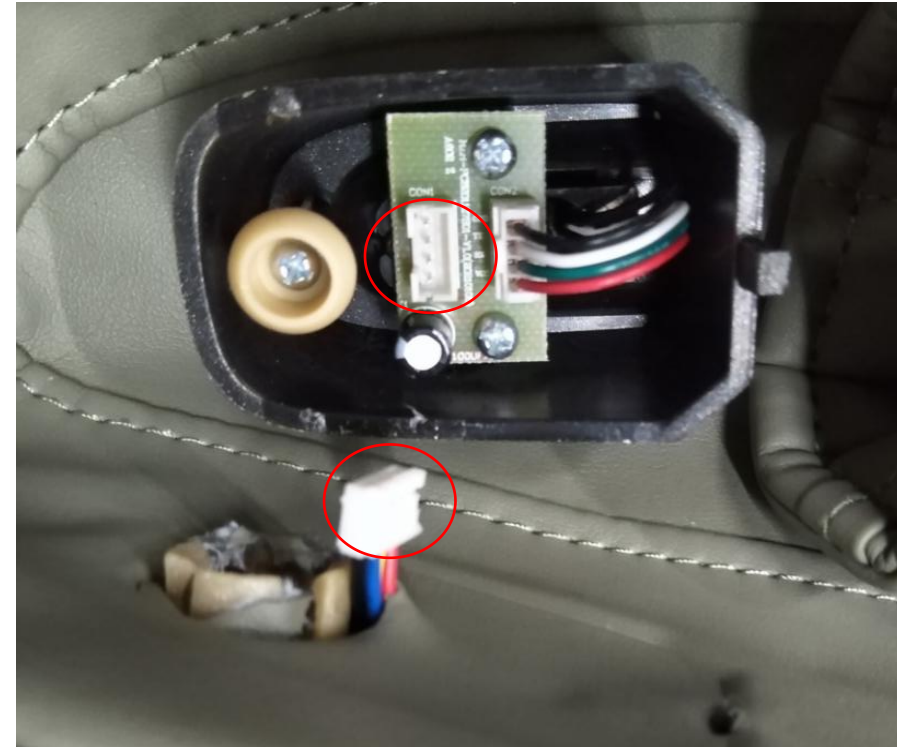
B. Remove the plugin in Figure B

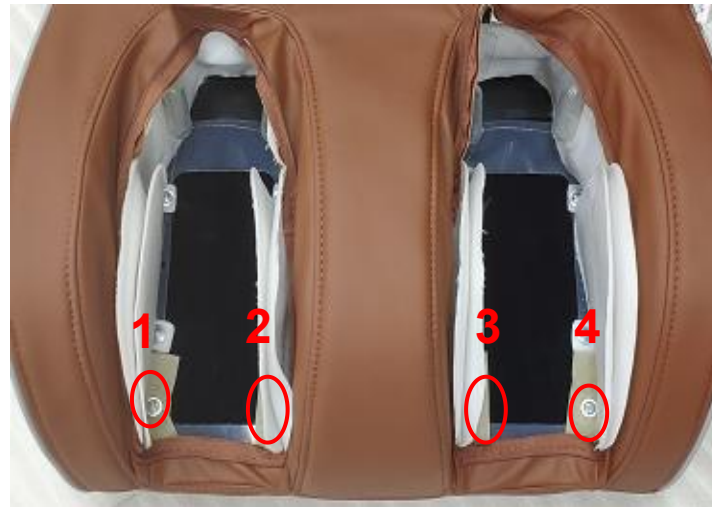
B

B. Remove the four screws as Figure B.

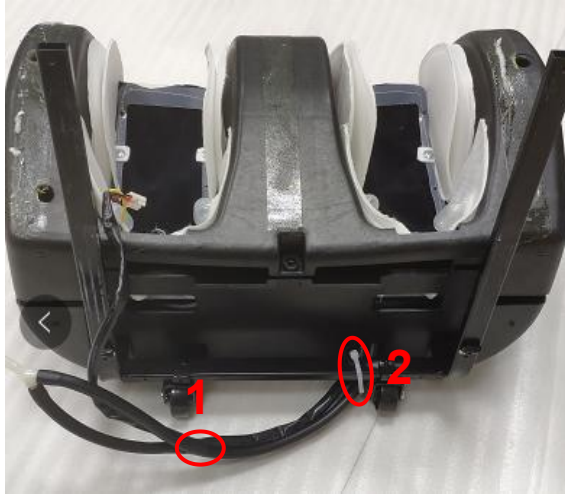
A

A. Remove the tape at position 1 and the zip ties at position 2 shown in Figure A.

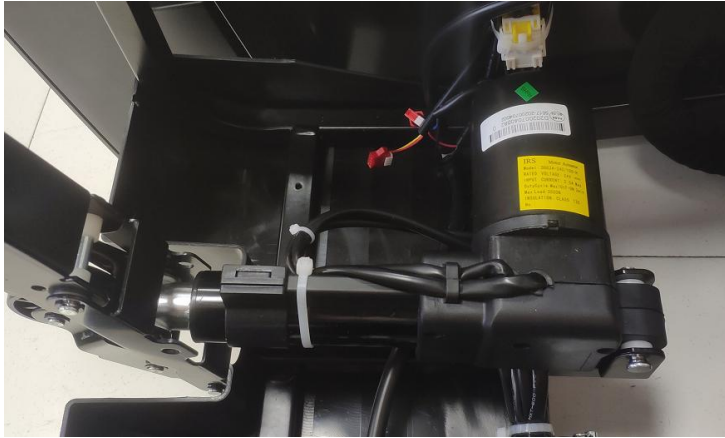
1

A. First, press and hold the electric cylinder control button, and listen, it sounds “beep, beep,” followed by two “drip” sounds when released. This indicates that the electric cylinder signal has not been detected, suggesting that the electric cylinder or the drive board may be faulty. A substitution test can be performed to determine the exact issue.

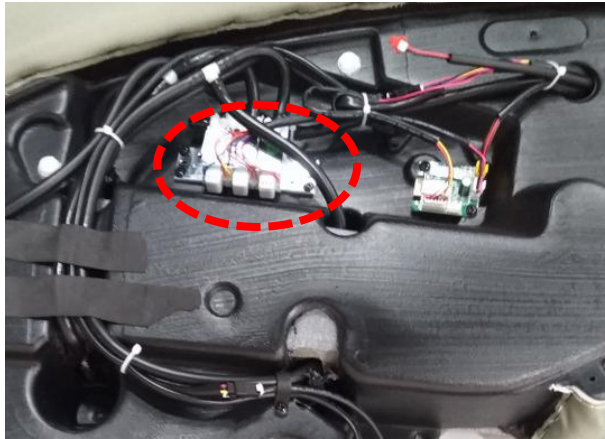
2

A. Check whether the airbag in this circuit is broken or if there are any kinks in the air hose (Figure 2, Figure 3). Visual inspection is recommended, as this is highly probable!

B. The solenoid valve controlling the air pressure in this circuit is damaged (Figure 2). The probability of this being the issue is relatively low.

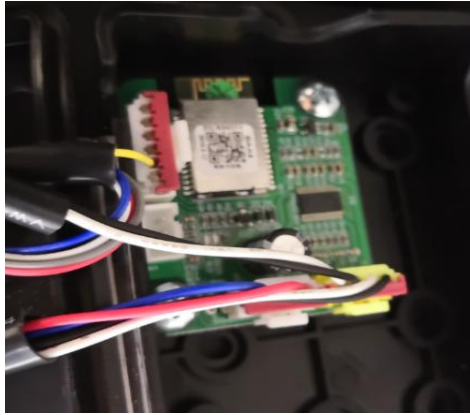
1

A. (Prerequisite: Bluetooth pairing with the phone) Check for poor contact in the audio Bluetooth board wiring or faulty Bluetooth MP3 board; replace it (Figure 1).

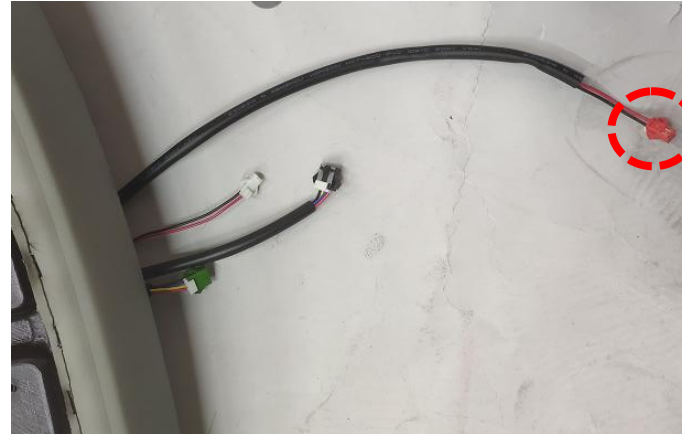
2

B. Check whether there is poor contact or detachment in the armrest wire connector (Figure 2).

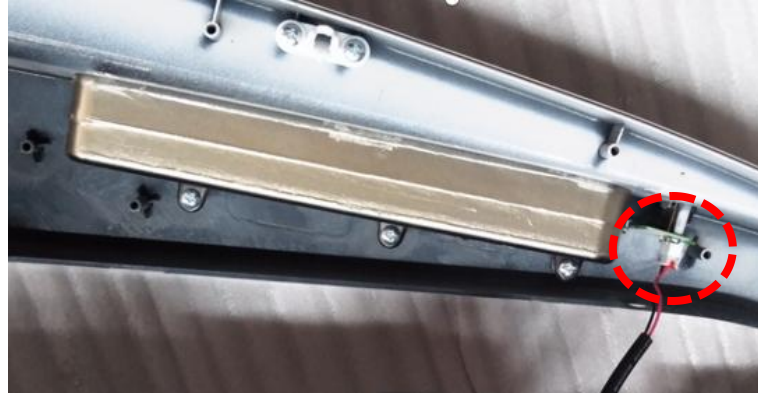
2

B. Check whether the USB connector inside the armrest phone slot has fallen off (Figure 2).

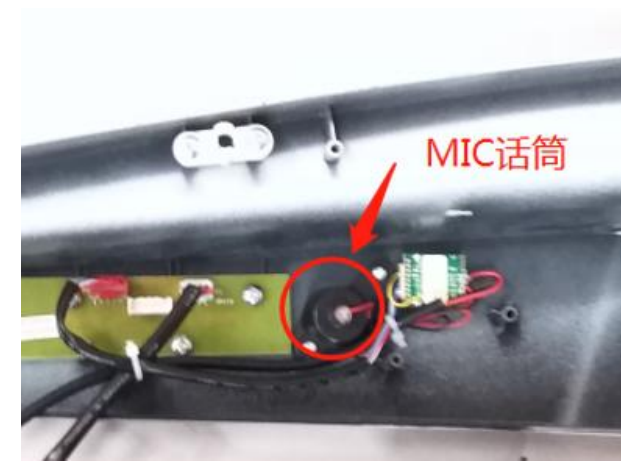
3

- A. Activate the massage chair functions using voice commands and check if there is a voice response (Figure 1).
- B. If the voice control is not working, inspect the wiring and signal quality of the small microphone or check for damage to the smart voice control board (Figure 2 and Figure 3).
