**EASEPAL** 厦门蒙发利电子有限公司客户服务部

# EI-8701C-massage chair service guide

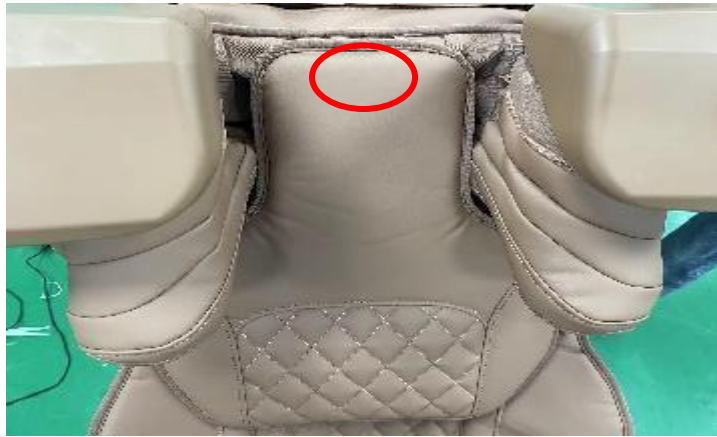
### 3.1、disassembly of the pillow:

A, Pull the magnet apart  
and remove the pillow
