# **A502S-2 Massage Chair After-sale Maintenance**

## **Acro massage chair after-sale service product internal structure**

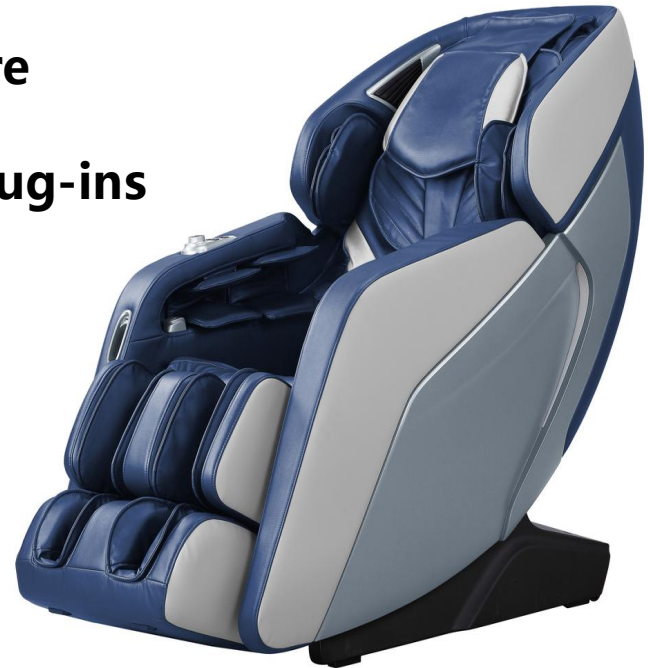
## Part Name

1. Head cushion
2. Sound
3. Upper arm airbag
4. Palm Arm Bag
5. Help shortcut keys
6. Bump Magnetic Therapy Massage
7. Health test seat
8. Controller placement slot and USB Charge Plug
9. Remote controller
10. Seat cushion
11. Leg rest
12. Foot
13. Backrest cushion
14. LED Artistic Conception Lamp
15. Help
16. Side cover

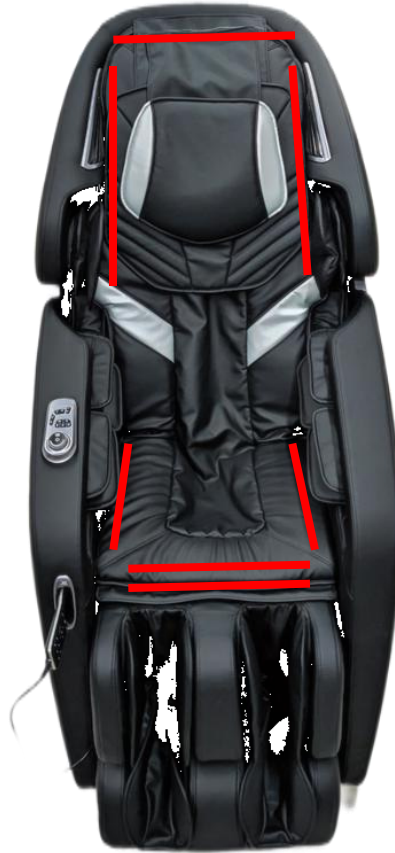
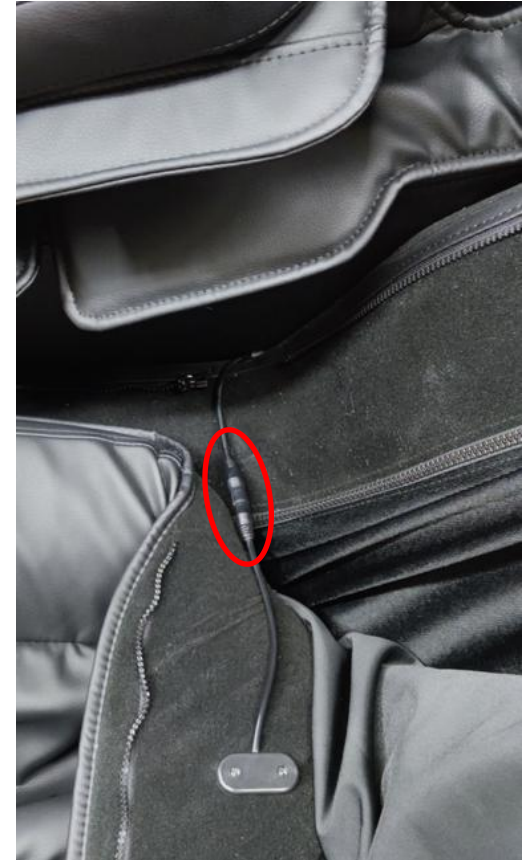
## 5.1. Disassembly Schematic Diagram of Cushion Assembly

1. Remove the chain at the position of 7 red lines on the inner side of the cushion edge

2. Lift the cushion and remove the heating wire interface on the right to remove the cushion assembly

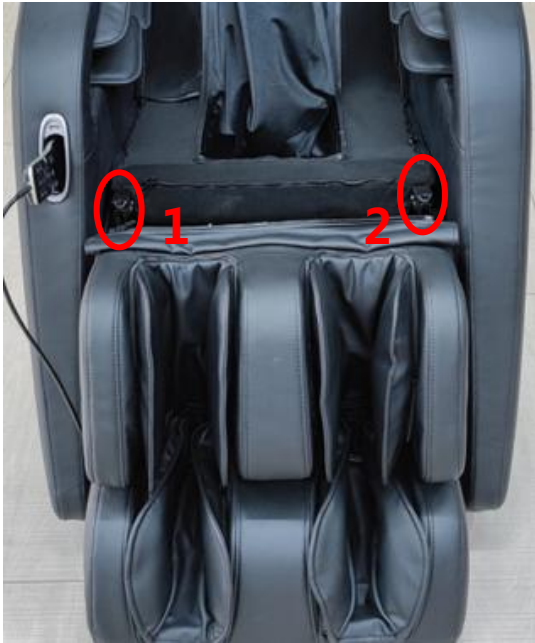
**A**

**A. Remove the mounting seat screws 1 ~ 2 in Figure A**

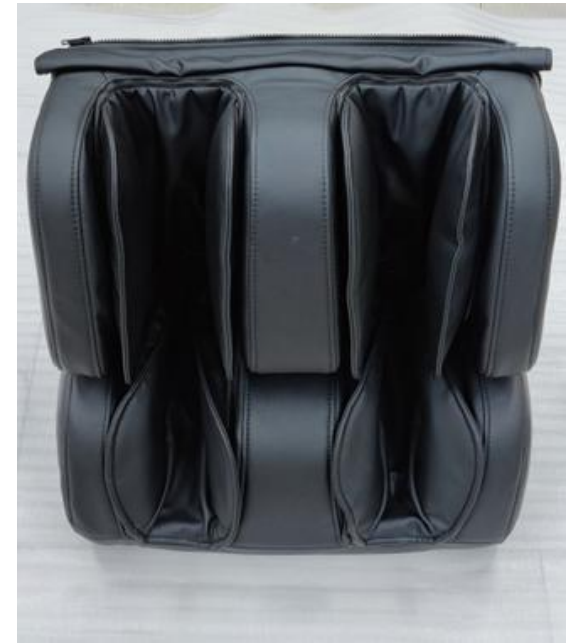
**C**

**C. Remove the lower leg assembly**

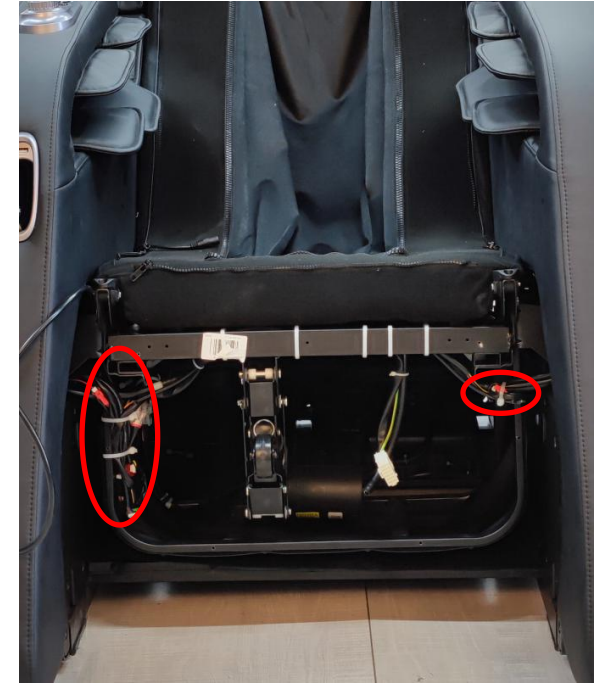
**C**

**C, Circle the figure C to the left and right  
Remove plug-in, air hose and tie**

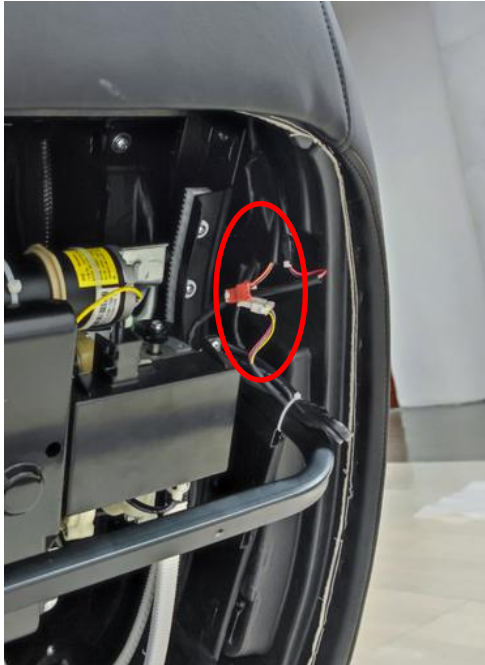
**A**

**A. Plug-in, separation**

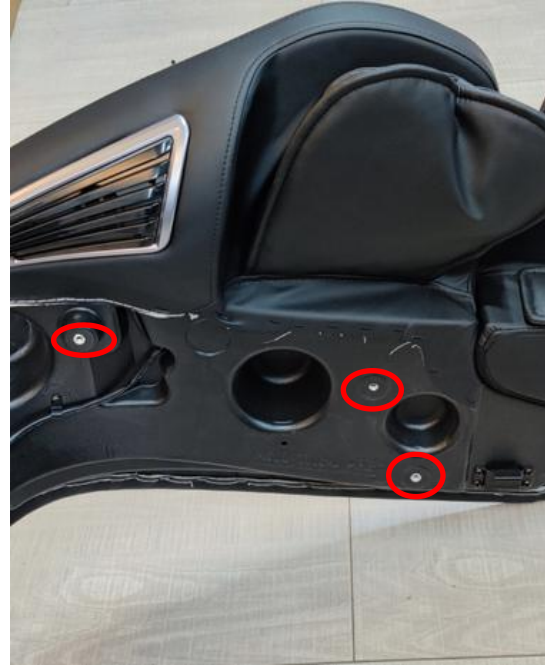
**B**

**B. Remove the left and right fixing screws on the inner side of the capsule.**

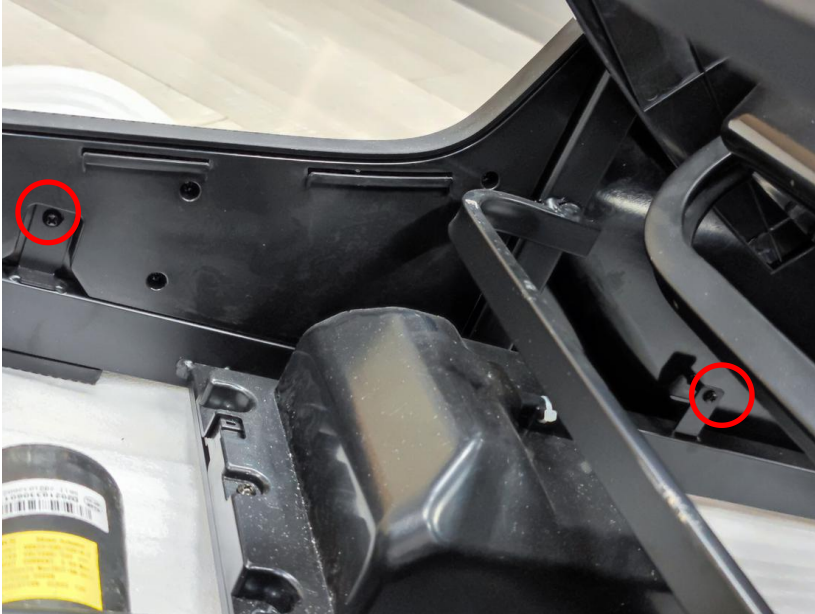
**A**

**A. Remove two screws**

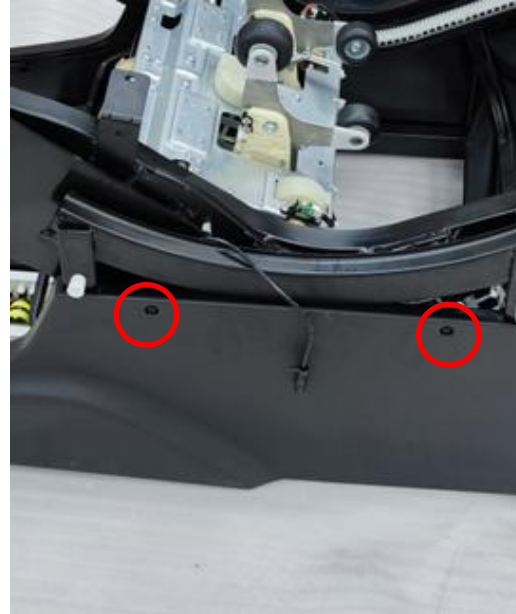
**B**

**B. Remove two screws**

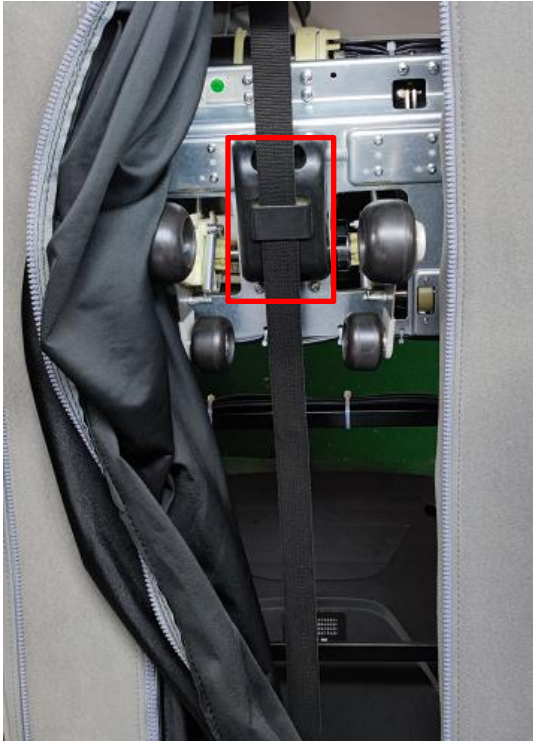
**A**

**A. Remove the screws on the fixed block of the belt**

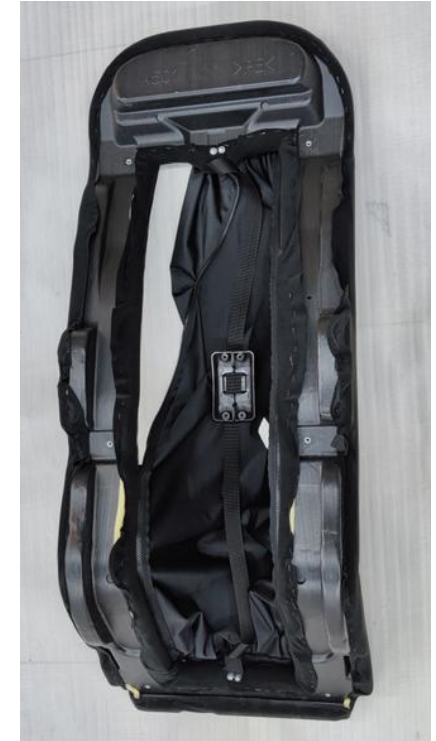
**C**

**C. Remove the rack frame cover**

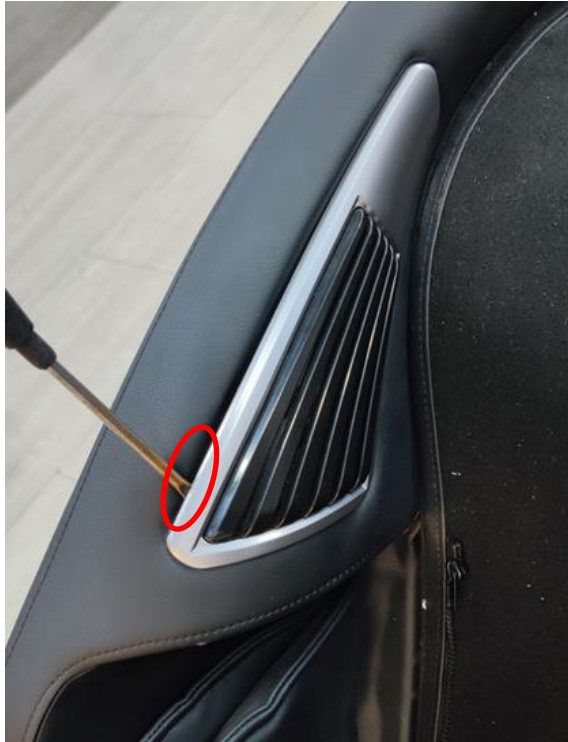
**A**

**A. slightly tilt the inner side of the decorative strip with a straight screwdriver**

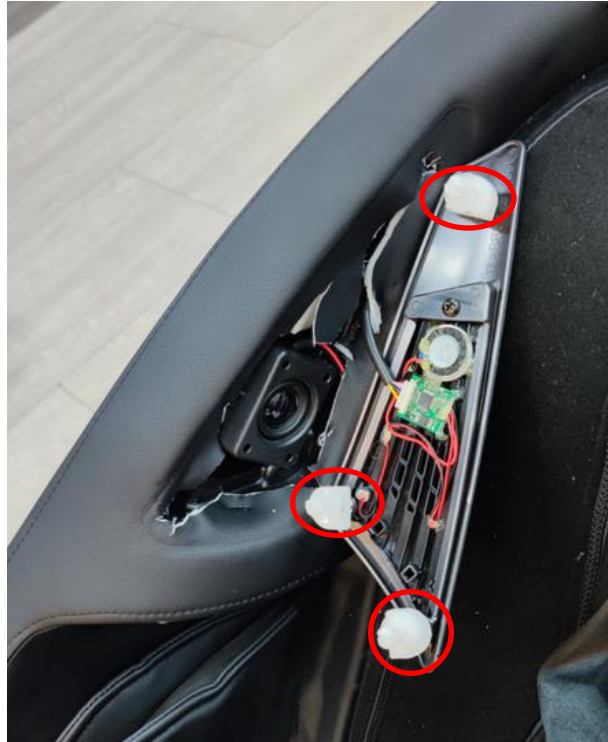
**B**

**B. Remove 3 pieces, take off the speaker cover of the car buckle**

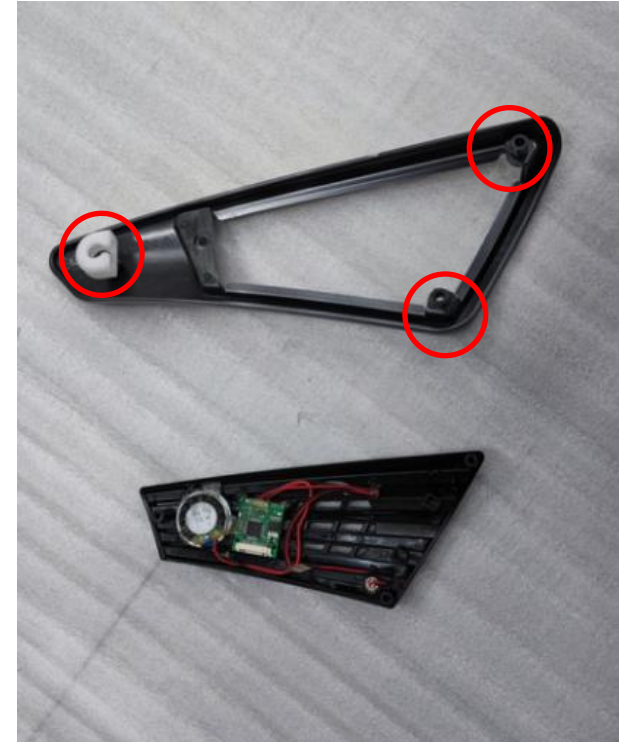
**C**

**C. Remove three fixing screws**

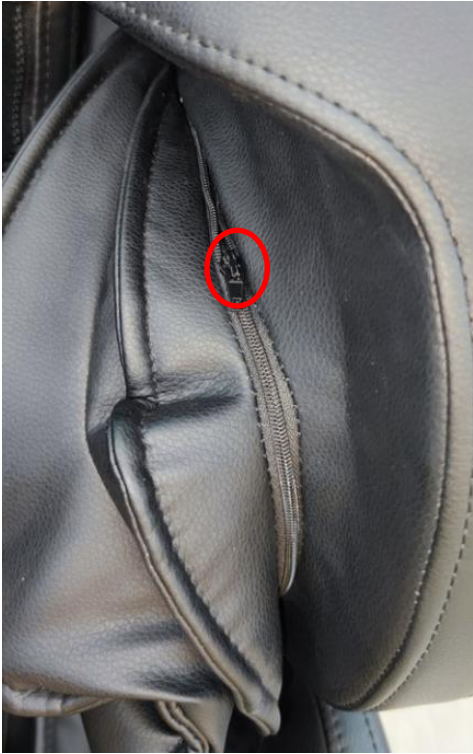
**A**

**A. Unzip Figure A**

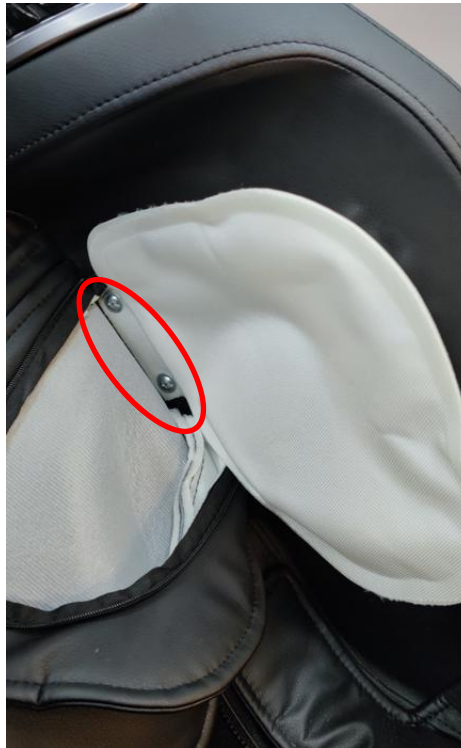
**B**

**B. Remove the screws**

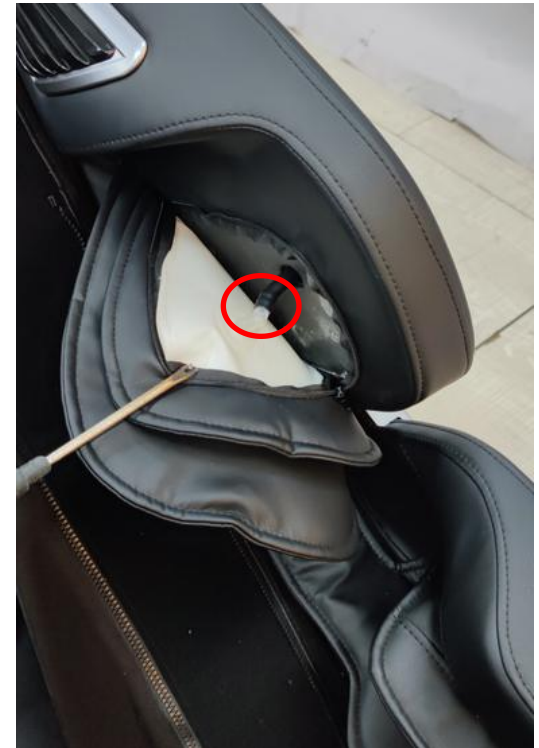
**C**

**C, Separate that air hose**

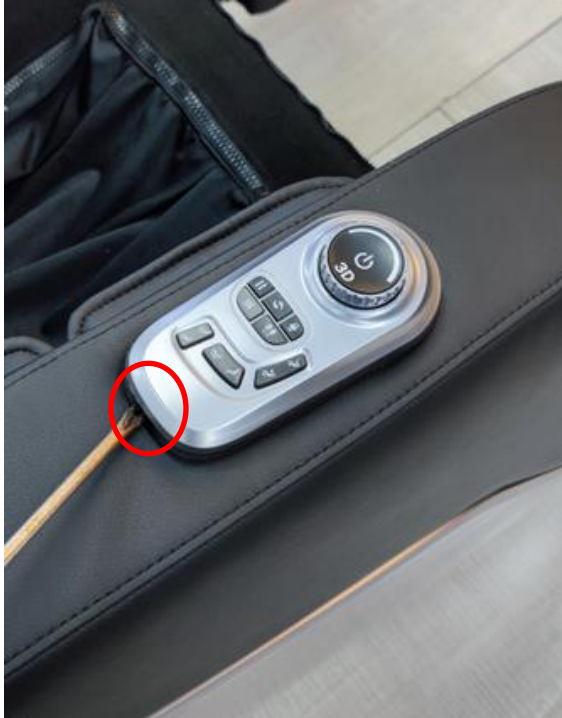
**A**

**A. Tilt the inner side of the decorative strip with a straight screwdriver slightly**

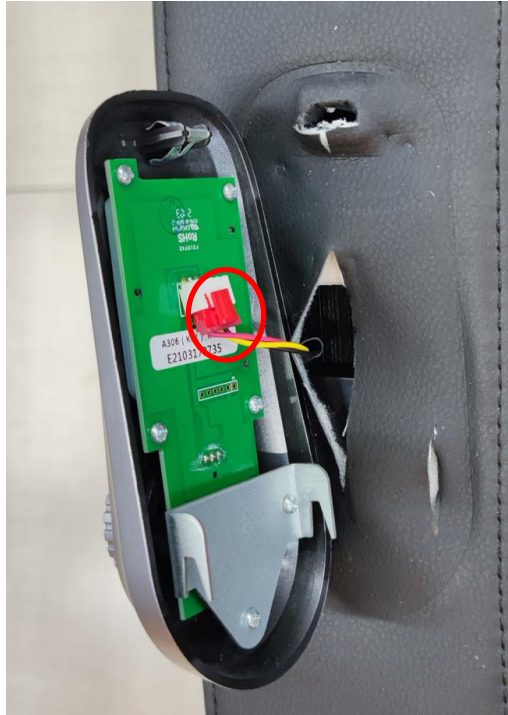
**B**

**B. Separate the key board plug-in**

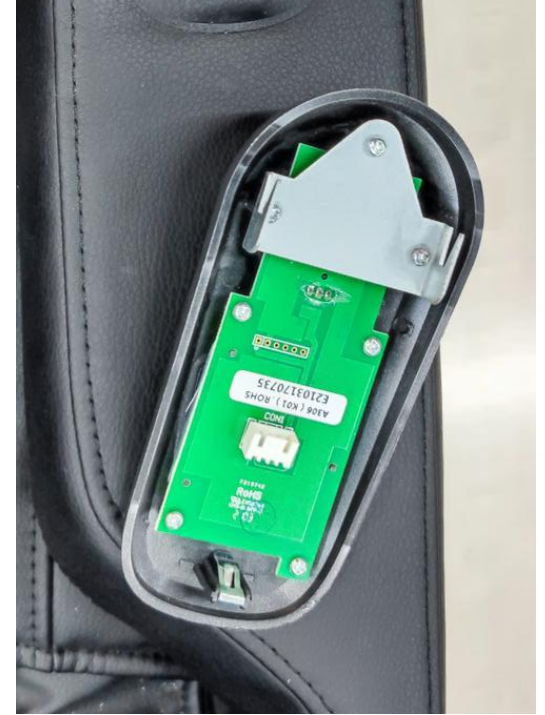
**C**

**C. Remove the armrest shortcut button**

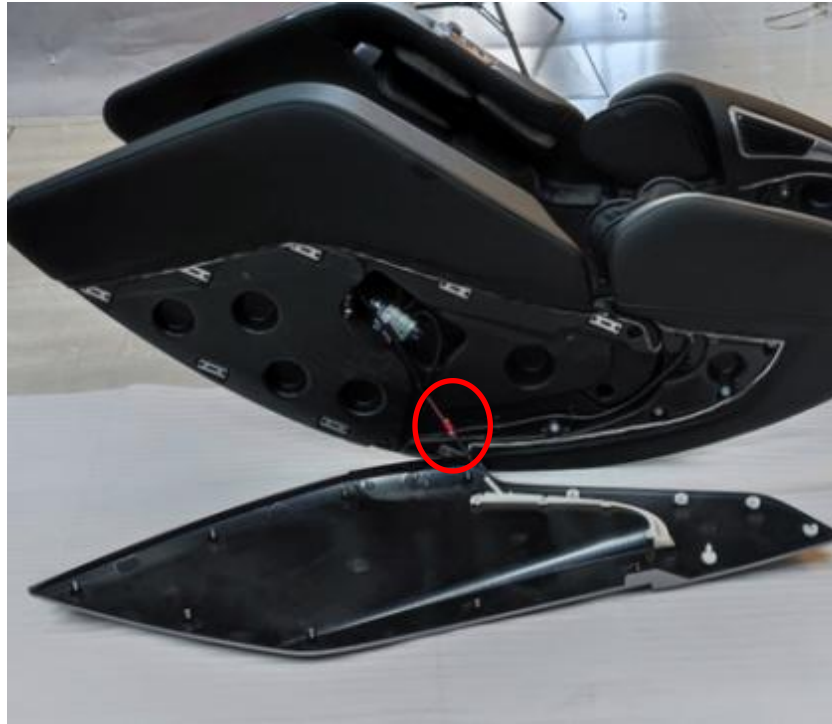
**B**

**B. Separate the LED light plug-in as shown in Figure B**

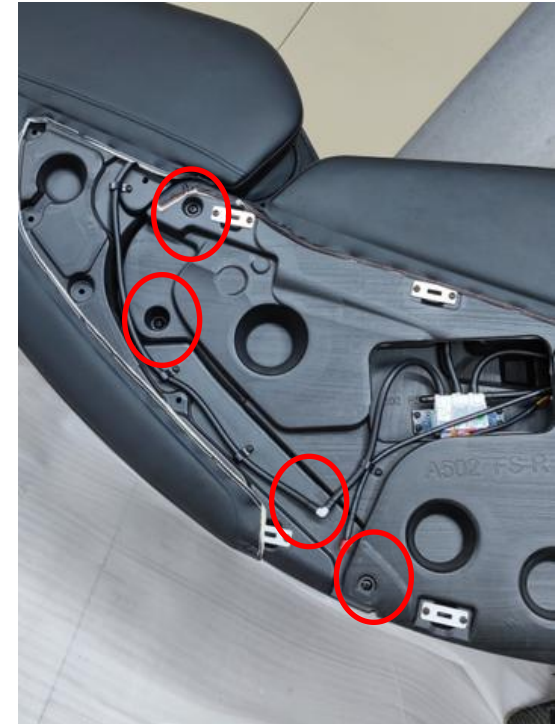
**C**

**C. Separate the air hose and remove fixing screws on the armrest to separate it**

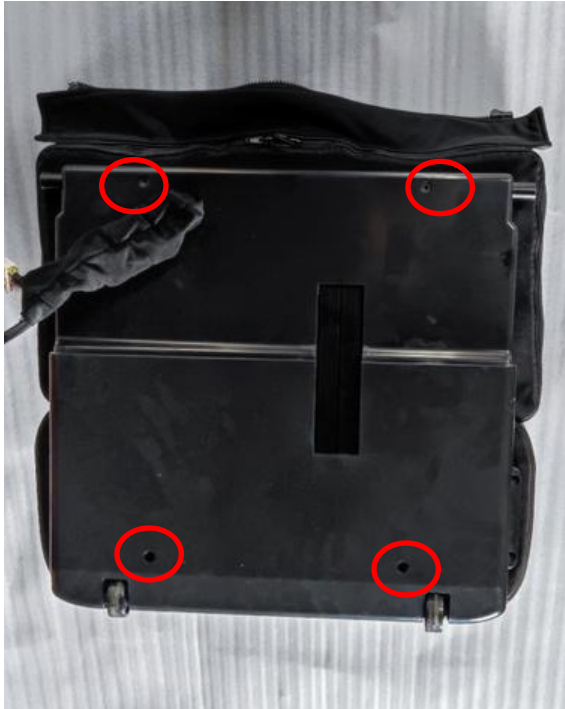
**A**

**A. Remove the 4 screws**

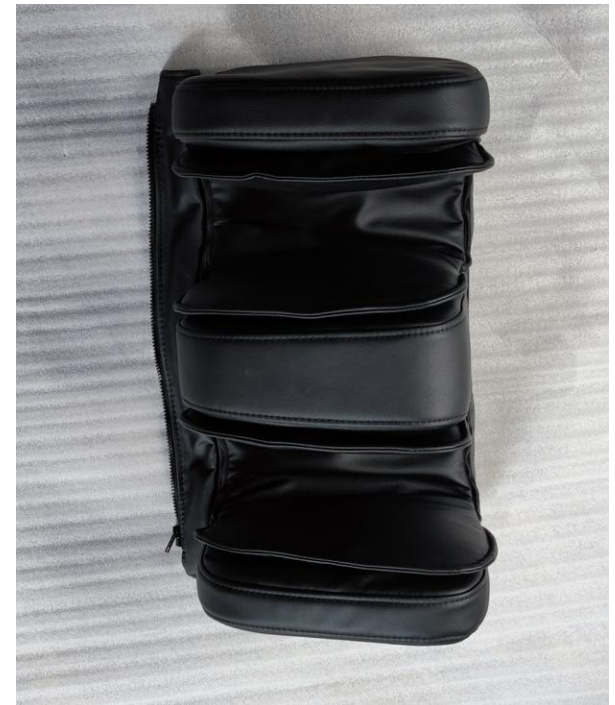
**C**

**C. Separate the upper leg kneading assembly.**

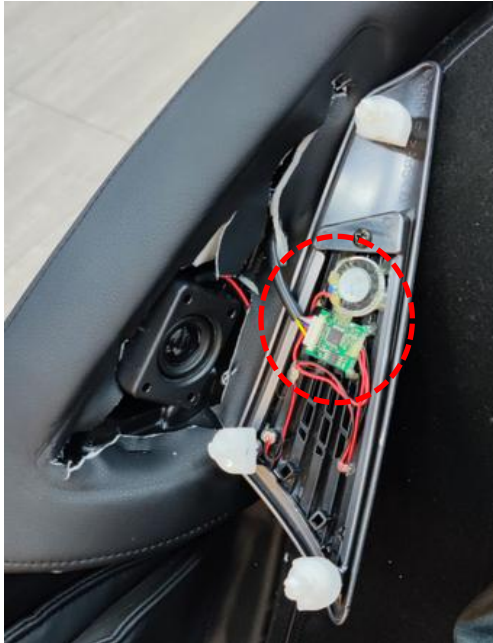
Figure 1

- A、 Start the massage chair function through the voice entry, and listen to whether there is a response to the voice (Figure 1);**
- B、 Voice control does not work, the wiring harness or microphone signal receiving is broken, or the drive board and intelligent voice control board are damaged (FIG. 2 and FIG. 3);**
